December 2, 2025

MIR-25-41

Lithium-ion Battery Fires aboard Cargo Vessel *Genius Star XI*

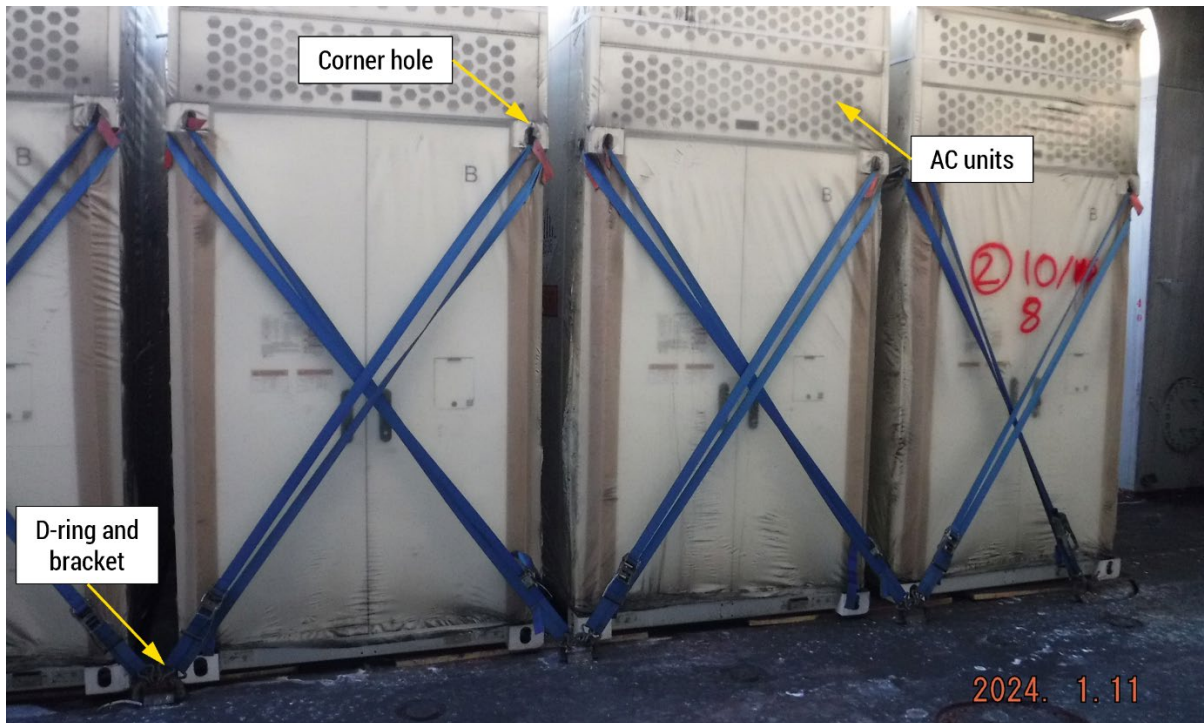
The belts connected to the four corner-lifting holes located between the air conditioning section and the battery storage section of the BESS unit. Chafing gear was placed in the lifting hole to protect the lashing belt from rubbing. One of the hooks on the belt was connected to a D-ring on the deck; the belt was then fed up through one of the corner-lifting holes and returned to the D-ring where the second hook was also connected. Stevedores would then ratchet up the lashing belt until it was taut (see figure 6).

Figure 6. Postcasualty photo showing the method used to secure the units within the cargo hold. (Source: US Coast Guard).

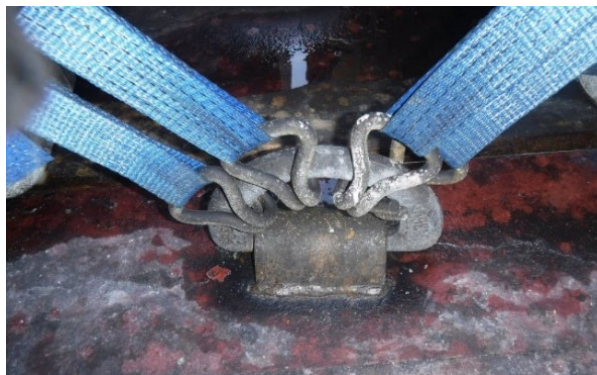
Figure 7. Postcasualty photo showing a D-ring held by a bracket that is attached to the tween deck, with four hooks (two lashing belts). (Source: Coast Guard)

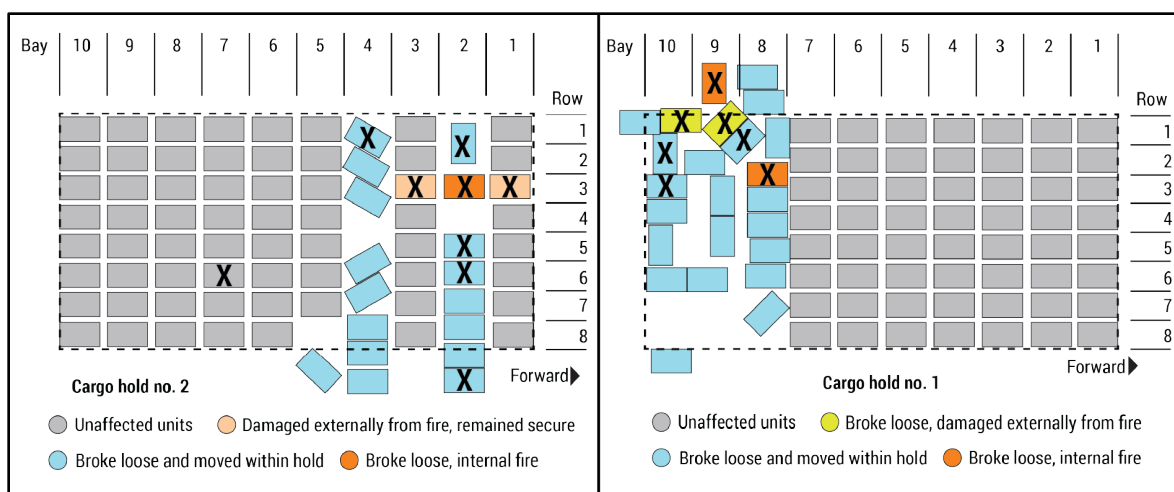
Investigators focused on 15 of the 43 damaged BESS units on the tween decks (seven from cargo hold no. 1 and eight from cargo hold no. 2) (see figure 20). Of those 15 units, 13 had broken away from their lashing belts and had shelf rail deformations that were bent down. In addition, investigators noted that within these 13 units, some or all of the shelves containing the lithium-ion battery packs had also collapsed. It was also noted that the exterior of these units had several dents and scratches, but this damage did not penetrate deep enough into the interior of these BESS units to damage shelf rails.

Figure 20. BESS units marked with an X were examined by investigators on February 25, 2024. (Background source: ESA)

The other two units of the 15 examined had fire damage but remained secured during the incident. Investigators found that the unit located in cargo hold no. 2, row 3, bay 1 had heavy thermal damage on its exterior, and the unit located in cargo hold no. 2, row 3, bay 3, had soot located within the interior.
