MIR-25-42

Collision between Offshore Supply Vessel *Jack Edwards* and Cargo Vessel *Julie C*

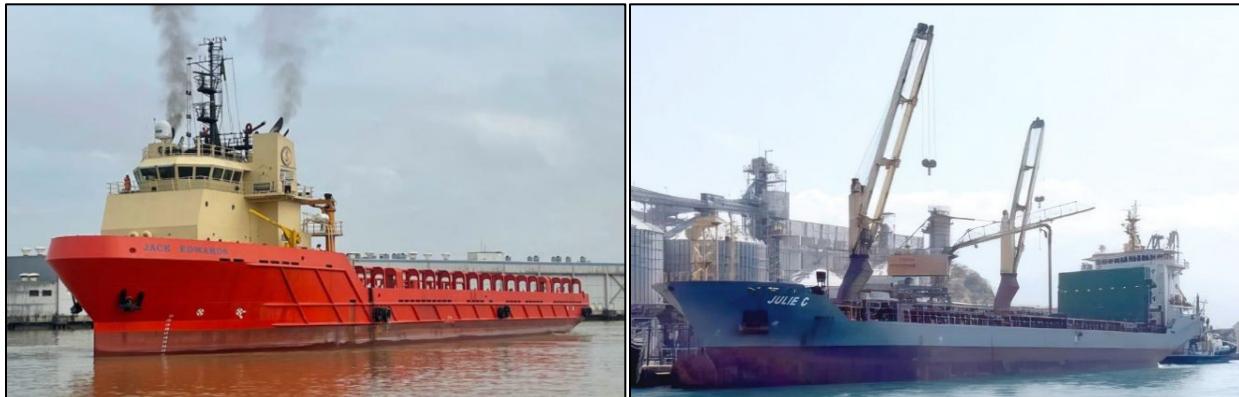
On March 17, 2024, at 2253 local time, the offshore supply vessel *Jack Edwards* was in the Atlantic Ocean transiting inbound to Georgetown, Guyana, when it veered to port and collided with the outbound general cargo vessel *Julie C* (see figure 1 and figure 2).¹ After the collision, the *Jack Edwards* continued to Georgetown under its own power. The *Julie C* returned briefly to Georgetown before proceeding on its intended voyage. Two crewmembers on the *Jack Edwards* sustained minor injuries. As a result of the collision, an estimated 2,200 gallons of diesel fuel were released into the water from the *Jack Edwards*. Damages to the *Jack Edwards* and *Julie C* were estimated at \$1.025 million.

Figure 1. Left to right: *Jack Edwards* arriving at a repair shipyard in April 2024 after the collision, and the *Julie C* at an unknown date before the collision. (Source: Edison Chouest Offshore; The CSL Group Inc.)

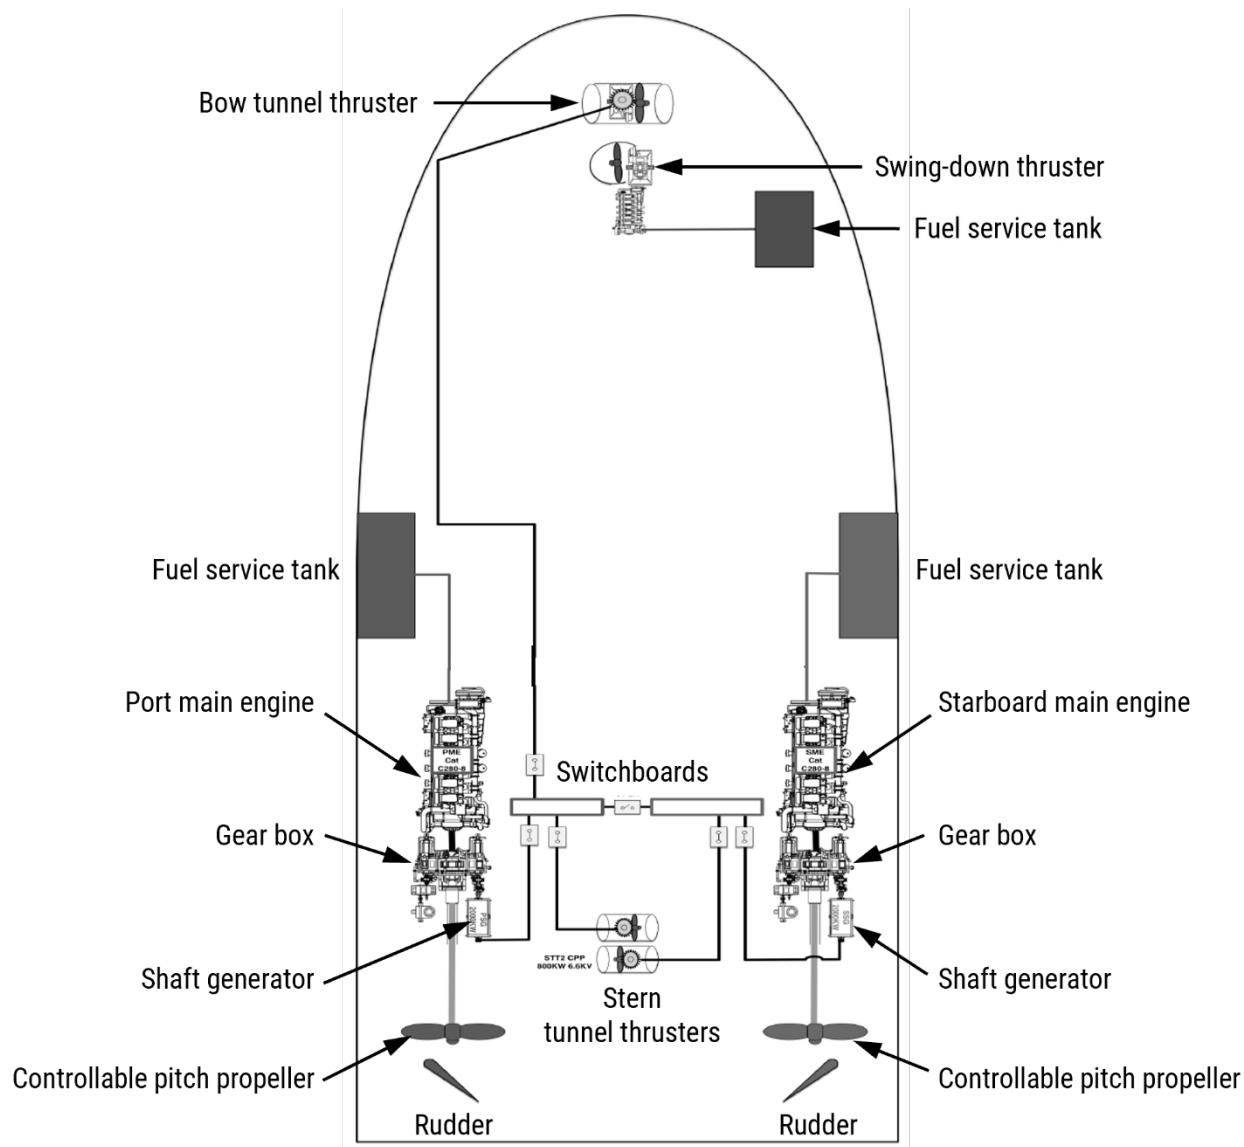
from the port main engine shaft generator. The aft stern thruster was powered from the starboard main engine shaft generator (see figure 4).

Figure 4. *Jack Edwards* propulsion and rudder simplified arrangements. Not to scale.
(Background source: ECO)

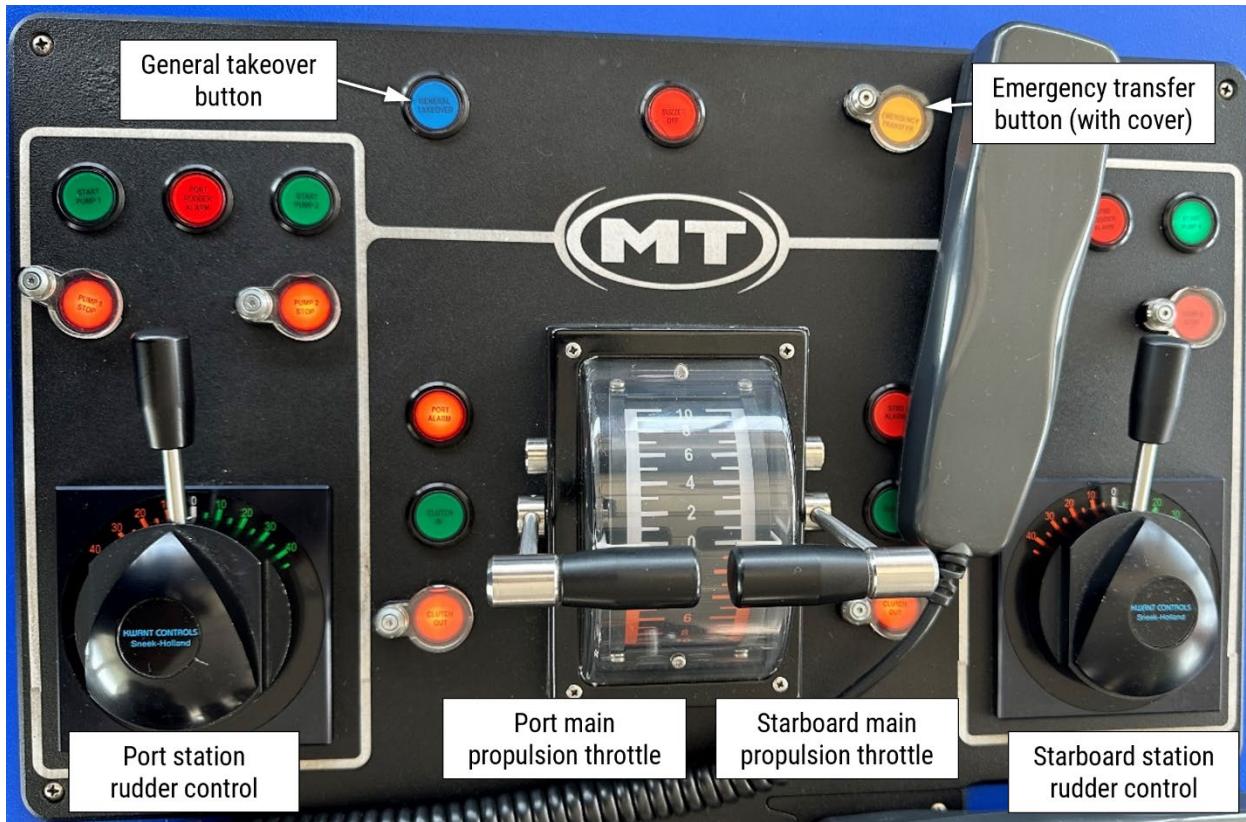
consoles. In an emergency, control could be taken at a console by depressing an "emergency transfer" button one time. To prevent an inadvertent shift of control, the emergency transfer button had a protective cover that had to be rotated away from the button before pushing it (see figure 5).

Figure 5. *Jack Edwards* propulsion and rudder controls on the forward bridge console.
(Background source: Coast Guard)

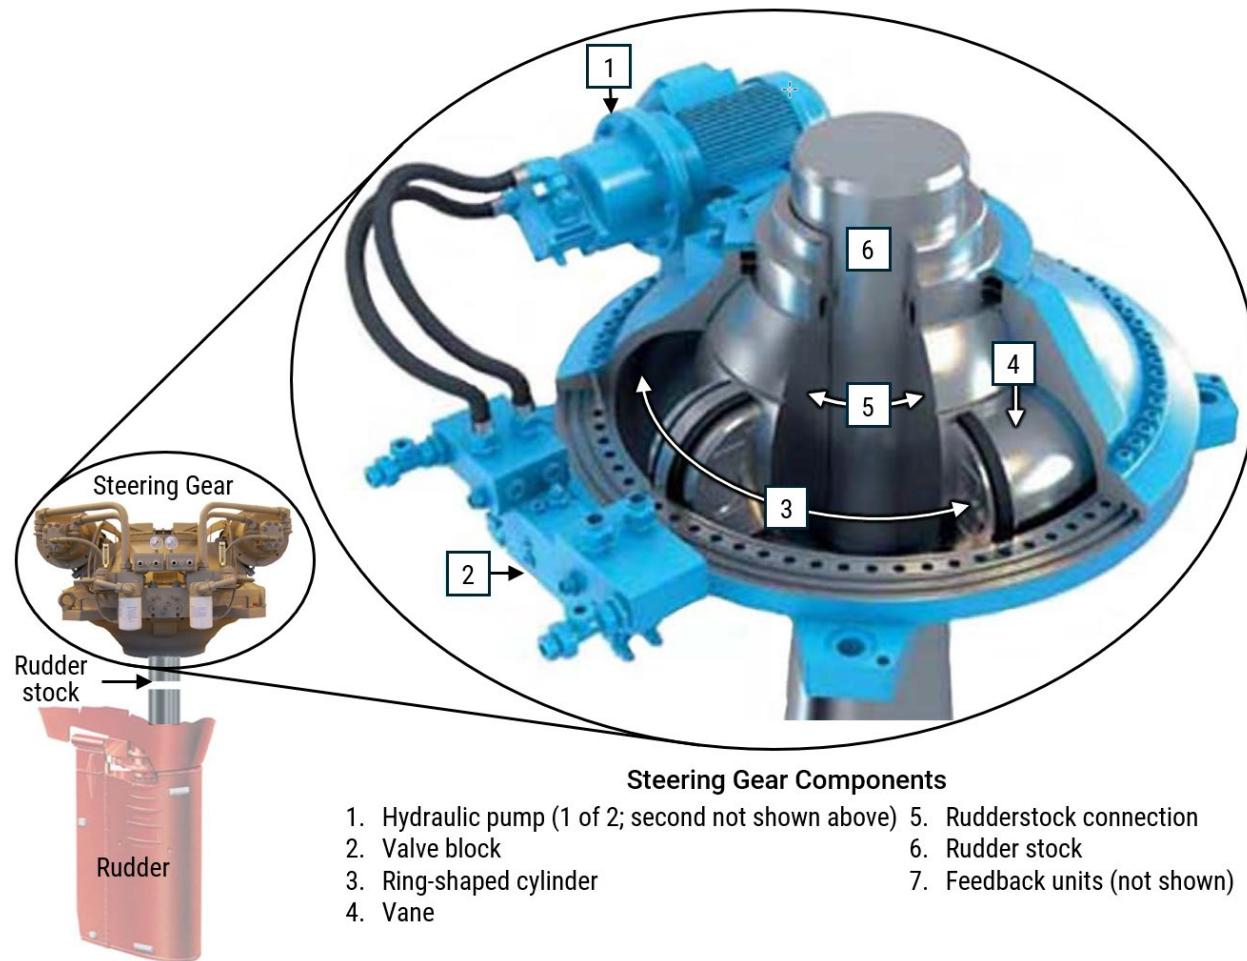
The *Jack Edwards* was fitted with vane-type Rolls-Royce SR 662 steering gears for the port and starboard rudders.⁵ When a rudder command signal was sent to a steering gear, two hydraulic pumps on the gear started and ported oil via a valve block into a ring-shaped cylinder (see figure 10). Vanes within the cylinder, which were connected to the rudder stock, moved under the hydraulic pressure and turned

the rudder to the ordered angle. Once the rudder reached the ordered angle, the pumps stopped. To move the rudder in the opposite direction, the pumps operated in reverse. A feedback unit attached to the steering gear provided the rudder's position to the rudder indicating system and bridge control system. The feedback unit followed the rudder by means of a gear and chain system.

Figure 10. *Jack Edwards* steering gear. (Background source: *User Manual, Rolls-Royce Steering Gear SR*)

In November 2023, a vessel engineer reported that the chain for the feedback unit on the *Jack Edwards*'s starboard steering gear was broken. A replacement chain was ordered and installed on February 4, 2024, while the vessel was in the shipyard. According to the steering gear manufacturer, installation of the chain was not a difficult procedure, but an improper installation could give faulty feedback to the rudder angle indicator or the bridge control system.

On February 13, 2024, a vessel engineer reported that steering pump no. 4, one of the two steering pumps on the starboard steering gear, was "getting a hydraulic lock." As a result, when a command to turn the rudder was received, either from the bridge or locally at the steering gear, the rudder did not turn. During troubleshooting, technicians replaced solenoids and fuses in the steering gear. After these repairs, the rudder could turn to port but would still not move to starboard. Troubleshooting further, a technician replaced steering pump no. 4 and disassembled the steering gear valve block. Upon opening the valve block, he found that a plastic cap on a hydraulic-lock sensor was missing and a cap on another hydraulic-lock sensor was melted. He also reported that the hydraulic oil was dirty. After replacing the sensors and reassembling the valve block, the system operated correctly, according to documentation for the repair. There was no record that the hydraulic oil was replaced during the repairs.

no further leakage observed. The technician attributed the wiper and low-pressure void seal failures to "a damaged dust ring, allowing trash buildup past the wiper seal and into the low-pressure void." According to the manufacturer representative, the poor condition of the low-pressure seals would not directly affect the performance of the steering gear, but if "dirt" got into the steering gear system, it could affect other seals and valves.

During postcasualty drydock repairs to the vessel conducted in Navegantes, Brazil, the starboard steering gear pumps were serviced, during which an elastic coupling was replaced and the hydraulic oil in the system was changed out.
