December 10, 2025

MIR-25-45

## Contact of Bulk Carrier *Algoma Discovery* with BNSF Allouez Taconite Facility

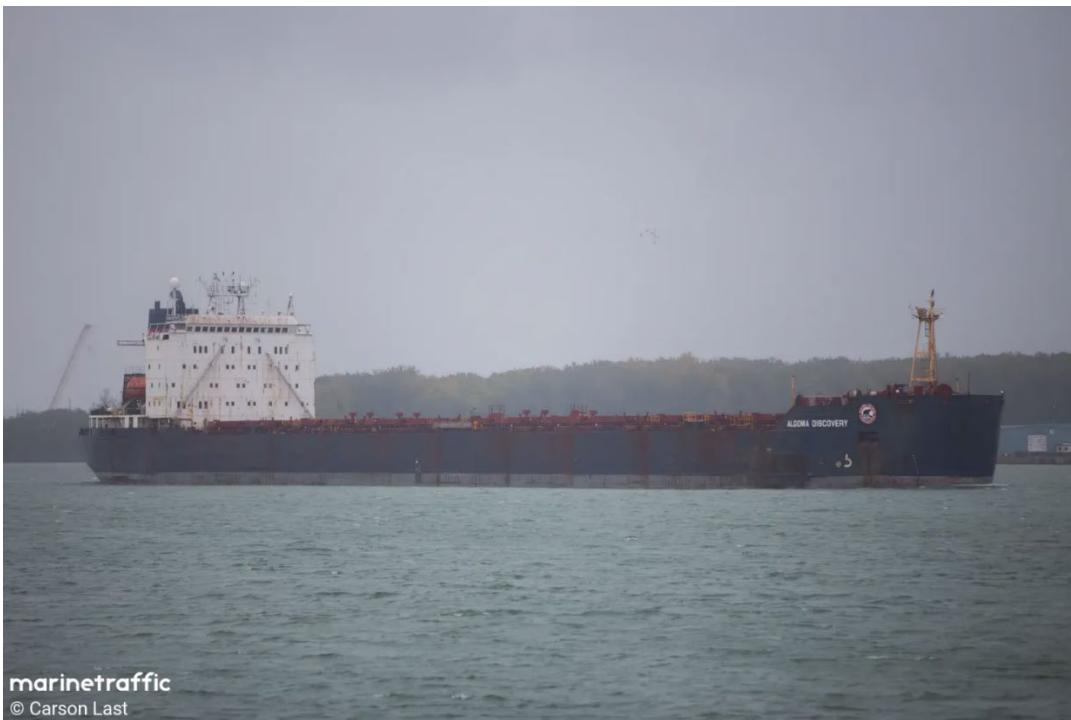
**Figure 1.** *Algoma Discovery* at unknown date before the contact. (Source: Carson Last, marinetrack.com)

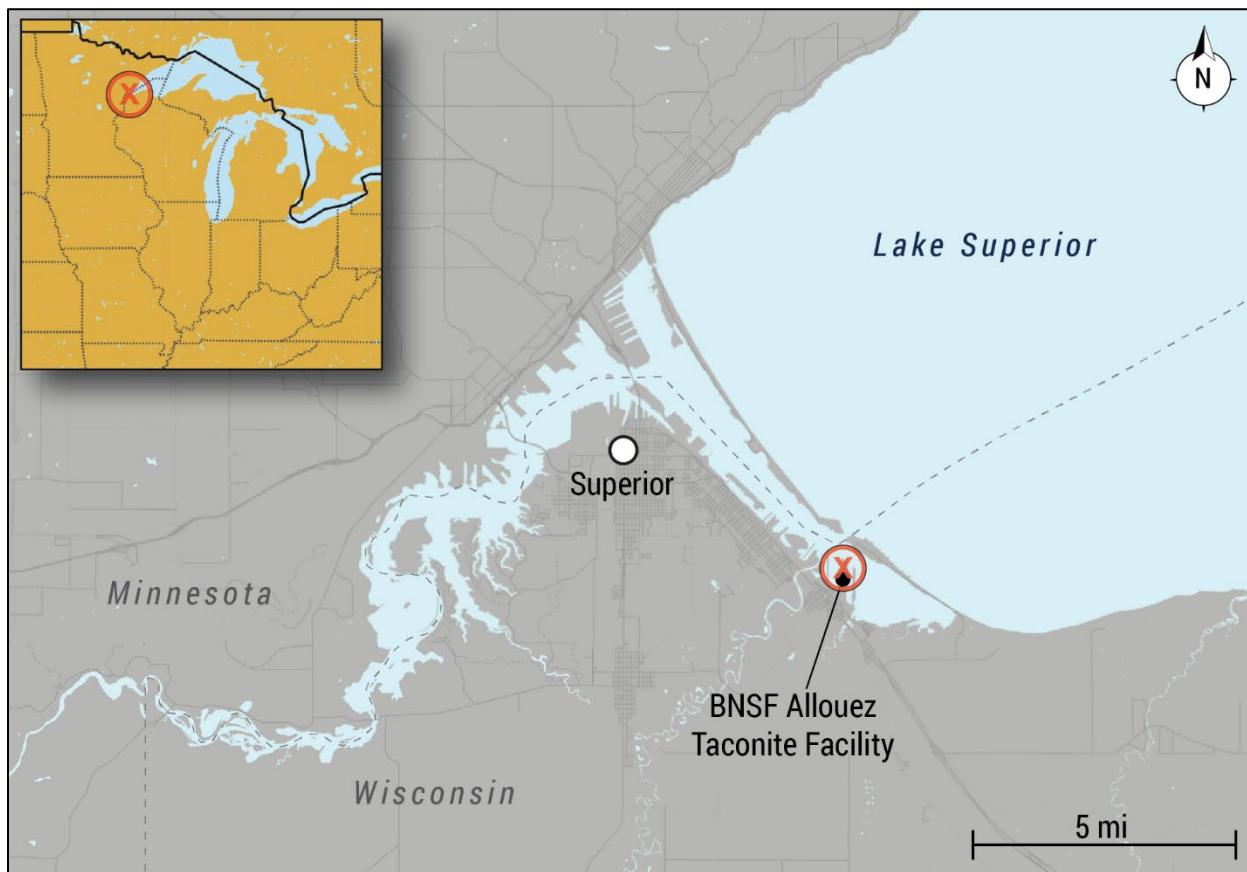
On July 20, 2024, about 2215 local time, the Canada-flagged cargo vessel *Algoma Discovery* struck five of the loading shuttles at the BNSF Allouez Taconite Facility, in Superior, Wisconsin, after losing electrical power and main propulsion while docking (see figure 1 and figure 2).<sup>1</sup> There were no injuries, and no pollution was reported. Damage to the facility was estimated at \$950,000, and damage to the *Algoma Discovery* was estimated at \$130,000.

**Figure 2.** Area where the *Algoma Discovery* contacted the BNSF Allouez Taconite Facility, as indicated by a circled X. (Background source: Google Maps)
