MIR-25-46

# Sinking of Barge PTC 706 and Subsequent Breakup of *Chad Pregracke* Tow

On March 16, 2024, about 0008 local time, the towing vessel *Chad Pregracke* was transiting southbound on the Lower Mississippi River pushing 34 loaded barges, near mile 260.6, about 5 miles east of New Roads, Louisiana, when a barge, the PTC 706, at the head of the tow rapidly sank, causing the tow to break apart (see figure 1 and figure 2).<sup>1</sup> Five barges in the tow were damaged. Damages were estimated at \$2 million. There were no injuries, and no pollution was reported.

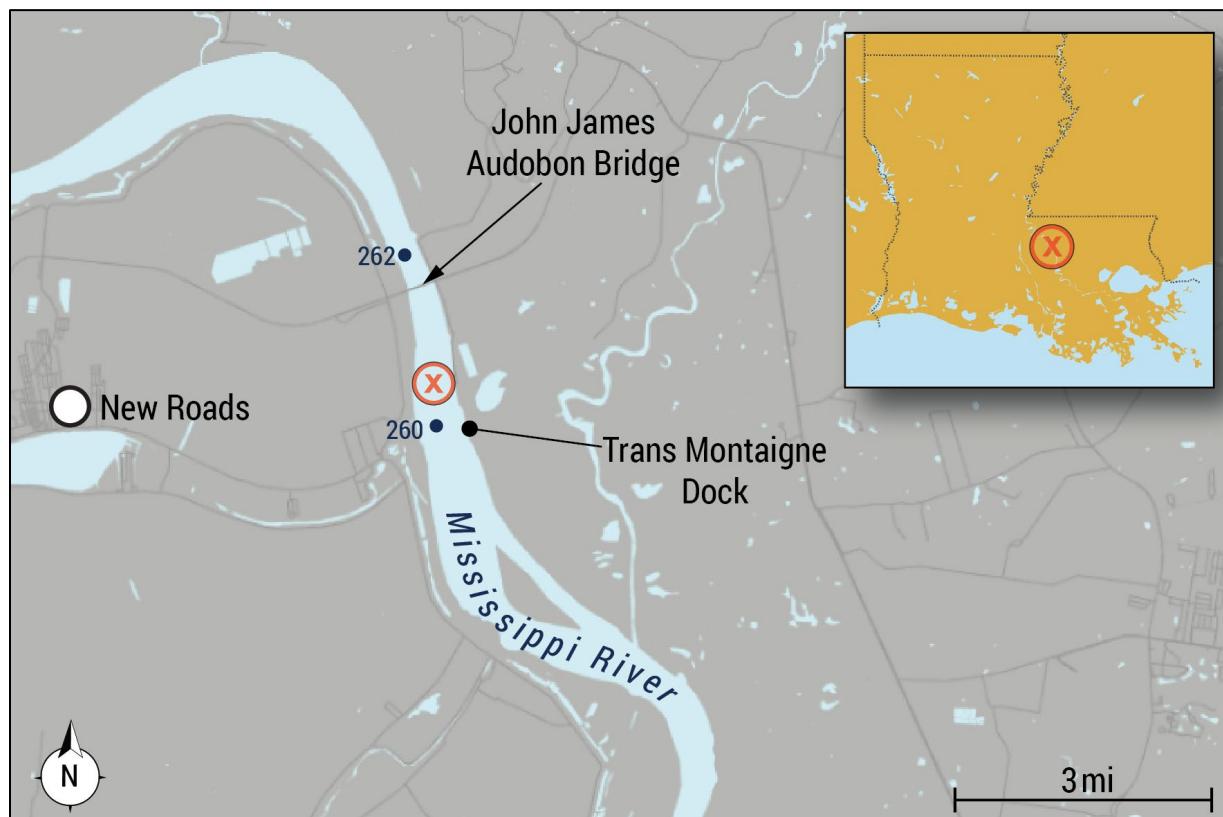
**Figure 2.** Area where the *Chad Pregracke* tow broke up, as indicated by a red X.  
(Background source: Google Maps)

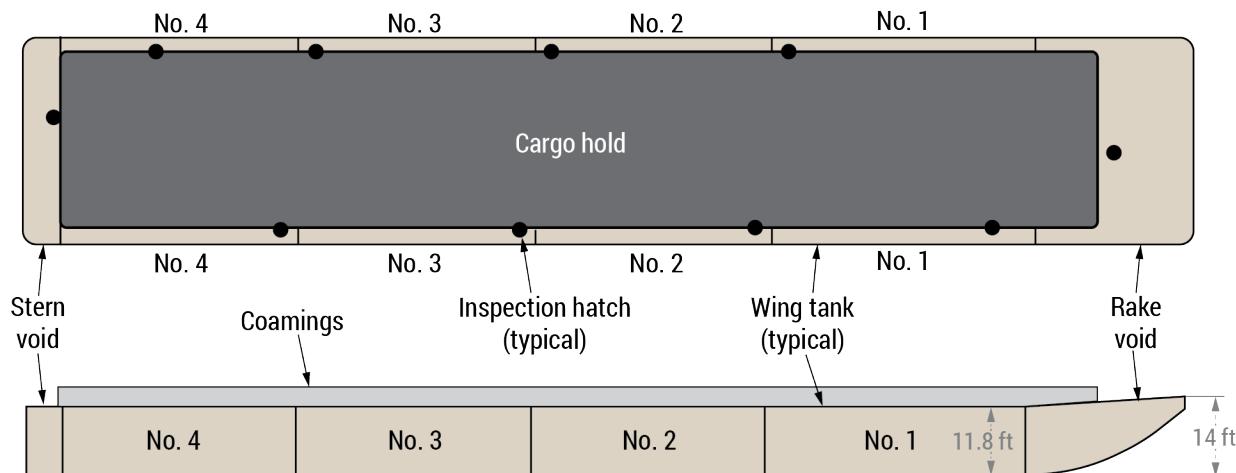
The 200-foot-long *PTC 706* was a steel hopper barge built in 2012 and owned by Parker Towing Company. The hull depth of barge *PTC 706* was 11.8 feet. The raked bow of *PTC 706* sloped upward from the forwardmost watertight bulkhead between the rake void and wing tank no. 1 by 2.2 feet (see figure 3).<sup>2</sup> The coamings for the cargo hopper were 3 feet above the main deck. When the *Chad Pregracke* crew picked up the barge, along with other barges, on March 14, per company policy they recorded the *PTC 706*'s drafts on their load draft reading form at 9 feet 5 inches forward and 9 feet 6 inches aft.

**Figure 3.** Simplified plan and profile views of hopper barge *PTC 706*.

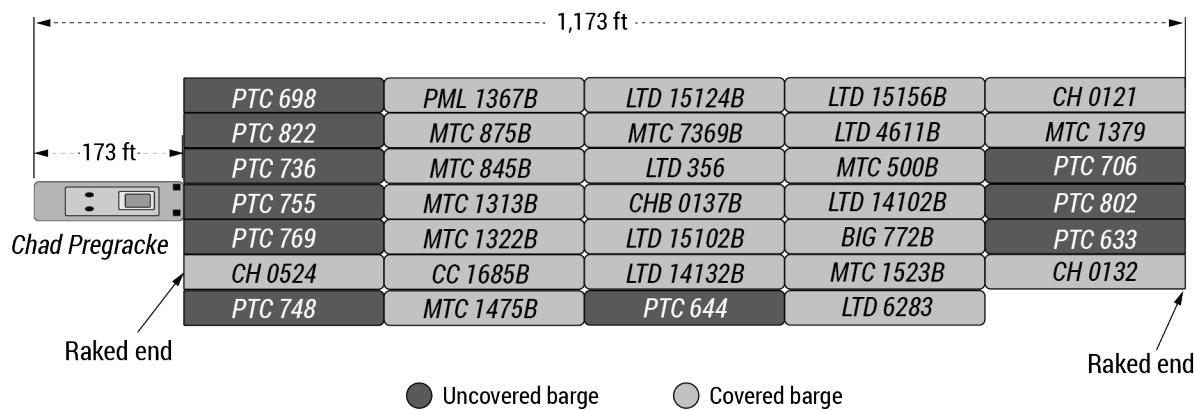
and coal. The barges with soybeans and corn had covers over their cargo hoppers; the coal barges did not. At the head of the tow, the barges' raked ends faced forward, while at the aft end of the tow, the *Chad Pregracke* was faced up to the barges' raked ends. The PTC 706's freeboard was about 30 inches, and the two other uncovered coal barges at the head of the tow had a freeboard of 30-31 inches. The covered barges at the head of the tow had varying freeboards: the port outermost barge (CH 0121) had 18 inches, the second tier barge from port (MTC 1379) had 30 inches, and the starboard outermost barge (CH 0132) had 24 inches.

**Figure 4.** Tow diagram of the *Chad Pregracke*.
