March 10, 2026

MIR-26-07

## Grounding of Fishing Vessel *Eileen Rita*

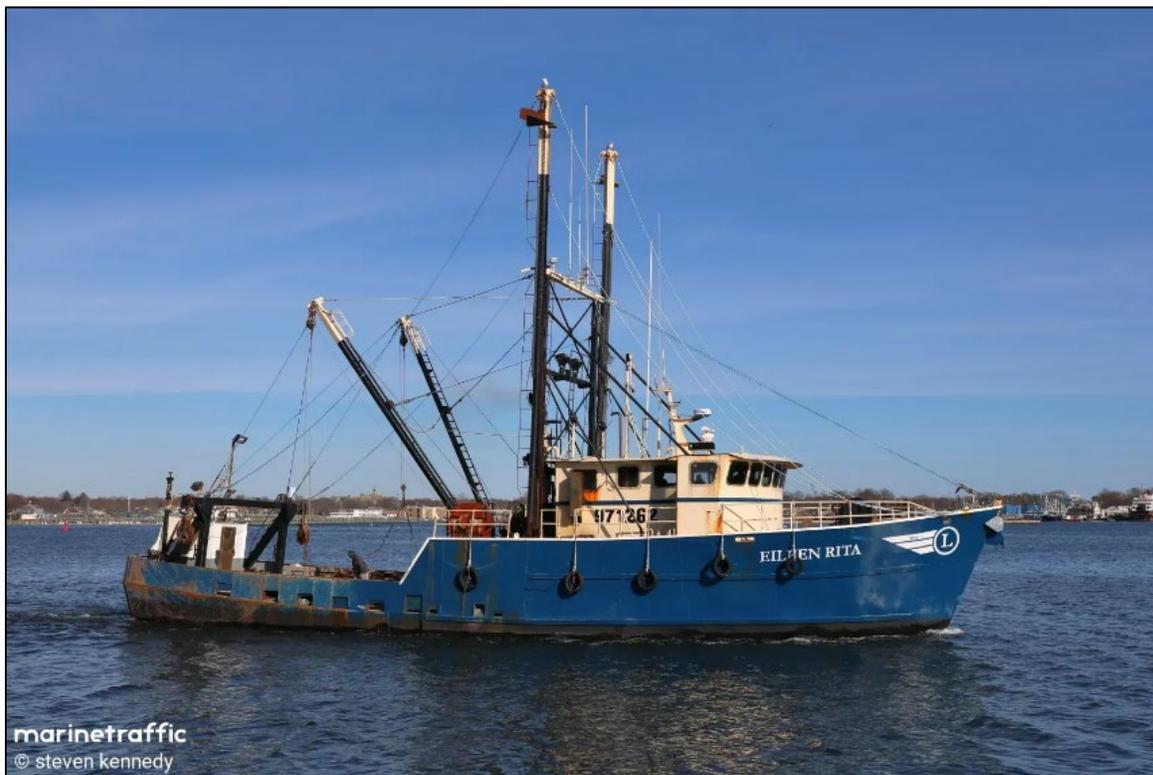
**Figure 1.** *Eileen Rita* underway in New Bedford, Massachusetts, in 2020. (Source: Steven Kennedy, marinetraffic.com)
