MIR-26-08

Engine Room Fire aboard Cargo Vessel *Lem Verbena*

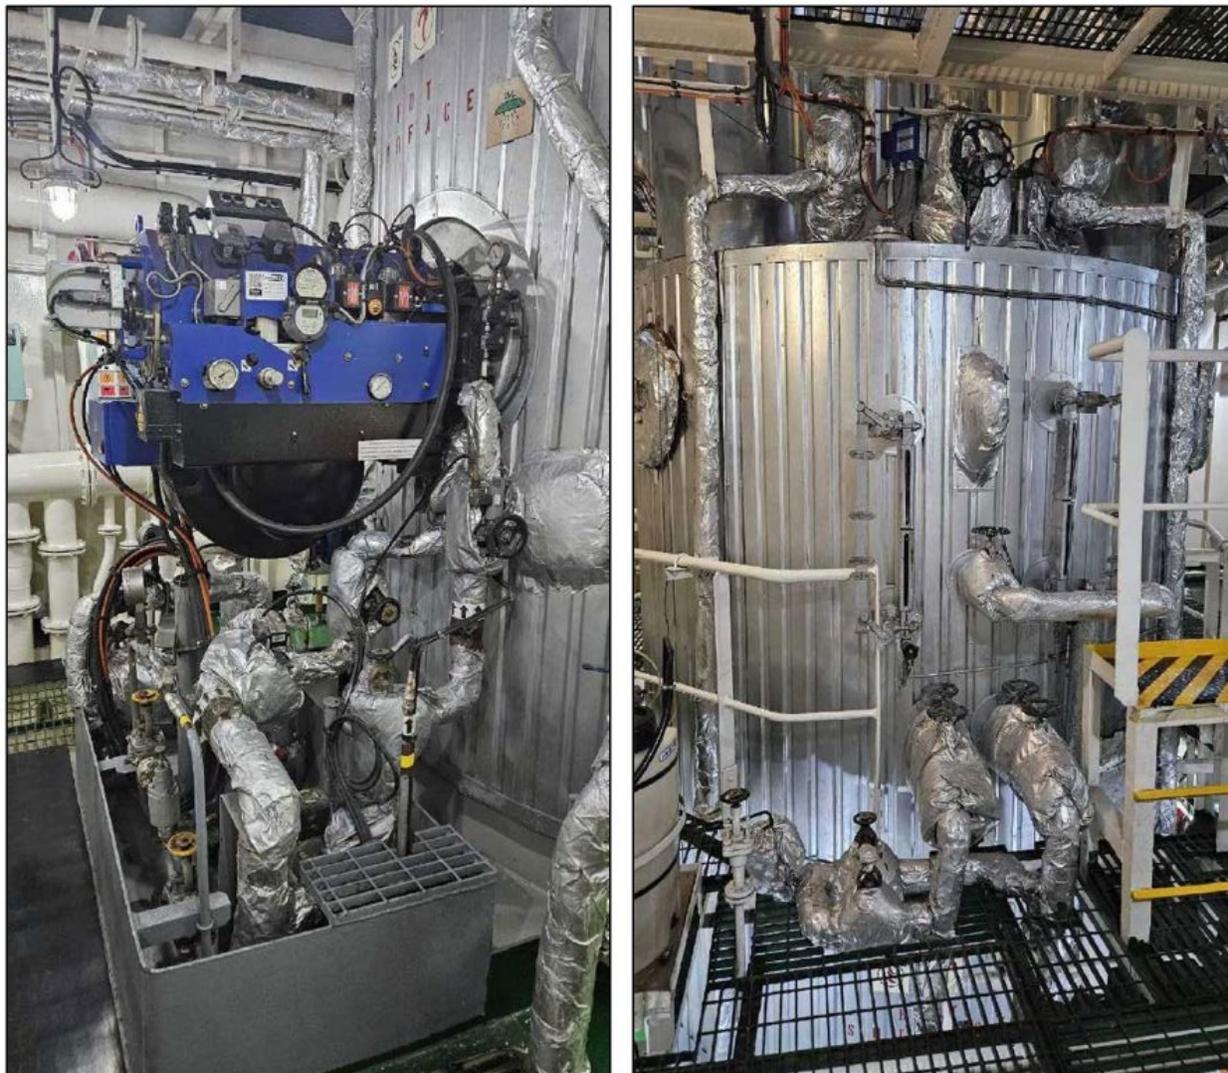
The *Lem Verbena*'s boiler created steam using two methods: a furnace heated by a burner unit fired from diesel oil, and waste heat from the main engine or the no. 2 and no. 3 diesel generator exhausts, which ran through vertical tubes within the boiler (the no. 1 diesel generator was not part of the boiler system). A portion of the no. 2 and no. 3 generator exhaust pipes ran directly below the burner unit in the engine room upper platform and through metal grating before it entered the boiler. Precasualty pictures of the no. 2 generator exhaust pipe showed that it was covered with protective lagging (see figure 6).⁵

Figure 6. Left to right: Boiler's burner unit and boiler on the *Lem Verbena* shown before the fire. (Source: Lemissoler Shipmanagement)
