MIR-26-10

Breakaway of Barges *MPC 907* and *MPC 644* and Subsequent Contact with Mooring Cells

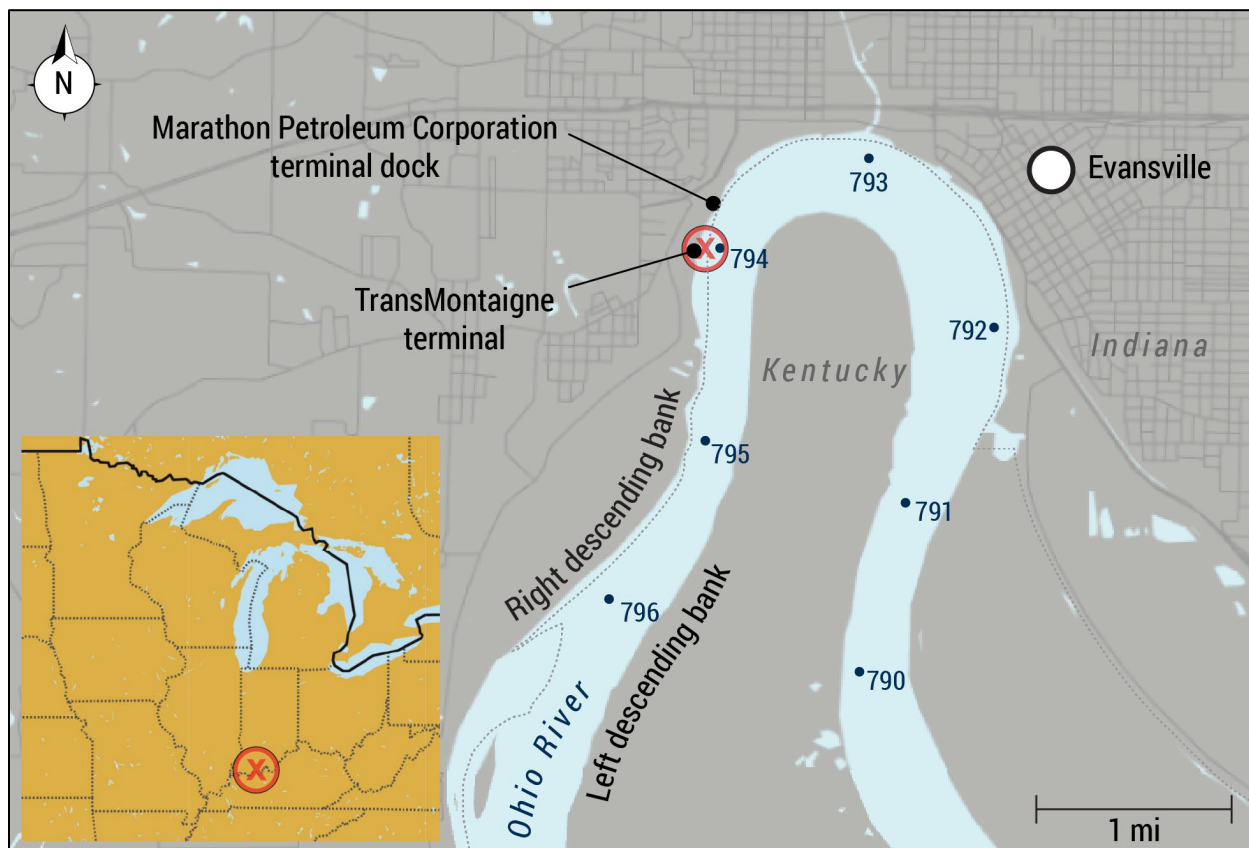
Figure 2. Area where the barges *MPC 644* and *MPC 907* contacted the mooring cells, as indicated by a circled X. (Background source: Google Maps)

The TransMontaigne terminal—located at mile 794.1, about 1,500 feet downstream of the MPC terminal—reported damage to its dock structure, which consisted of four mooring cells and a steel access walkway running from shore to cell nos. 2 and 3 (see figure 3). Cell no. 4, located farthest upriver, was no longer present. A sonar survey found that the cell piling was fractured at the river bottom and laid in the downstream direction at a 90° angle to the original vertical location (see figure 4). Cell no. 3 sustained significant damage to the upstream piling structure and concrete cell cap. Cell no. 2 sustained fracture damage to its concrete cap. Supports and steps for a spiral access stairway attached to cell no. 2 were deformed. No damage to cell no. 1 was noted. The steel access walkway to the mooring cells and associated piping was distorted in the downstream direction. TransMontaigne estimated the physical damage to the dock structure would exceed \$2.5 million.
