April 30, 2026

MIR-26-15

Contact of *Mackenzie Rose* Tow with Norfolk and Portsmouth Belt Line Railroad Bridge

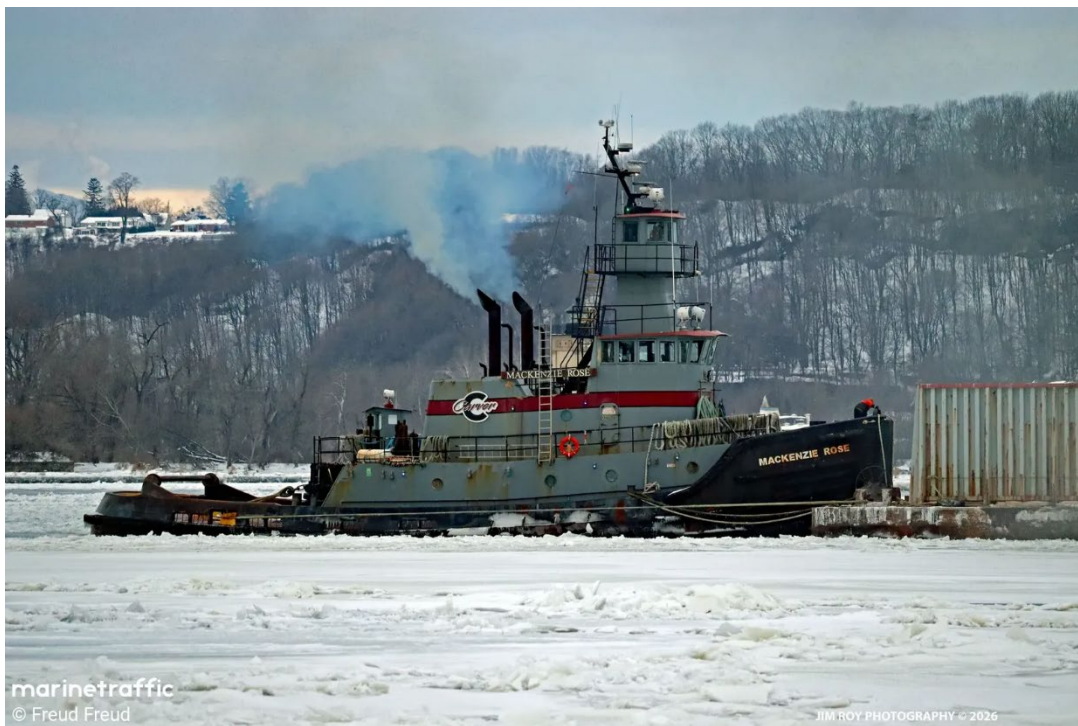
Figure 1. *Mackenzie Rose* underway in January 2026. (Jim Roy Photography, marinetraffic.com)

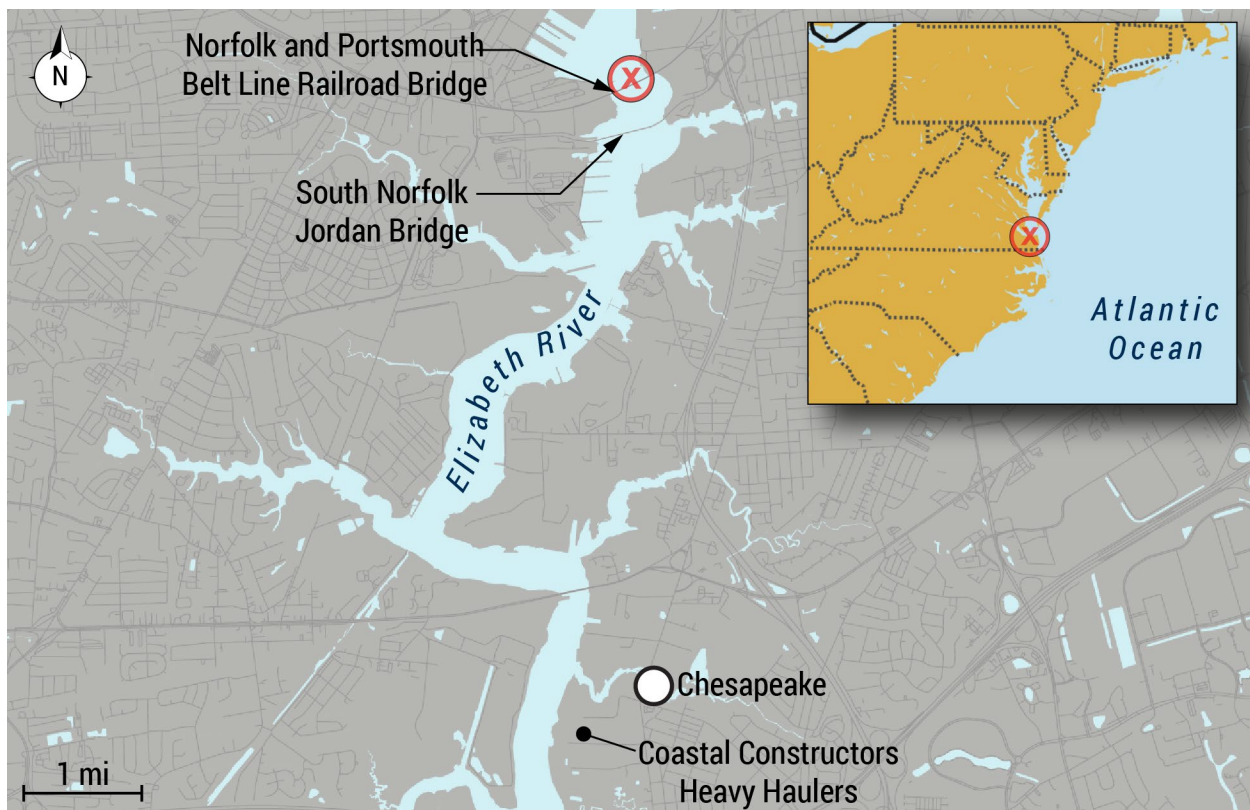
Figure 2. Area where the *Mackenzie Rose* tow struck the Norfolk and Portsmouth Belt Line Railroad Bridge, as indicated by a circled X. (Background source: Google Maps)

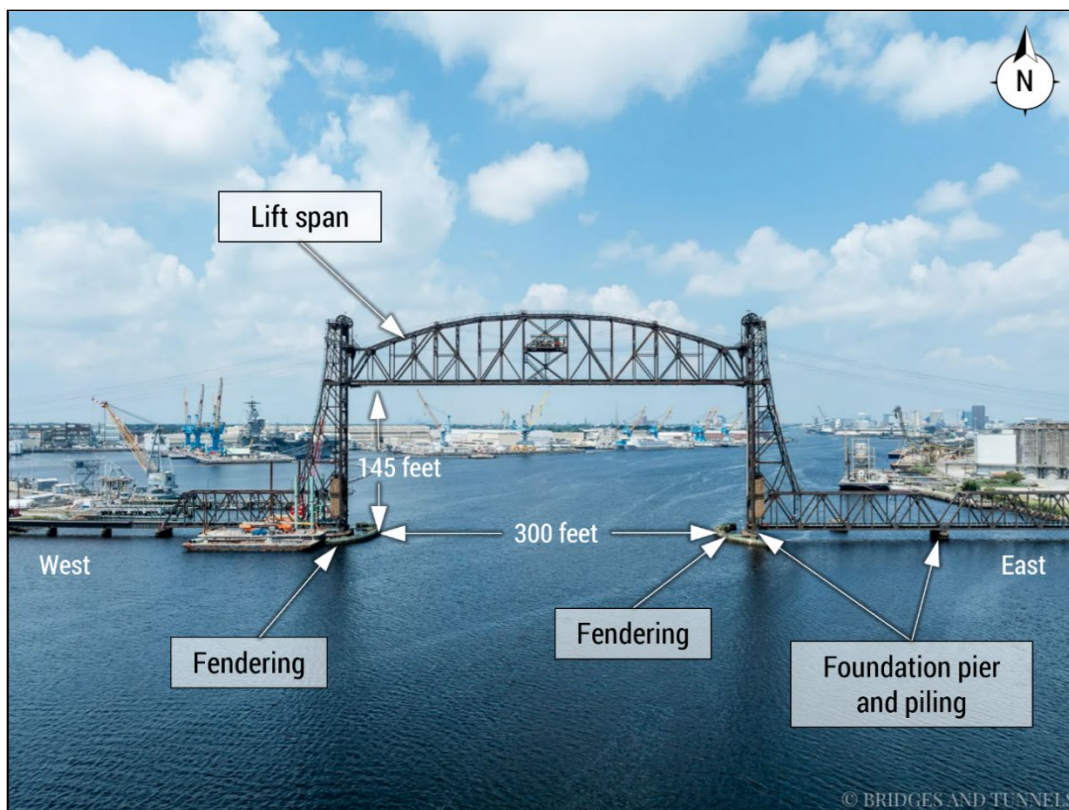
When lifted, the bridge's 378-foot-long lift span provided 300 feet of horizontal clearance and 145 feet of vertical clearance for vessel traffic through the navigational channel (see figure 3).² The lift span typically remained in the lifted position to allow free movement of waterway traffic. Concrete pilings and foundation piers anchored the approach to the railroad bridge from the eastern and western sides of the river. Arched protective wooden fendering and pilings shielded the main span's concrete pilings and foundation piers that paralleled the navigational channel.

Figure 3. North-facing view of the Norfolk and Portsmouth Belt Line Railroad Bridge with the lift span raised. (Background source: bridgestunnels.com)

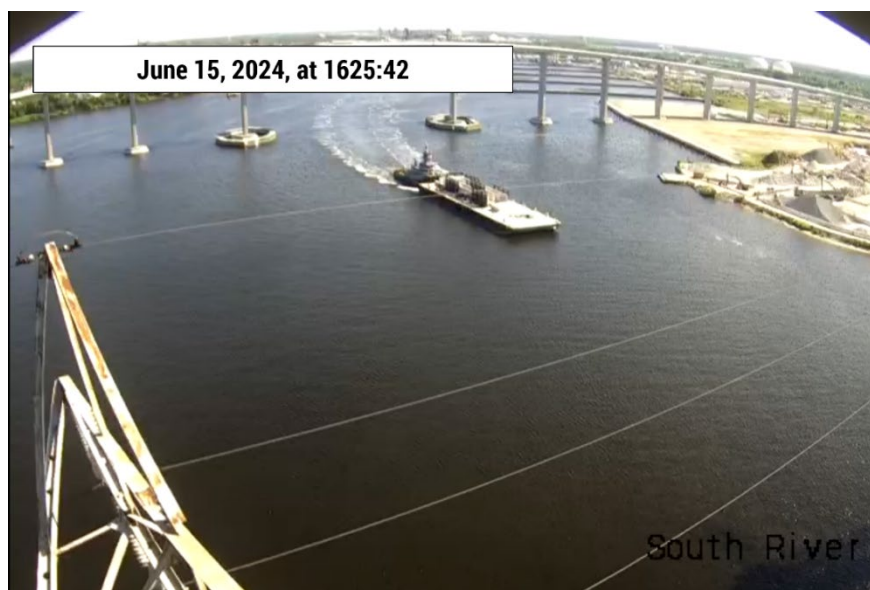
Investigators also reviewed recorded CCTV footage from the Norfolk and Portsmouth Belt Line Railroad Bridge, facing south, which showed the tow as it approached the bridge. The footage showed the tow heading’s rate of turn began to swing to port after the tow passed through the South Norfolk Jordan Bridge (see figure 10).

Figure 10. CCTV footage showing *Mackenzie Rose* tow passing through South Norfolk Jordan Bridge. (Source: Norfolk and Portsmouth Belt Line Railroad Bridge)
