Contact of *Rickey Hughes* Tow with the Vicksburg Highway 80 Bridge

On May 1, 2025, about 1454, the towing vessel *Rickey Hughes* was pushing 22 barges downbound on the Lower Mississippi River at mile 435.8 near Vicksburg, Mississippi, when the two lead barges on the starboard side of the tow contacted a fixed pier of the Vicksburg Highway 80 Bridge (see figure 1 and figure 2). As a result of the contact, seven barges broke away, six were recovered, and one sank. There were no injuries, and no pollution was reported. Damage to the barges was estimated at \$1.9 million.¹

¹ (a) In this report, all times are central daylight time, and all miles are statute miles. (b) Visit [nts.gov](https://www.nts.gov) to find additional information in the [public docket](#) for this NTSB investigation (case no. DCA25FM034).

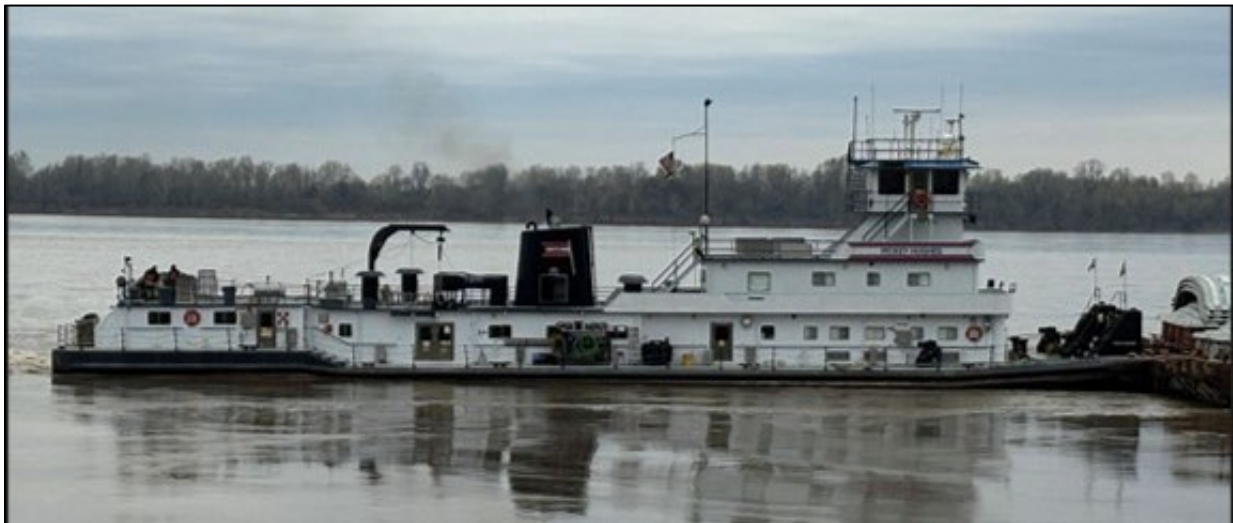
Figure 1. Towing vessel *Rickey Hughes* in Tunica, Mississippi, in March 2026.

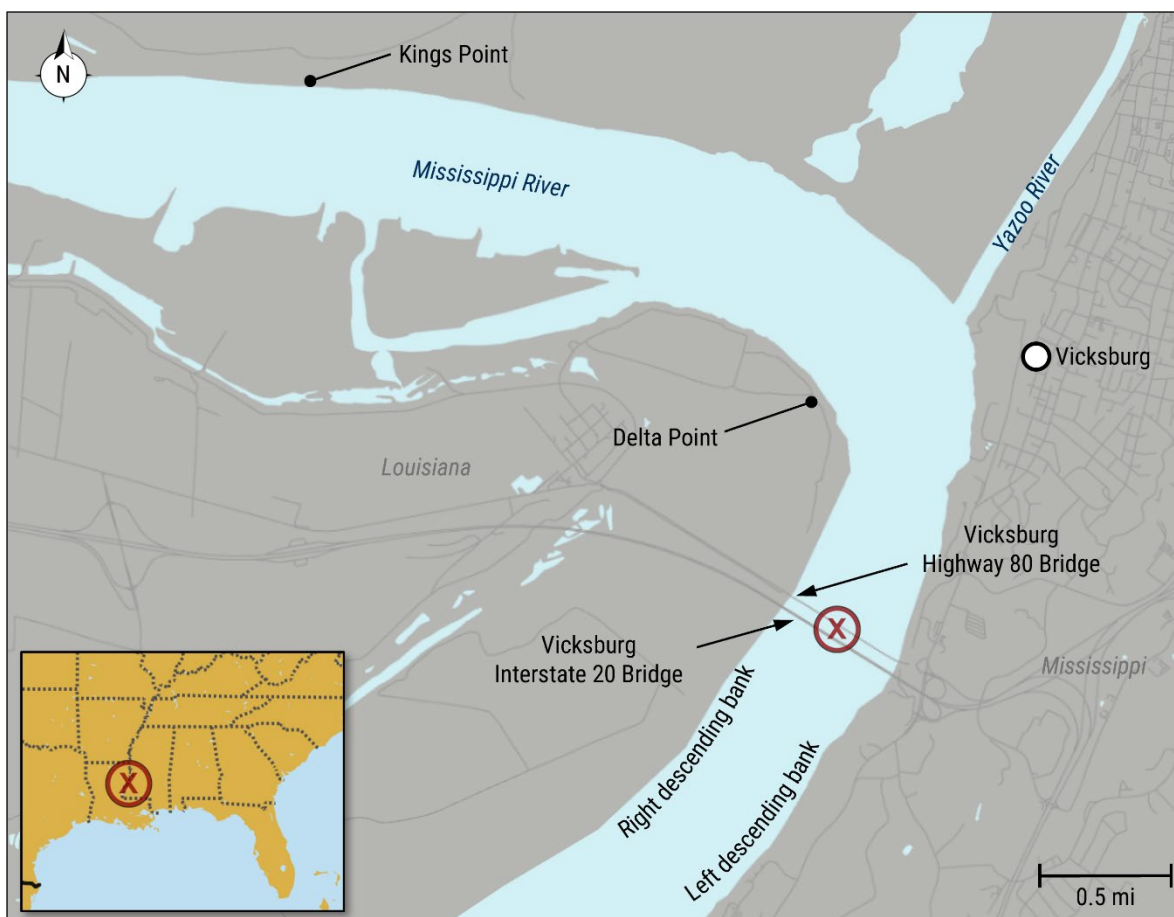
Figure 2. Area where the tow of the *Rickey Hughes* contacted the Vicksburg Highway 80 Bridge, as indicated by a circled X. (Background source: Google Maps)

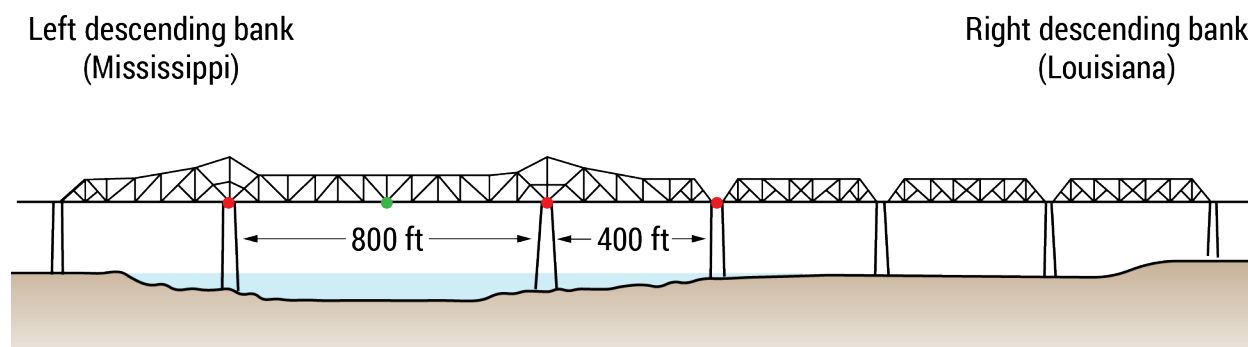
On May 1, the tow approached Vicksburg, Mississippi. At Vicksburg, the crew had to navigate the tow through two bridges: the Vicksburg Highway 80 Bridge and the Interstate 20 Bridge. The Vicksburg Highway 80 Bridge opened in 1930 as a highway and railroad crossing and, at the time of this report, was serving as a railway bridge (see figure 3). The Interstate 20 bridge, which opened in 1973, was built with piers spaced to match the adjacent and upriver Vicksburg Highway 80 Bridge piers. The bridges were located 1.1 miles downstream from a 121° bend in the river. In addition to the cross-currents associated with such a large change in direction of the river, the current from the Yazoo River converged in the bend.

Figure 3. Illustration of the Vicksburg Highway 80 Bridge, looking downriver. (Background source: US Army Corps of Engineers)

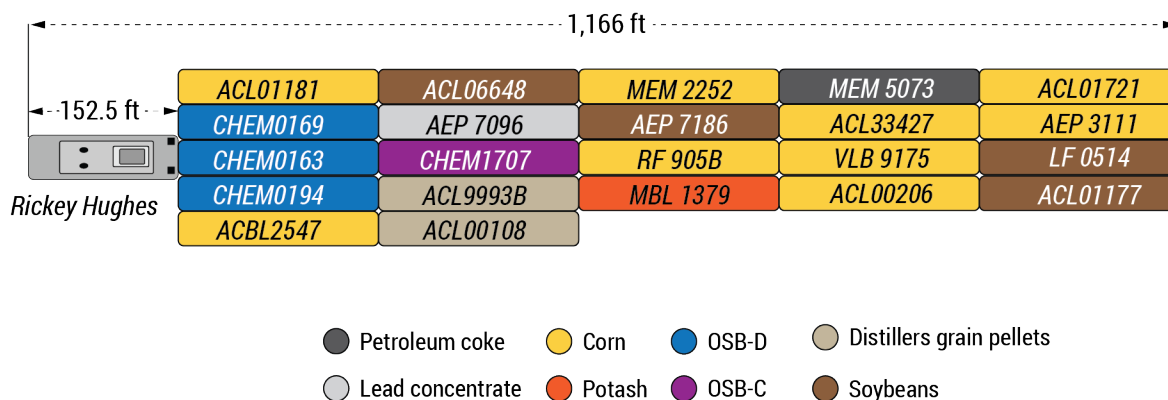
After picking up the shoreside captain, the tow departed Kings Point about 1405, and about 1430, the tow was underway downriver toward the Vicksburg bridges. When the tow departed Kings Point, it was comprised of 22 barges in five strings of barges: four strings with five barges deep, and the fifth string (on the starboard side) with two barges at the rear of the tow (see figure 4). The width of the tow was 175 feet, and the total length of the *Rickey Hughes* and barges was 1,166 feet. The barges were filled with potash, petroleum coke, corn, distillers grain pellets, lead concentrate, OSB-C, OSB-D, and soybeans.³ Four of the barges—those carrying OSB-C and OSB-D—were considered chemical barges. In compliance with the Waterways Action Plan for the Lower Mississippi River, these barges were placed directly ahead of the towing vessel, surrounded by corn and soybean barges.⁴

Figure 4. *Rickey Hughes*’ tow configuration on May 5, 2025. (Background source: ACBL)
