MIR-26-19

Collapse of Emissions Control Barge *STAX 1* Capture and Control Articulated Arm

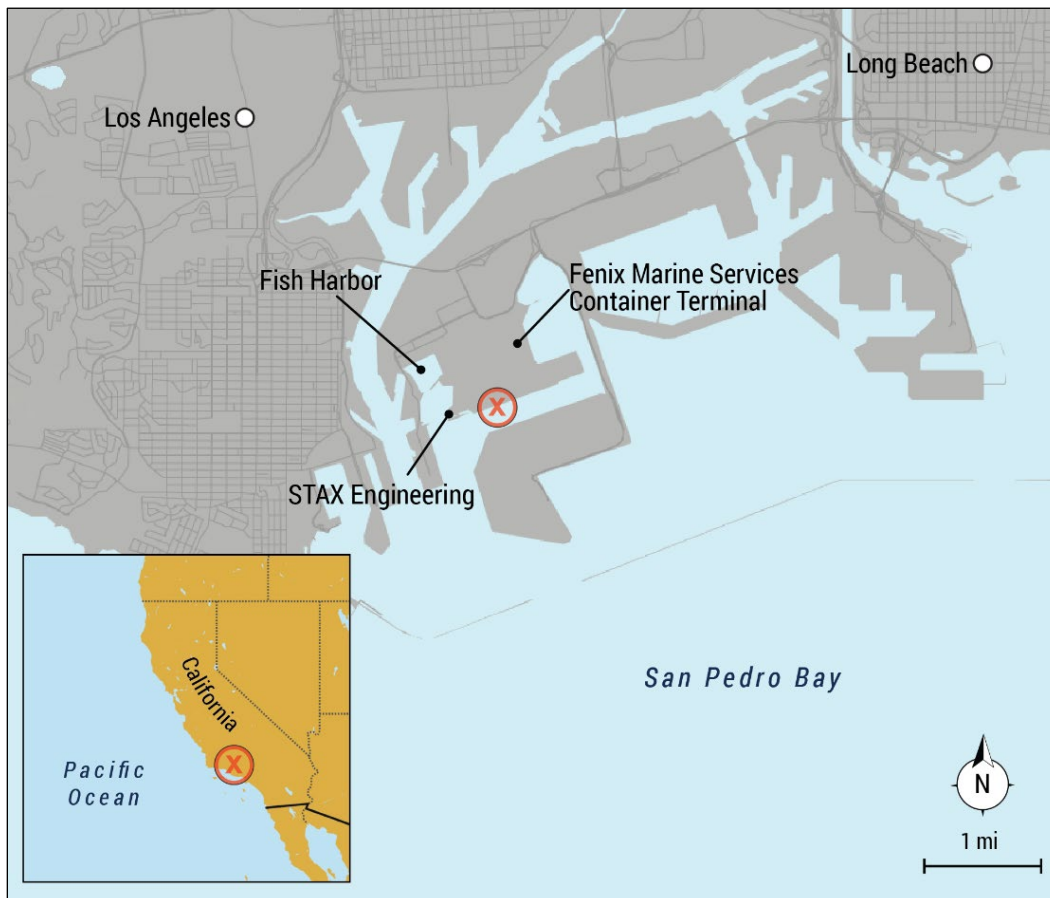
Figure 2. Area where emissions control barge *STAX 1* sustained equipment damage, as indicated by a circled X. (Background source: Google Maps)
