Marine Investigation Report MIR-26-24

# Collision Between Bulk Carrier *Yangze 7* and Towing Vessel *Miss Peggy*

Houston Ship Channel  
Lynchburg, Texas  
July 19, 2024

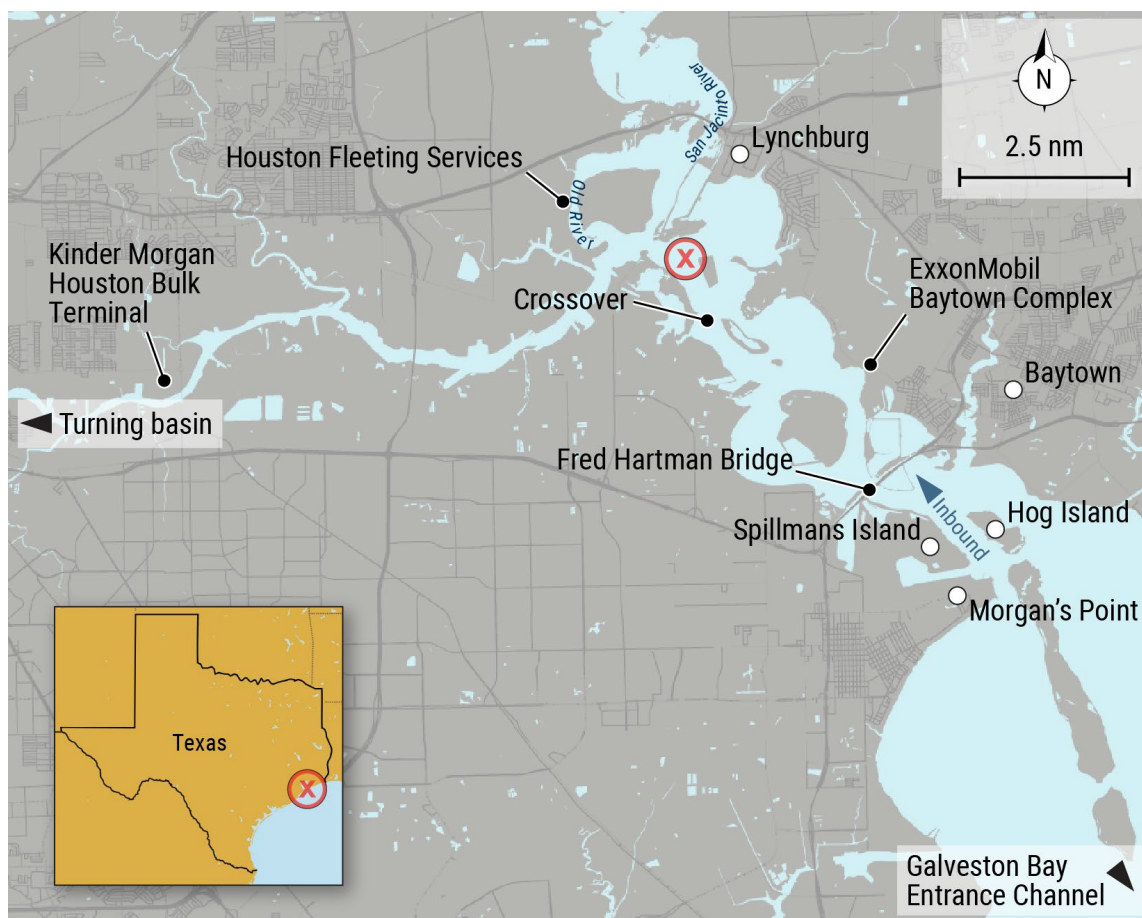
**Figure 3.** Area where the *Yangze 7* and the *Miss Peggy* collided, as indicated by an X. (Background source: Google Maps)

The upper channel, where the collision occurred, runs from the entrance to Galveston Bay at Morgan's Point to the turning basin and varies in width from as little as 250 feet to over 750 feet. The area of the Houston Ship Channel near the collision site was 600 feet wide, with a project depth of 45 feet (see figure 4).<sup>4</sup> Although the

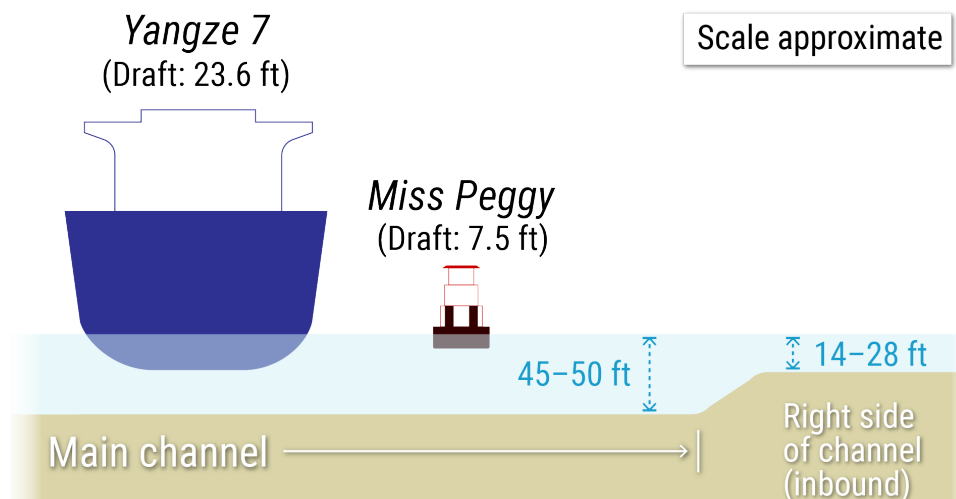
area did not have dedicated barge lanes for towing vessels along the main deep-draft vessel channel, there were 35-foot-wide transition slopes on either side of the main channel, measuring 45 feet deep at their innermost point and 14 feet deep at their outermost point.<sup>5</sup>

**Figure 4.** Approximate channel and bank depths (inbound, right side of the Houston Ship Channel) near the casualty site.

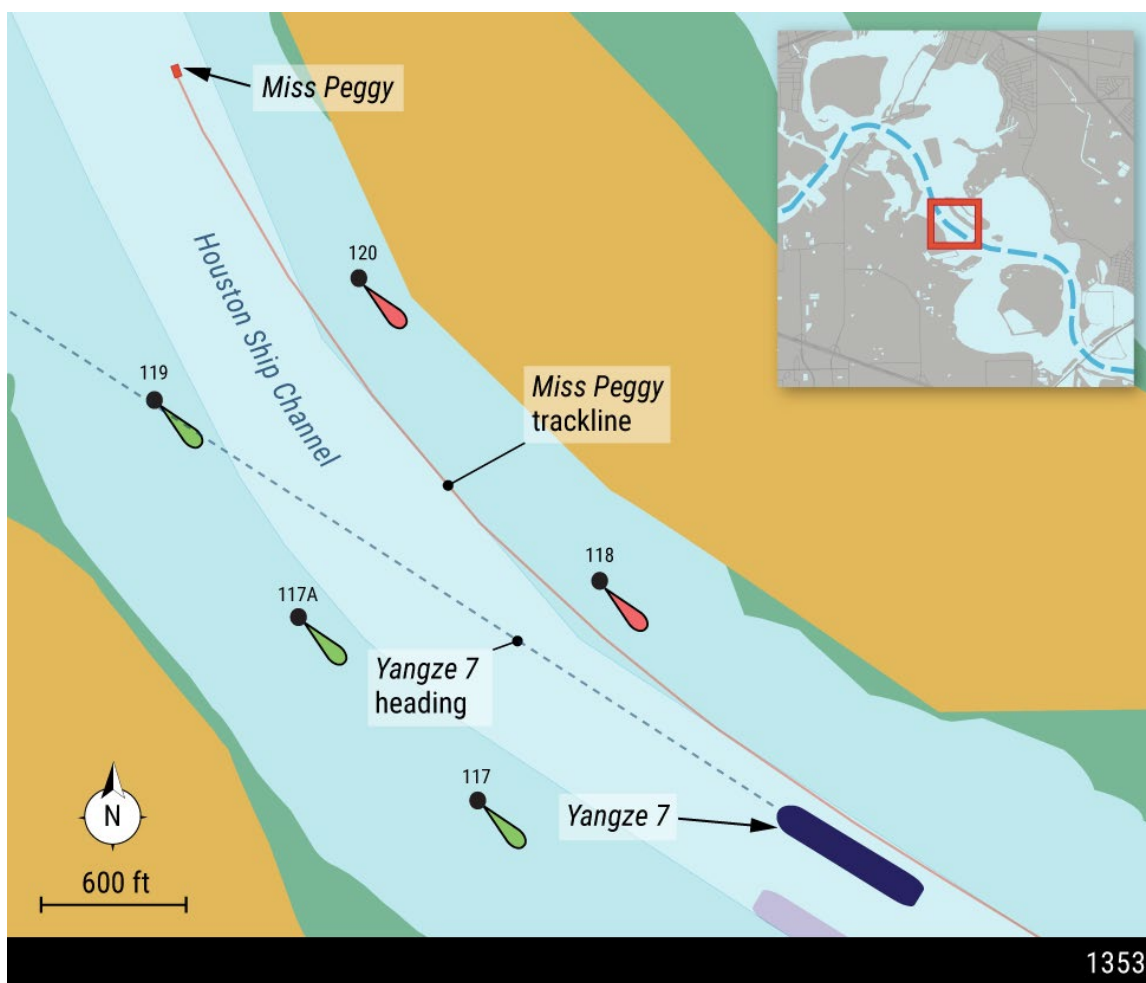
The pilot continued his phone conversation while issuing various rudder and heading orders as the *Yangze 7* progressed up the Houston Ship Channel. At 1349:57, he paused the phone conversation to issue a slow ahead propulsion order. At 1352:26, he paused his phone conversation to order half ahead, and about 30 seconds later, to full ahead. The second officer executed both propulsion orders. Figure 6 shows the *Miss Peggy*'s and the *Yangze 7*'s positions shortly after these orders.

**Figure 6.** Locations of the *Yangze 7* and the *Miss Peggy* (about 0.6 miles ahead of the bulk carrier) at 1353. The area depicted in the graphic is indicated by the rectangle on the inset map. (Channel markers not to scale.) (Background sources: National Oceanic and Atmospheric Administration [NOAA] Electronic Navigation Chart [ENC] US5HOUF and Google Maps)

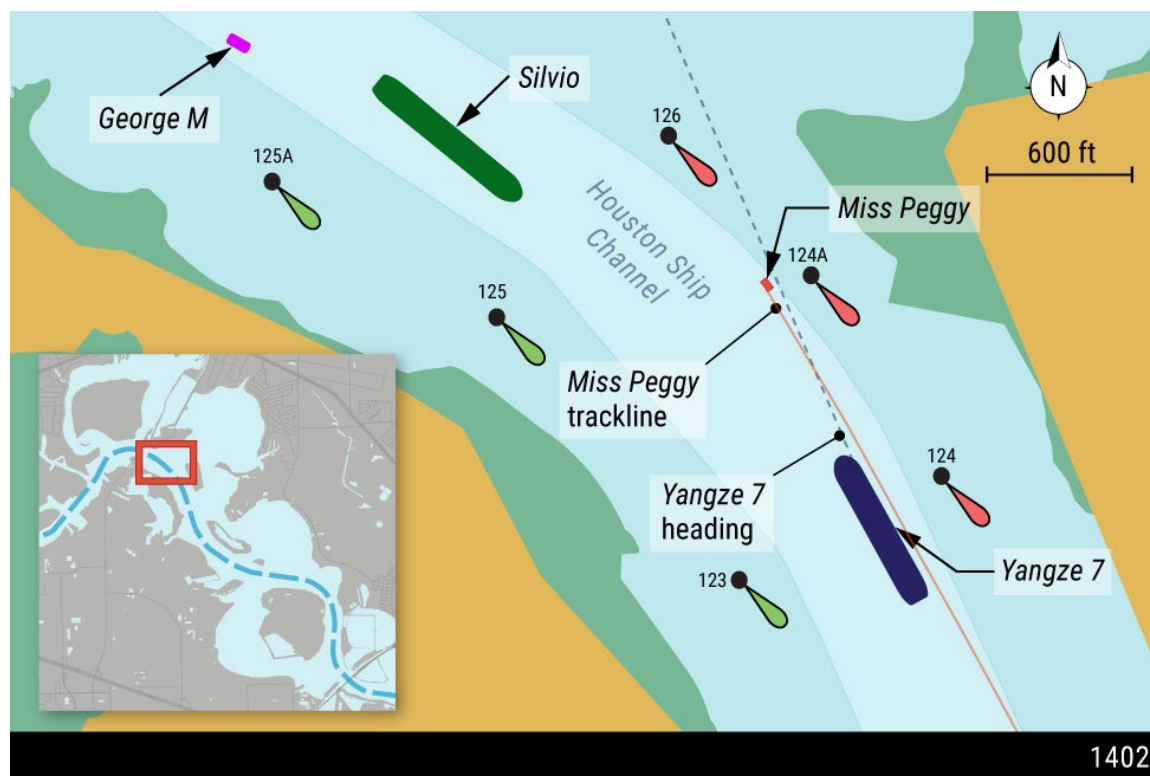
At 1401, the *Miss Peggy* was about 1.8 ship lengths (1,151.0 feet [350.8 meters]) ahead of the *Yangze 7* (see figure 8). The *Yangze 7* was passing red CM 122A, and the *Miss Peggy* was between red CMs 124A and 124. At this time, the *Yangze 7* bridge VDR captured the pilot ordering port 10° on the rudder, the helmsman reading the order back, and the pilot saying, “I’m going to hang up with you.” The pilot’s cell phone records indicated that the phone call ended at 14:01:44. The pilot then continued issuing midship and port 10° rudder orders as the ship approached the bend at Lynchburg.<sup>12</sup> At 1402:00, the *Yangze 7* was still at full ahead and about 1.2 ship lengths (781.0 feet [238.0 meters]) astern of the *Miss Peggy* (see figure 8 and figure 9).

**Figure 9.** Locations of the *Yangze 7*, the *Miss Peggy*, the *Silvio*, and the *George M* at 1402. The area depicted in the graphic is indicated by the rectangle on the inset map. (Channel markers not to scale.) (Background sources: NOAA ENC US5HOUEF and Google Maps)

Before rounding the bend at Lynchburg, inbound ships must make a 120° course alteration to port (see figure 9 inset map). When approaching the bend at Lynchburg, the second officer said that he was focused on the vessel coming down on the port side (*Silvio*) since the pilot was issuing steering orders and chatting.

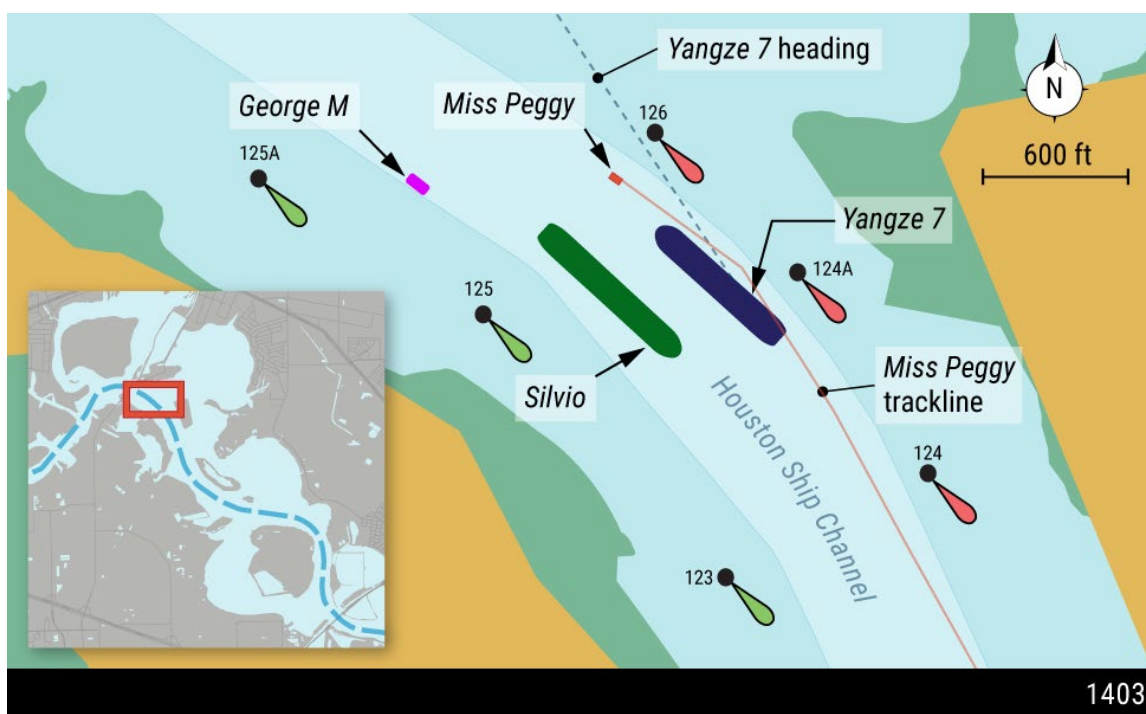
At 1403, as the *Yangze 7* and *Silvio* began to pass each other port to port, the *Yangze 7* pilot ordered the rudder to starboard 20° and then back to midship (see figure 10 and figure 11). VDR bridge audio captured the pilot asking the bridge team, “We’re half ahead right?” The second officer responded, “Yes,” but then corrected himself, stating, “It’s full ahead, sir.” The pilot then ordered the propulsion to half ahead, and the second officer executed the order.

**Figure 10.** Locations of the *Yangze 7*, the *Miss Peggy*, the *Silvio*, and the *George M* at 1403. The area depicted in the graphic is indicated by the rectangle on the inset map. (Channel markers not to scale.) (Background sources: NOAA ENC US5HOUEF and Google Maps)

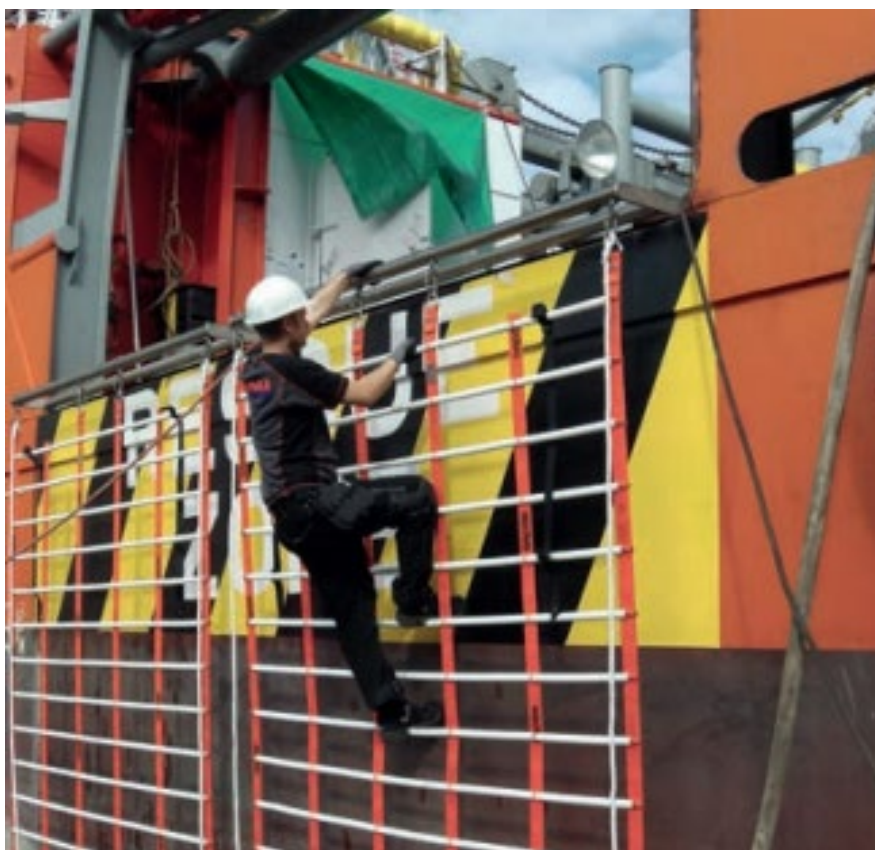
LDH1 said that both he and DH2 had been wearing their work vests at the time of the rollover of the boat.<sup>18</sup> Aboard the *George M*, the mate-in-training had gone down to the main deck to prepare the vessel's man overboard equipment (a Dacon-brand rescue frame/cradle) after the general alarm was sounded (see figure 13). When the captain arrived in the pilothouse, the mate on watch went to the deck to assist with rescue operations. The captain maneuvered the *George M* close to where they could throw liferings and lines to the four people visible in the water (see figure 14).

**Figure 13.** A Dacon rescue frame, similar to that aboard the *George M*, being used to climb aboard a vessel during a product demonstration. (Source: Dacon Group)

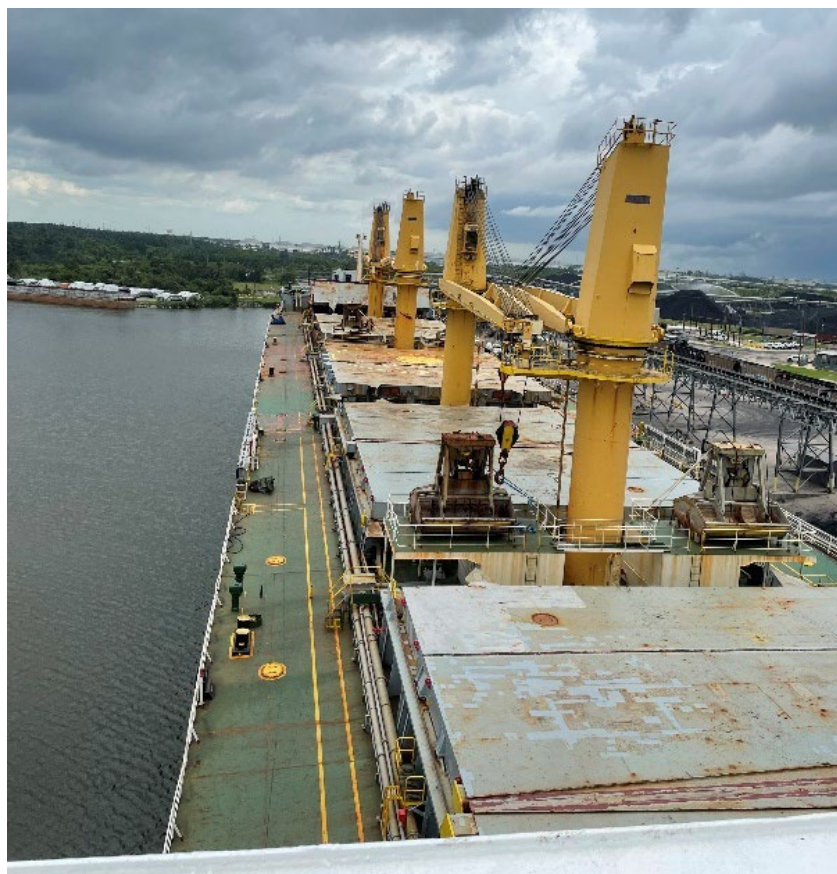
The *Yangze 7* had four deck-mounted cargo cranes positioned on the centerline of the main deck. The cranes were in the stowed position at the time of the transit inbound the Houston Ship Channel (see figure 16 and figure 17).

**Figure 16.** The *Yangze 7*'s cranes stowed, as seen from the port side of the bridge, after the casualty.

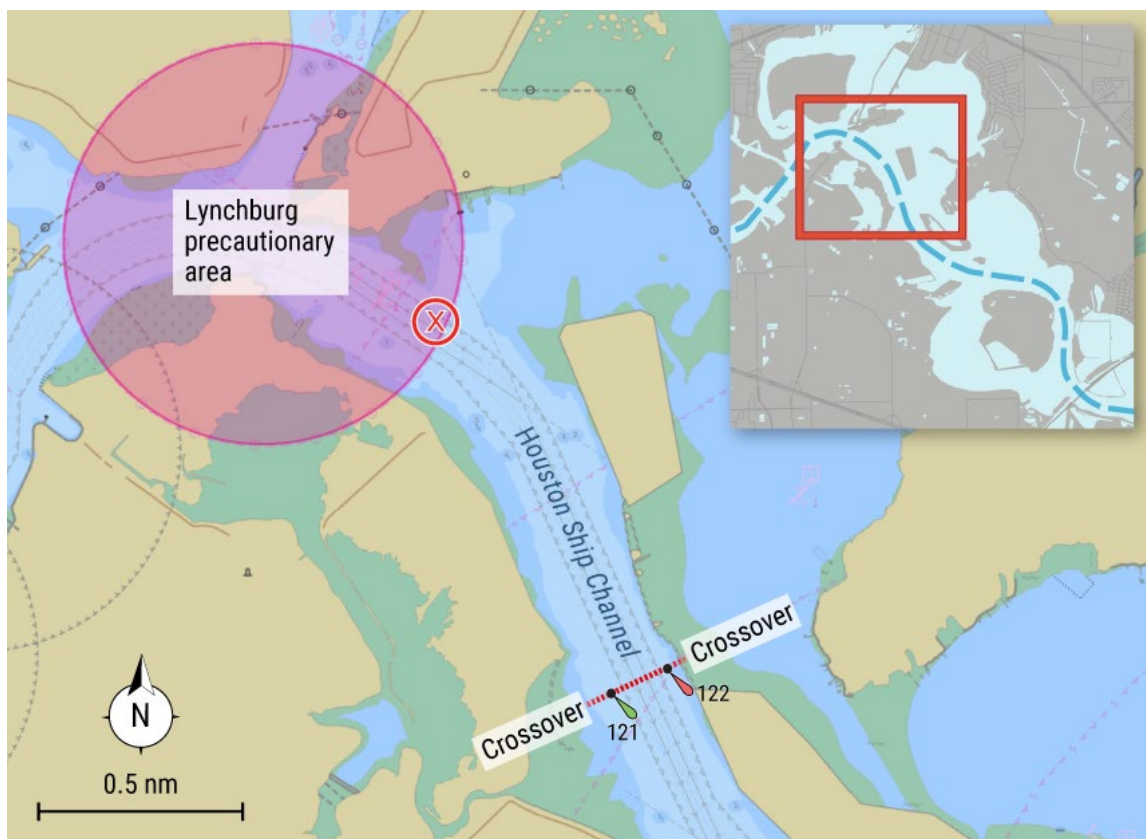
The casualty occurred near the boundary of the Lynchburg precautionary area. The Coast Guard designated Lynchburg as a precautionary area “due to frequent congestion of meeting, crossing, and overtaking of dissimilar traffic including ships, tows with/without barges, ferries, and industrial vessels.”<sup>29</sup> Figure 19 shows the radius of the precautionary area.

**Figure 19.** The area where the collision occurred, relative to the Lynchburg precautionary area and the Crossover mandatory reporting area. The area depicted in the graphic is indicated by the rectangle on the inset map. (Channel markers not to scale.) (Background sources: NOAA ENC US5HOUF and Google Maps)
