MIR-26-25

## Fire aboard Fishing Vessel *GITN'R DUN*

On July 24, 2025, about 0900 local time, a fire broke out in the engine compartment aboard the fishing vessel *GITN'R DUN* while the two crewmembers aboard were hauling lobster traps in the Gulf of Maine near Mount Desert Rock, Maine (see figure 1 and figure 2).<sup>1</sup> The captain of the vessel attempted to put out the fire but was unsuccessful. Both crewmembers abandoned the vessel, which burned to the waterline and sank. There were no injuries, and no pollution was reported. The vessel was a total loss, with damages estimated at \$717,500.

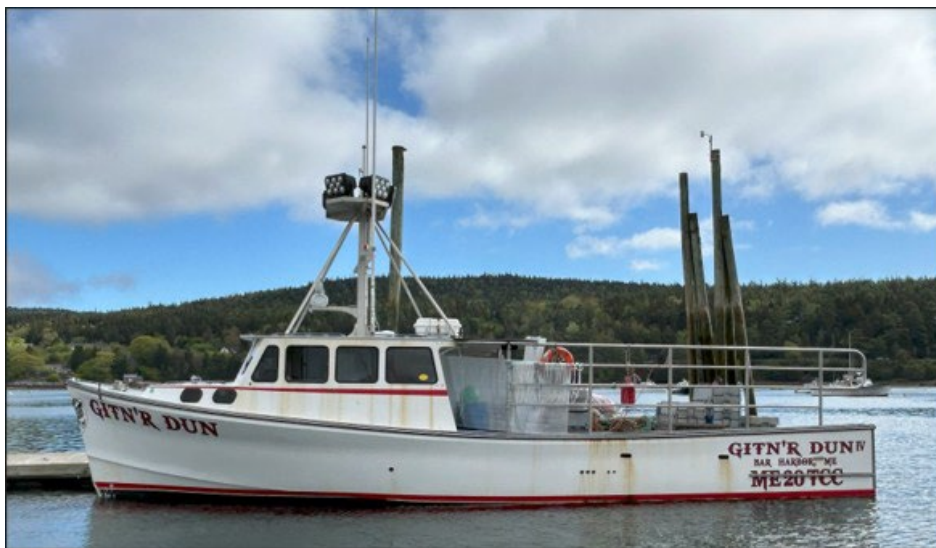
**Figure 1.** *GITN'R DUN* moored on May 29, 2025. (Source: US Coast Guard)

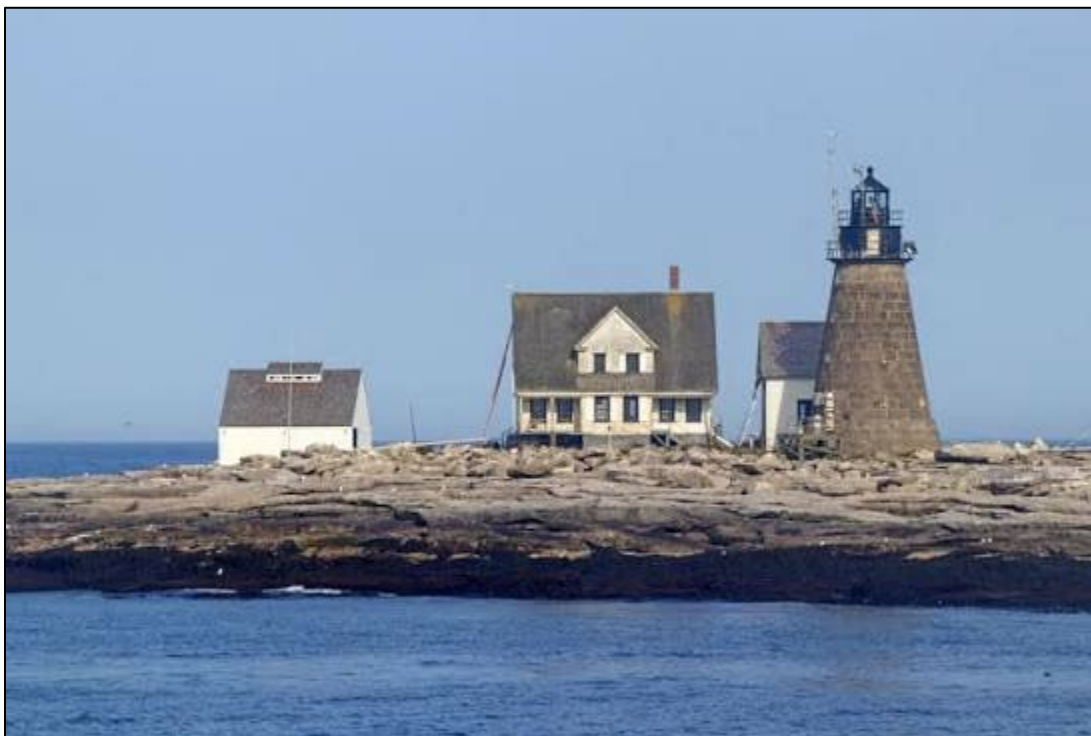
**Figure 3.** Lighthouse (“watch tower”) on Mount Desert Rock. (Source: Jeremy D’Entremont, [newenglandlighthouses.net](http://newenglandlighthouses.net))
