August 27, 2026

MIR-26-29

# Engine Room Fire aboard Chemical Tanker *Scot Stuttgart*

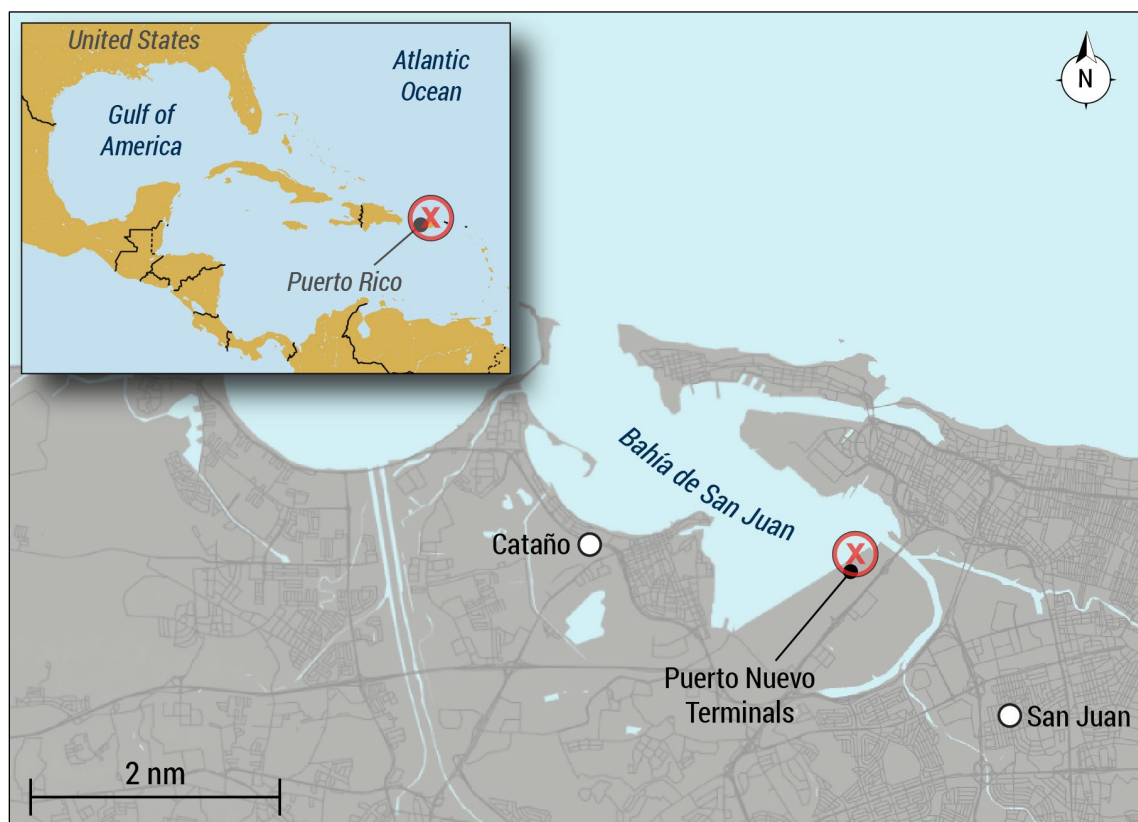
**Figure 2.** Area where the fire aboard the *Scot Stuttgart* occurred, as indicated by a circled X. (Background source: Google Maps)

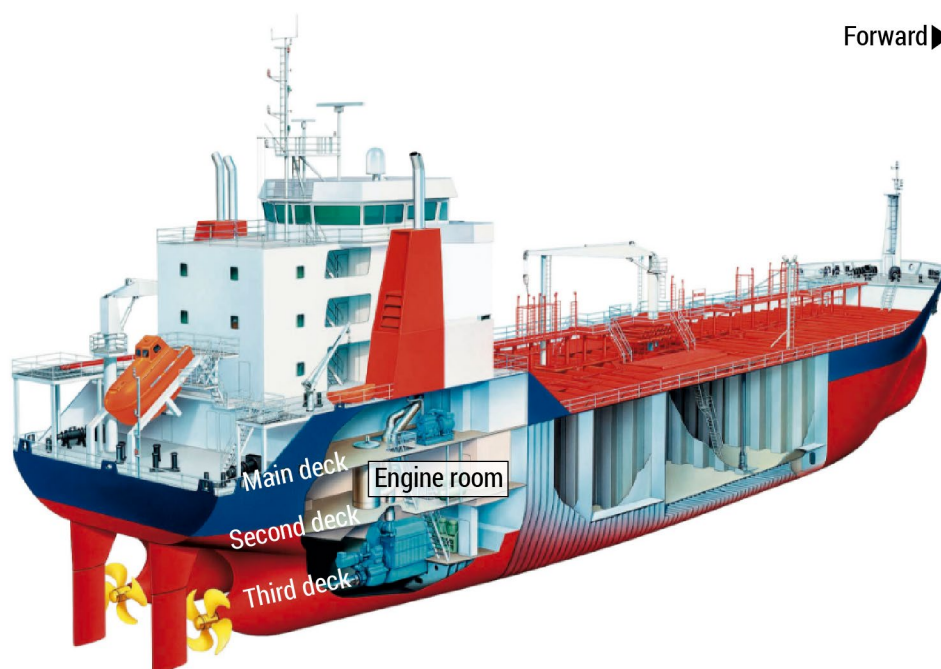
**Figure 3.** Side profile view of the *Scot Stuttgart* showing starboard engine room (port engine room similar). (Background source: Scot Stuttgart SA)
