Marine Investigation Report MIR-26-32

# Collision Between National Oceanic and Atmospheric Administration Uncrewed Surface Vessel and Prestige 450 Flybridge Recreational Vessel

Lake Erie

August 10, 2024

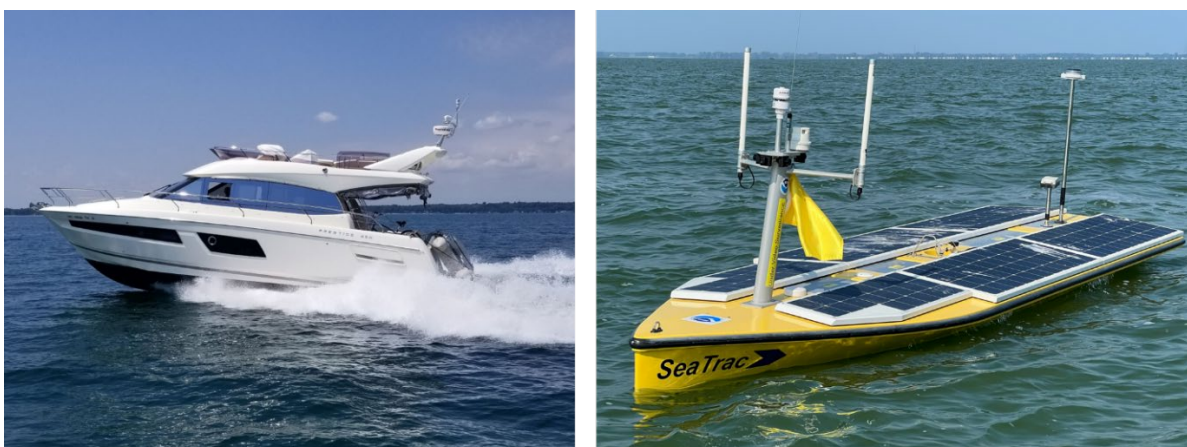
**Figure 1.** Left to right: Prestige 450 Flybridge recreational vessel and NOAA USV underway before the collision. (Sources: Recreational vessel owner [left] and NOAA [right])

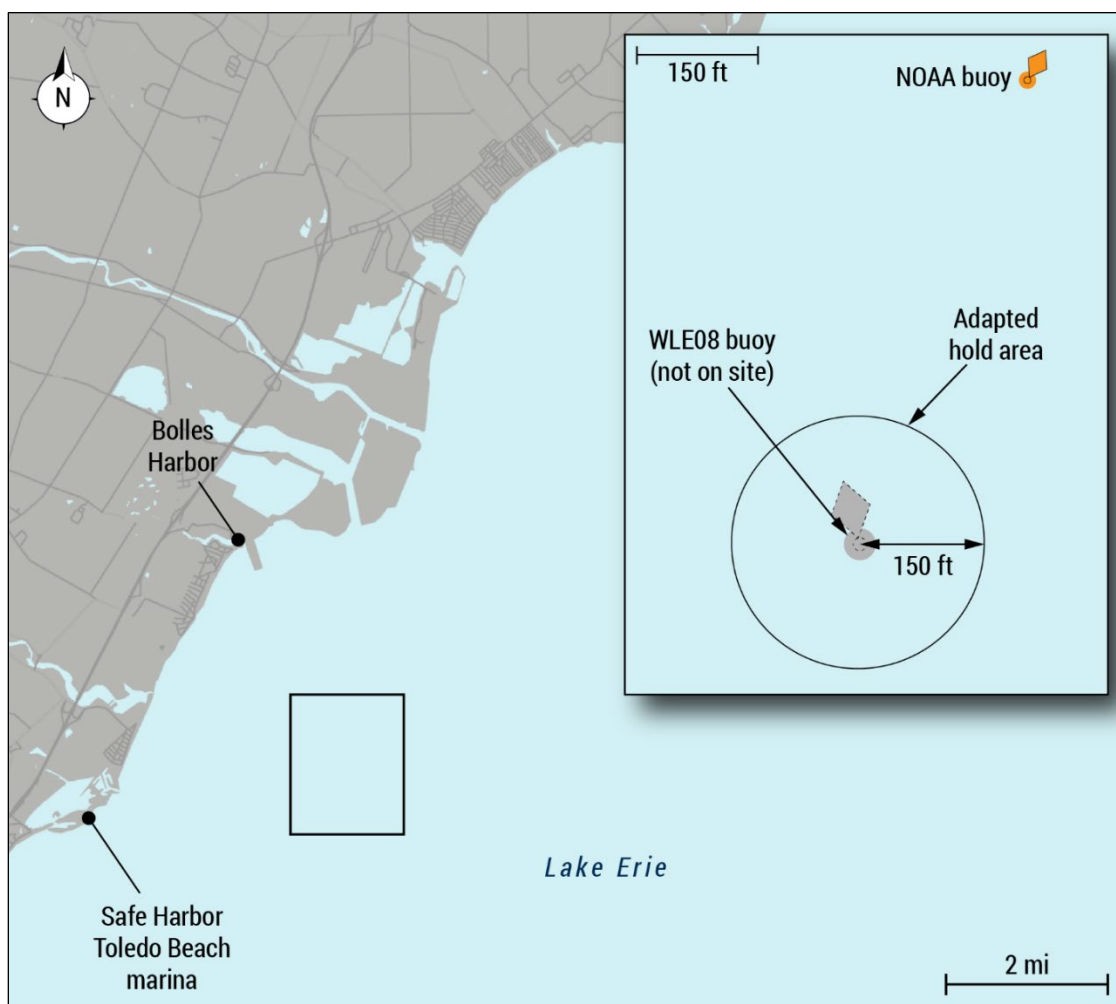
When the pilot set the USV to adapted hold mode at 1620, the USV was about 275 yards from the NOAA buoy (see figure 2).

**Figure 2.** Approximate WLE08 buoy and NOAA buoy locations relative to adapted hold area. (Background source: Google Maps)

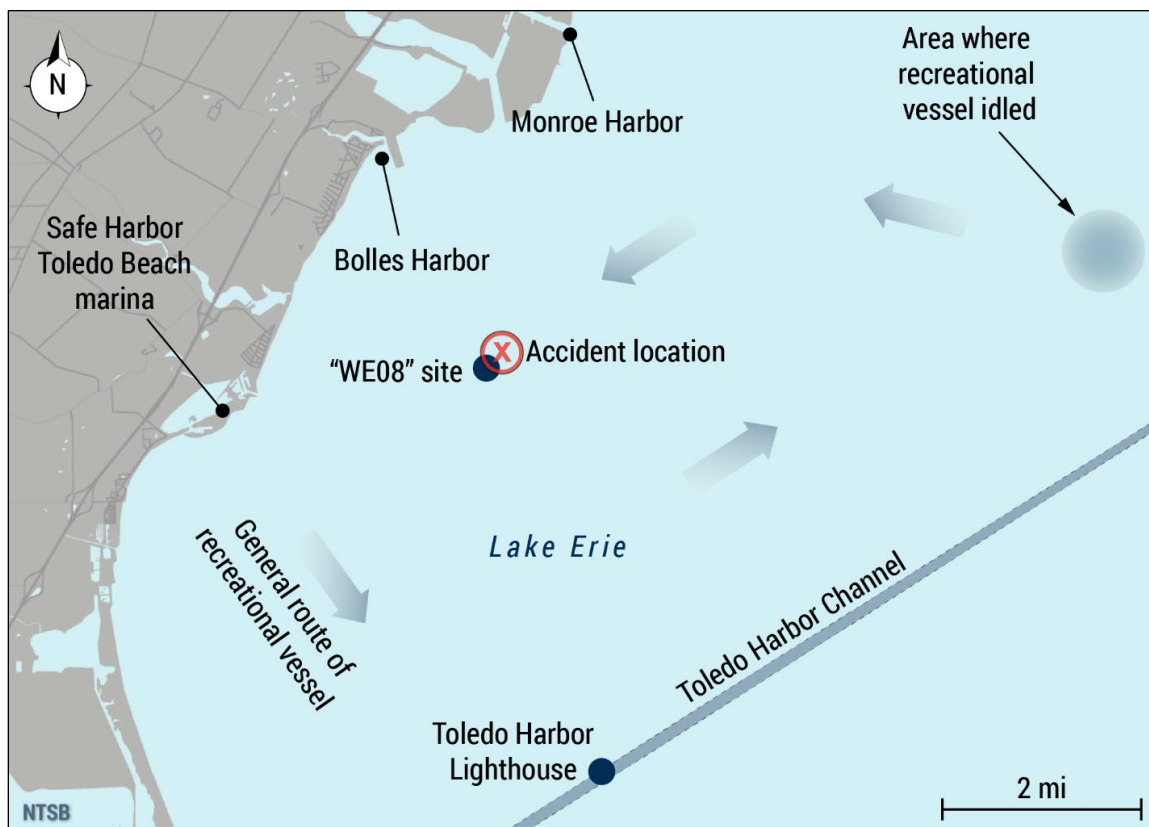
About 1912, the Prestige 450 Flybridge was on a southwest heading, about 240°, at a speed of about 25 mph when it struck an object. The operator told investigators that there were no other vessels, buoys, or objects in the immediate vicinity of the vessel at this time, and "there was nothing there that we would have hit" (see figure 3).<sup>12</sup>

**Figure 3.** Location of WE08 site and where the recreational vessel operator idled to observe a freight vessel in the Toledo Harbor Channel. The casualty location, near WE08 station, is marked with a circled X. (Background source: Google Maps)

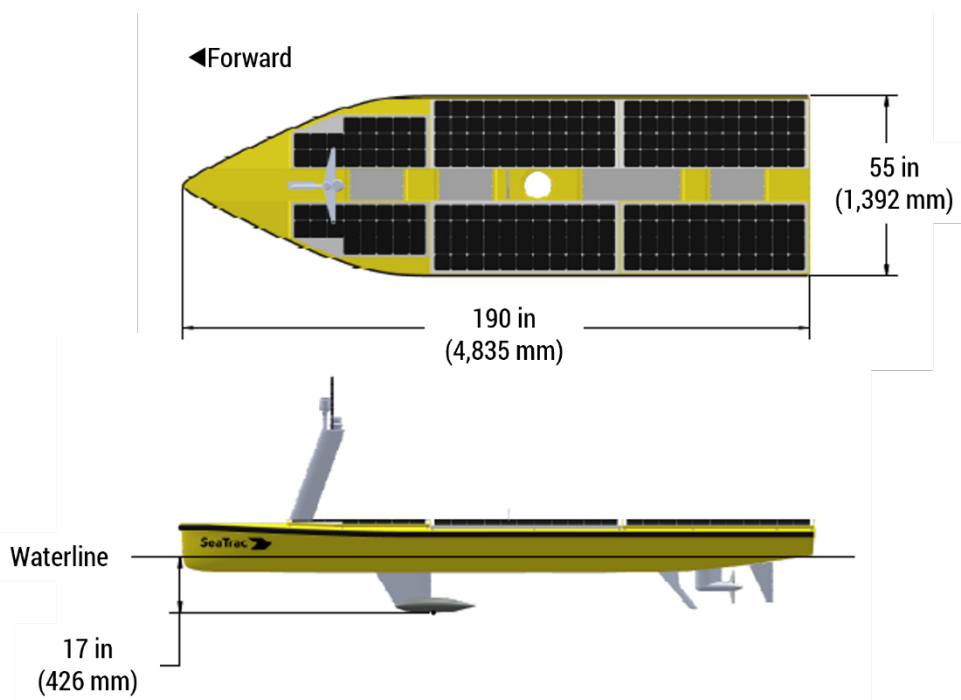
The USV had a yellow hull and main deck (see figure 8). The stern displayed the text “UNCREWED SURFACE VESSEL” in black lettering. Solar paneling covered most of the vessel’s surface area, aside from the centerline area, parts of the bow, stern, and freeboard area. According to the GLERL lead engineer, the vessel’s freeboard was about 1 foot.<sup>15</sup> The USV was capable of transiting at a speed up to 5 knots.

**Figure 8.** SeaTrac SP-48 overhead and profile view. Note: The drawing shows the vessel as built without GLERL’s modification to add the aft mast. (Background source: SeaTrac)

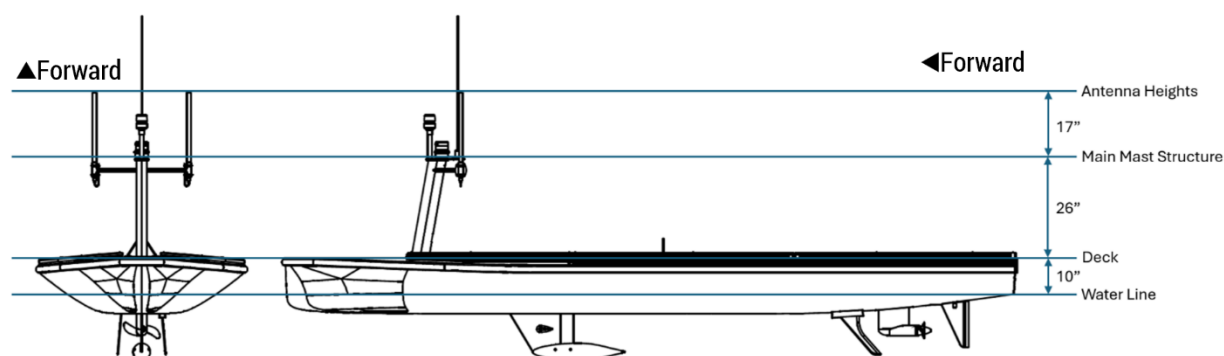
The vessel had a forward mast structure, about 26 inches tall, which housed instrumentation and antennas (see figure 9).<sup>16</sup> The highest antenna was about 17 inches above the mast, about 3.6 feet from the deck. A small yellow flag was also secured to the mast to increase visibility.<sup>17</sup> The GLERL lead engineer estimated the flag was about 2.5 feet above the waterline. The mast also housed a combined lantern with red and green running lights and a white stern light.

**Figure 9.** Forward view (looking aft) and profile view of USV. Note: The drawing shows the vessel as built without GLERL’s modification to add the aft mast. (Background source: SeaTrac)

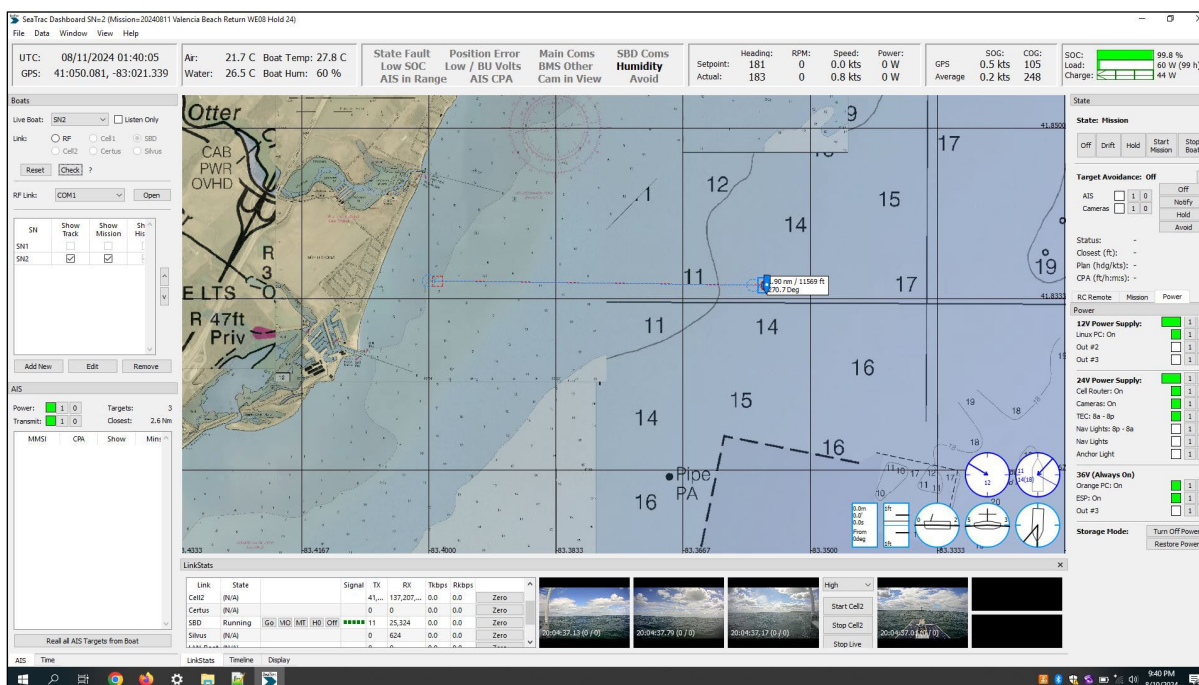
The USV pilot controlled the vessel remotely using its human machine interface software, or “dashboard” (see figure 11).<sup>20</sup>

**Figure 11.** GLERL USV dashboard, or human machine interface, showing the vessel in mission mode. (Source: GLERL)

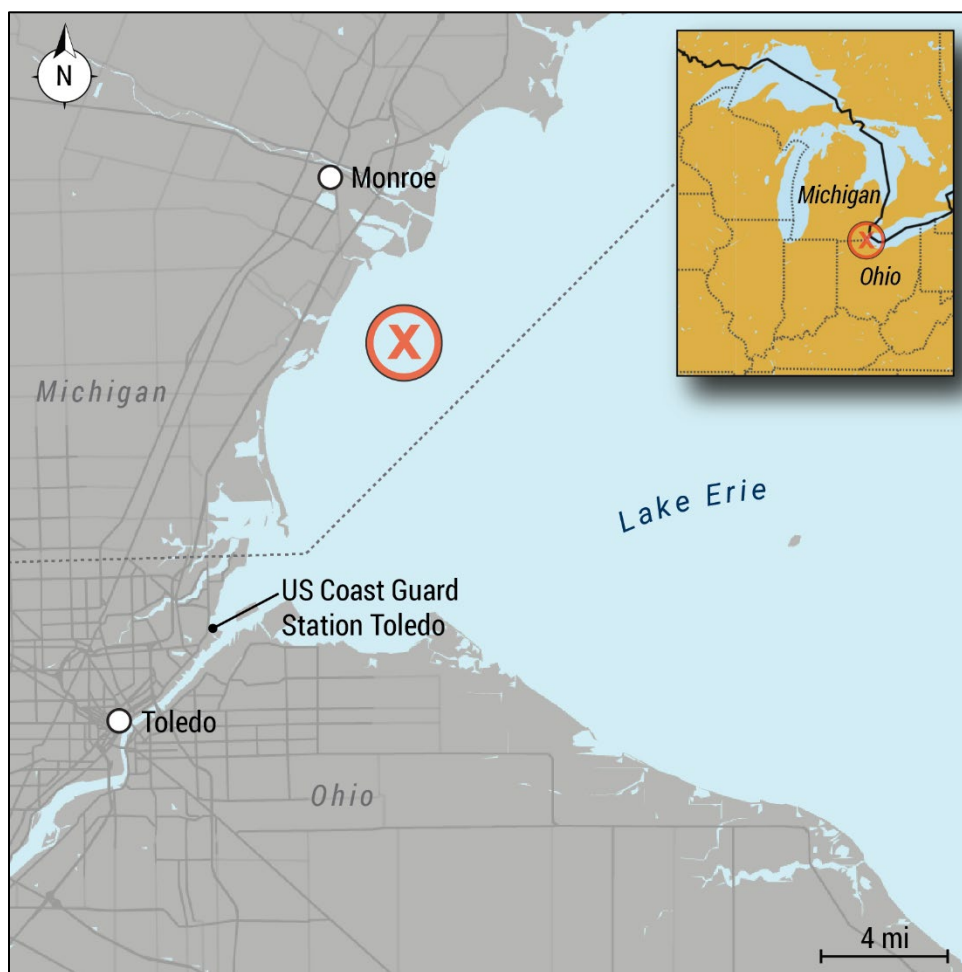
The collision occurred in Lake Erie, about 6 miles east-southeast of Monroe, Michigan (see figure 13). Lake Erie measures about 241 miles from east to west and 57 miles from north to south. At the time of the collision, the wave height was reported as 3 feet from the west. The waterway depth at the collision location was about 16 feet.

**Figure 13.** Area where the collision between uncrewed surface vessel and recreational vessel occurred, as indicated by a circled X. (Background source: Google Maps)

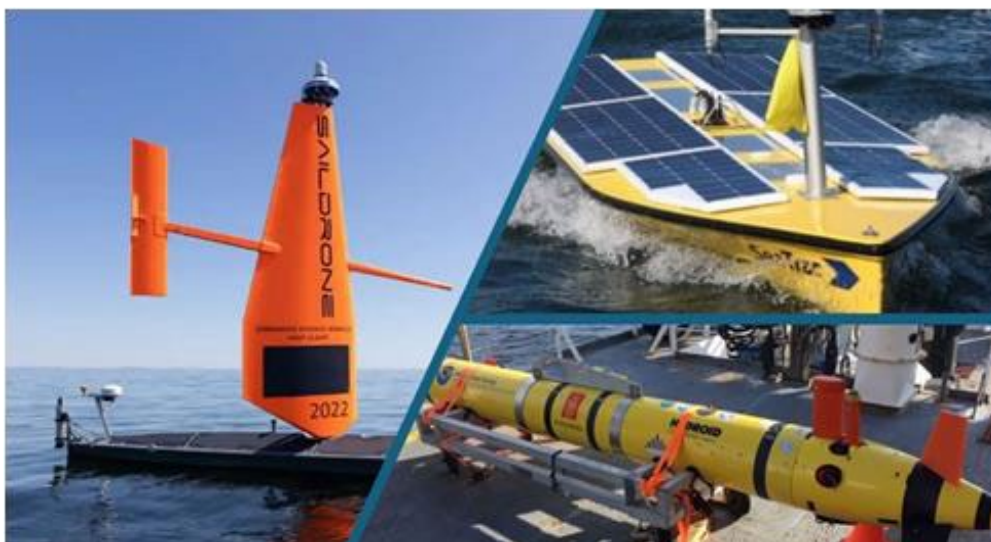
On November 7, 2024, the Coast Guard published MSIB 24-008, "Uncrewed Marine Craft and Autonomous Marine System Technology," to bring awareness to autonomous uncrewed marine crafts and systems operating in the northeast waters (US Coast Guard 2024b).<sup>41</sup> The MSIB stated that the systems' "increasing presence and diversity of form, shape, and function introduce significant layers of complexity to the maritime environment" and provided examples of vessels, including the GLERL USV (see figure 14). The MSIB listed the expected precautions that all mariners, vessel owners, and operators "must consider while planning an outing or transit." The bulletin recommended that owners and operators of autonomous craft engage early

with the Coast Guard when planning operations and ensure autonomous vessels include “appropriate marking” to help mariners see and avoid them.<sup>42</sup>

**Figure 14.** The GLERL USV pictured (top right) along with two other vessels in an MSIB.  
(Source: Coast Guard)
