**PIPELINE ACCIDENT REPORT
WASHINGTON GAS LIGHT COMPANY
NATURAL GAS EXPLOSIONS
AT ANNANDALE, VIRGINIA
MARCH 24, 1972**

**NATIONAL TRANSPORTATION SAFETY BOARD
Washington, D. C. 20591
REPORT NUMBER: NTSB-PAR-72-4**

Adopted: November 22, 1972

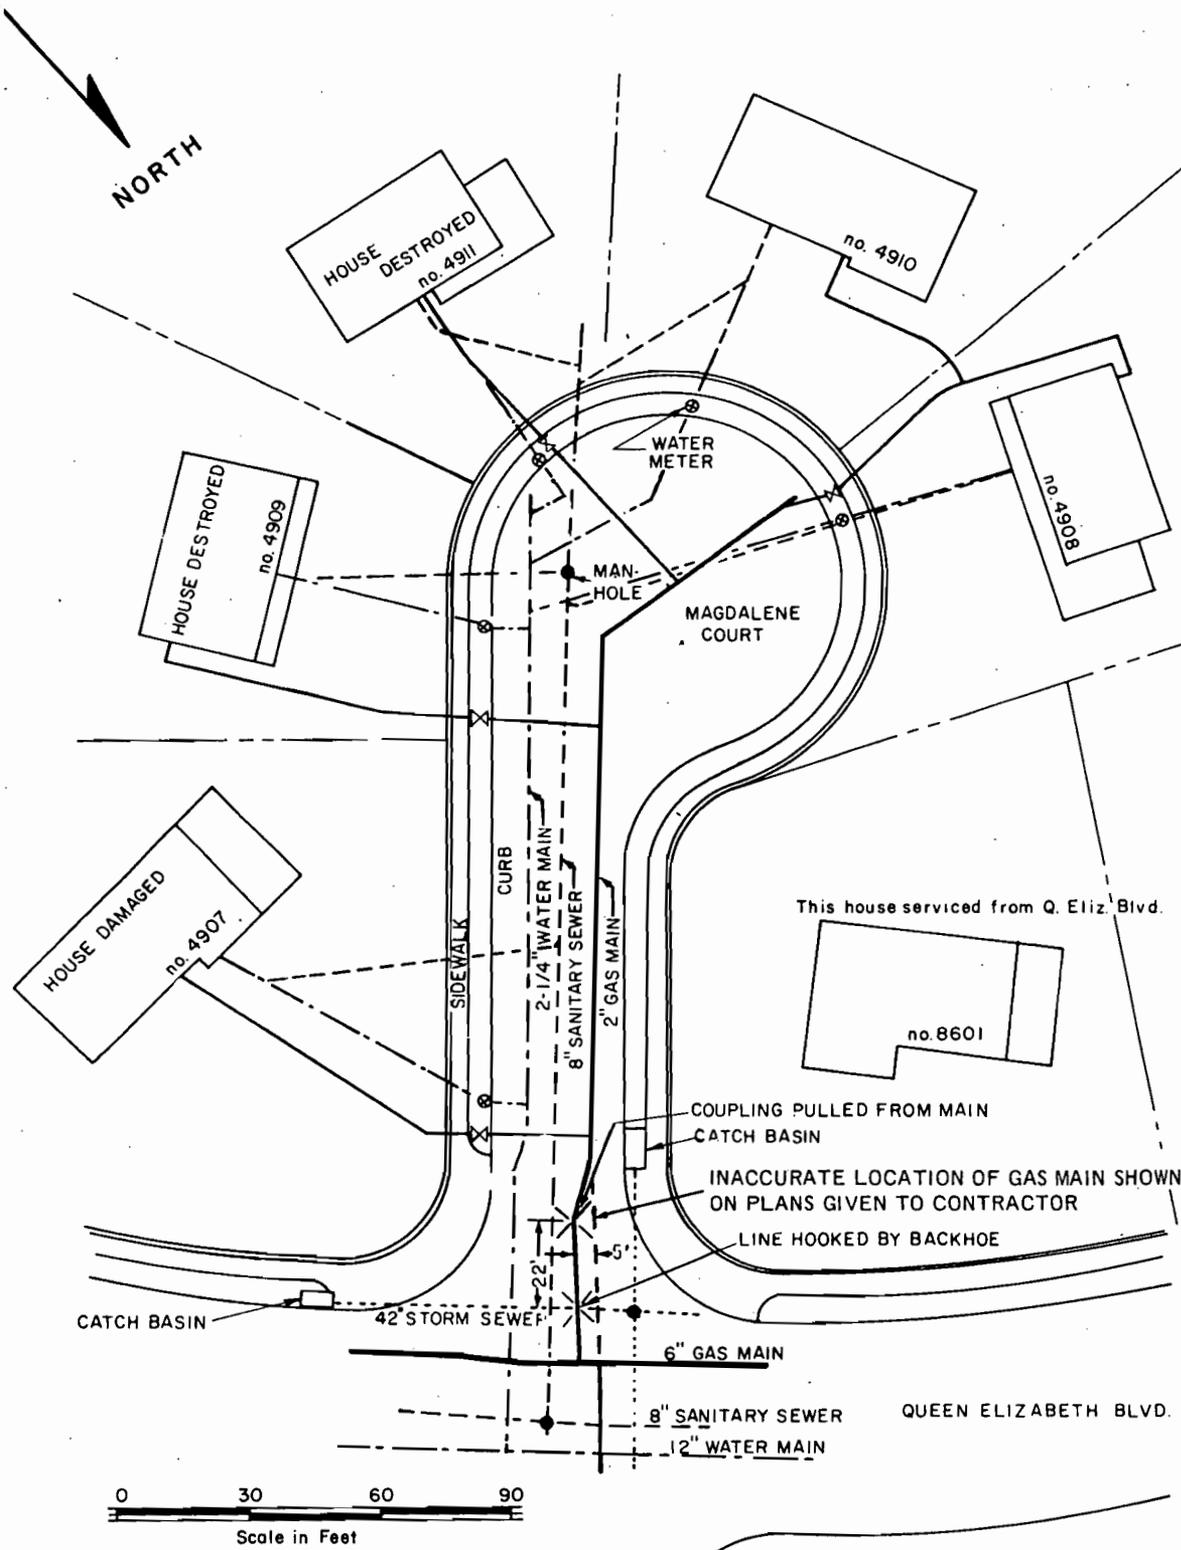
Figure 1. Accident site.

A 6-inch wrapped-steel gas main runs in an east-west direction on Queen Elizabeth Boulevard. Two 2-inch steel mains connected to this 6-inch main supply gas to the two culs-de-sac of Magdalene Court, north and south of the boulevard. (See Figure 1.)

The plans sent to WGL erroneously indicated that the 2-inch gas main serving Magdalene Court ran in a north-south direction straight across the 6-inch main on Queen Elizabeth Boulevard. Actually, the 2-inch line which ran into the southern cul-de-sac of Madgalene Court was set 5 feet to the east of the line which ran into the northern cul-de-sac. (See Figure 1.) This 5-foot offset was marked on the proposed plans by WGL and the plans were returned to the consulting firm in August 1971. In the transmittal letter, the gas company explained that the new locations marked on the prints were approximate, and stated:

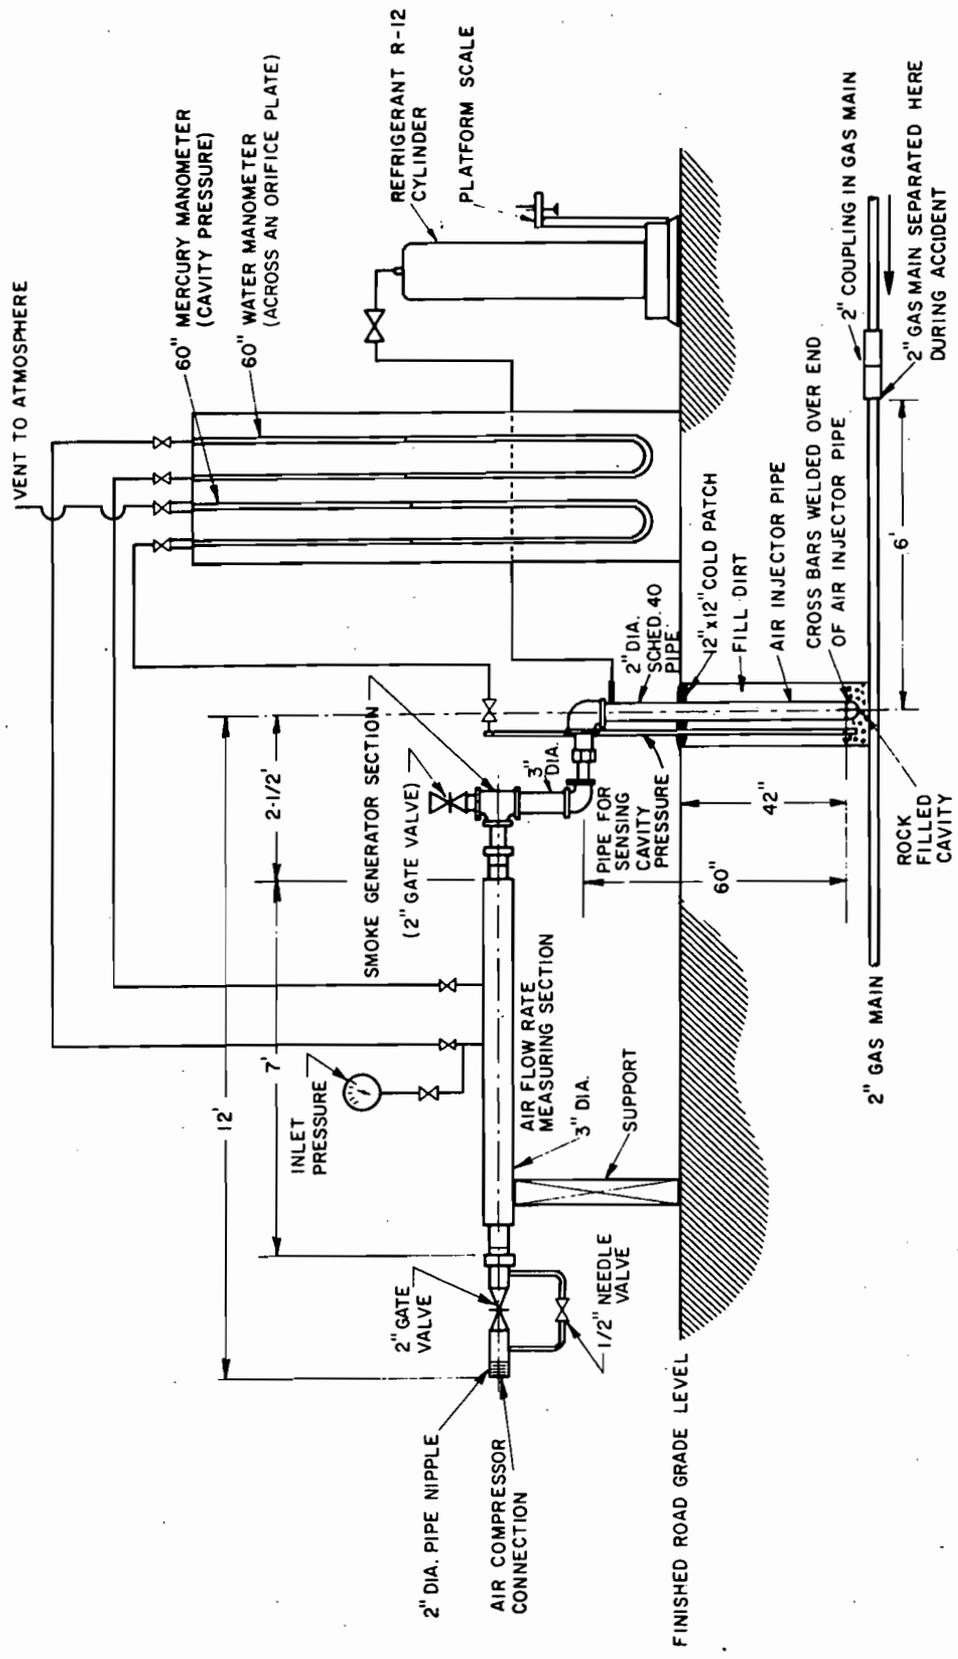
Figure 8. Set-up of National Bureau of Standards air-tracer injection.

Figure 8 shows the test setup used by NBS to inject the air-tracer mixture into the ground.

On the second day of tests, air-tracer mixture, flowing at a rate of 29.2 c.f.m. and at a pressure of 2.2 p.s.i.g., was introduced into the ground. Tracer was detected at many points at the accident site, including the points where natural gas was known to have been present during the accident. A complete list of the locations where tracer was and was not found is included as Appendix B.
