PIPELINE ACCIDENT REPORT

WASHINGTON GAS LIGHT COMPANY

BOWIE, MARYLAND

JUNE 23, 1973

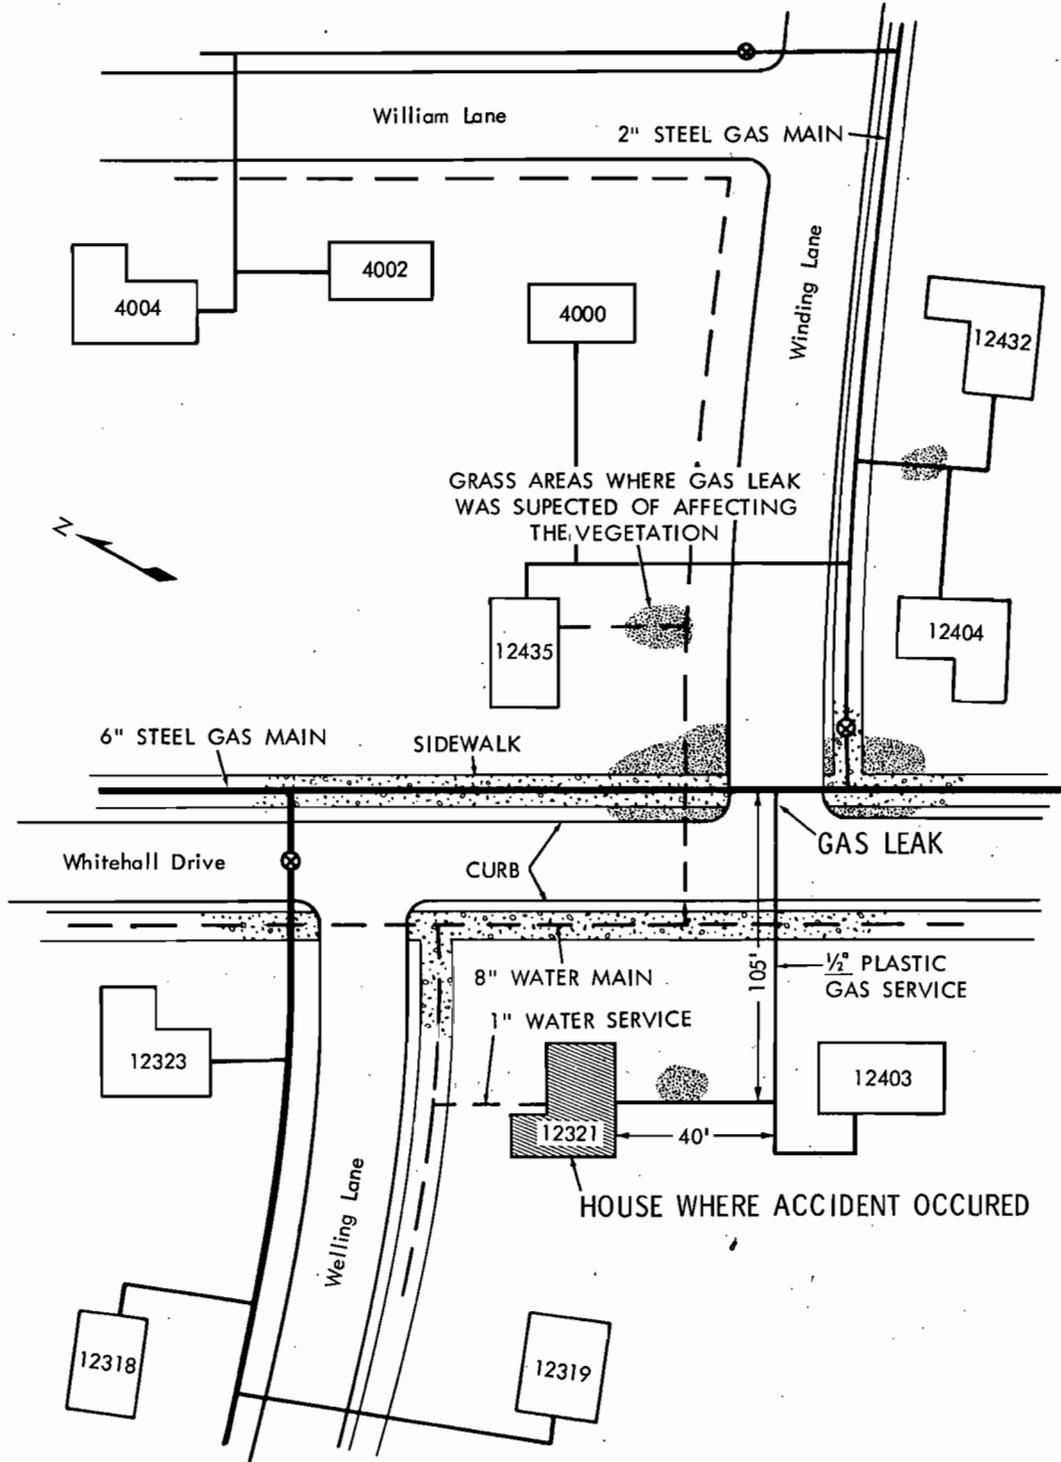
Figure 2. Accident site.

Leakage Survey. On June 26, a leakage consultant inspected the accident area. He reported the presence of natural gas under the slab, in the heating ducts, and around the house. ^{1/} Explosive concentrations of gas were detected in bar holes throughout the area. The highest reading, 60 percent gas, was found over the gas service near the southwest corner of 12432 Winding Lane (See Figure 2.)

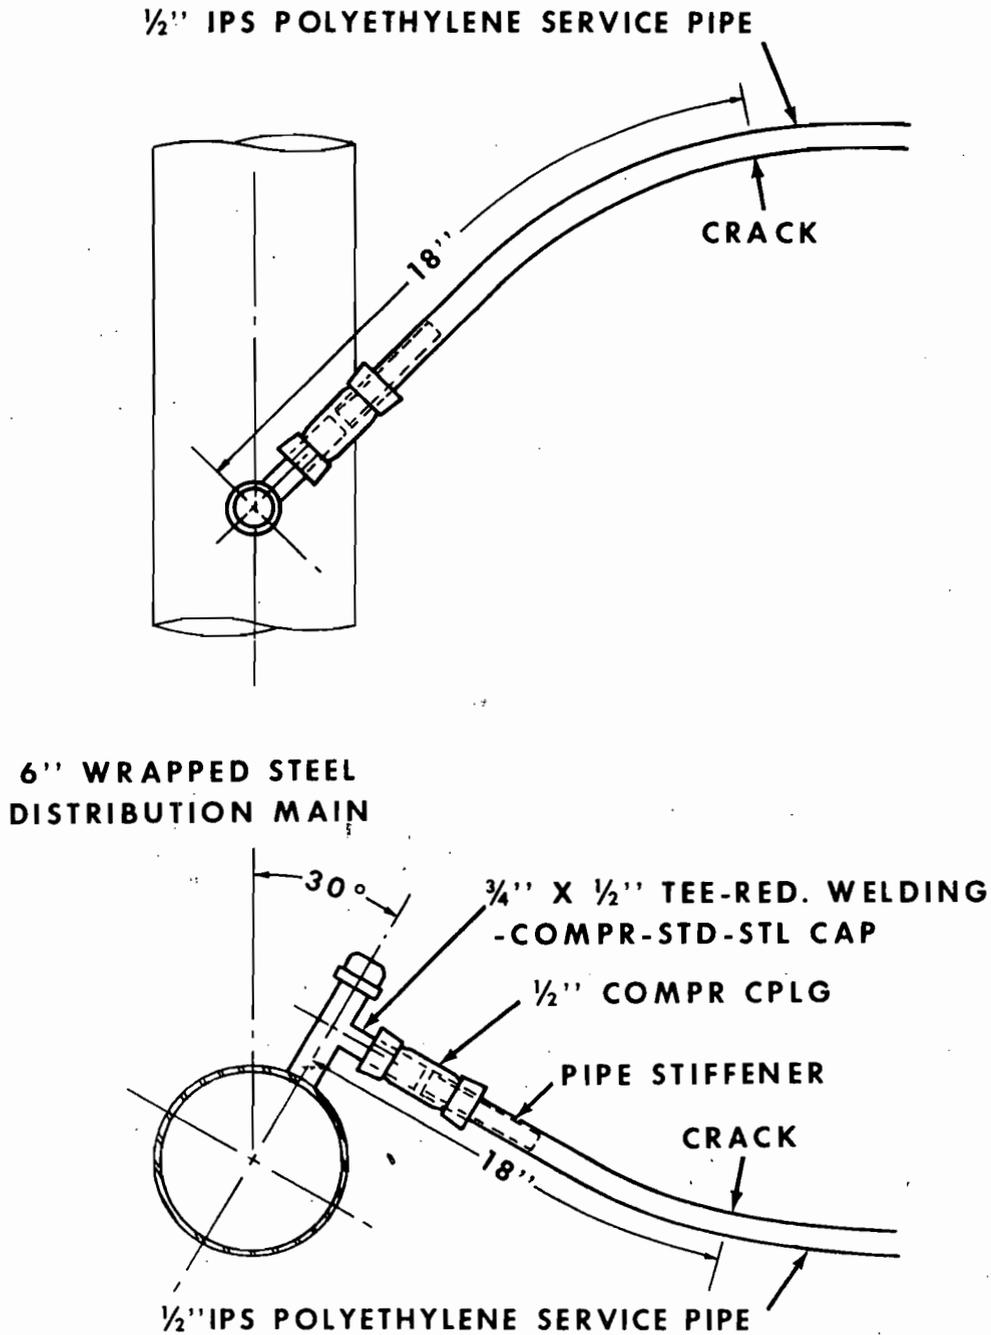
Figure 3. Plastic Service Connection to Steel Main

At that time, sketches were being used by WGL to show how the service connection to the main should be made. WGL practice was to use the same basic installation WGL had been using for copper tubing service lines, except that special service tees had to be made to complete the necessary connections. The $\frac{3}{4}$ in. x $\frac{3}{4}$ in. x $\frac{1}{2}$ in. compression outlet tee, which was required to connect the service line to the main, was not available commercially. WGL purchased the pipe and supplied it to a subcontractor, who installed the service line for the builder. The final connection of the service line to the main was made by WGL personnel. The service line was installed 40 in. below the ground, and in the process of coupling it to the steel main, the service line was bent slightly upward at a 30° angle. It was attached to a tee on the main by means of a standard compression coupling.

A $4\frac{1}{2}$ -inch-long aluminum pipe stiffener was used on the end of the plastic pipe that was placed in the compression coupling. (See Figure 3.)
