PIPELINE ACCIDENT REPORT

**UNION LIGHT, HEAT AND POWER COMPANY
NATURAL GAS EXPLOSION AND FIRE
SIMON KENTON HIGH SCHOOL
INDEPENDENCE, KENTUCKY
OCTOBER 9, 1980**

NTSB-PAR-81-1

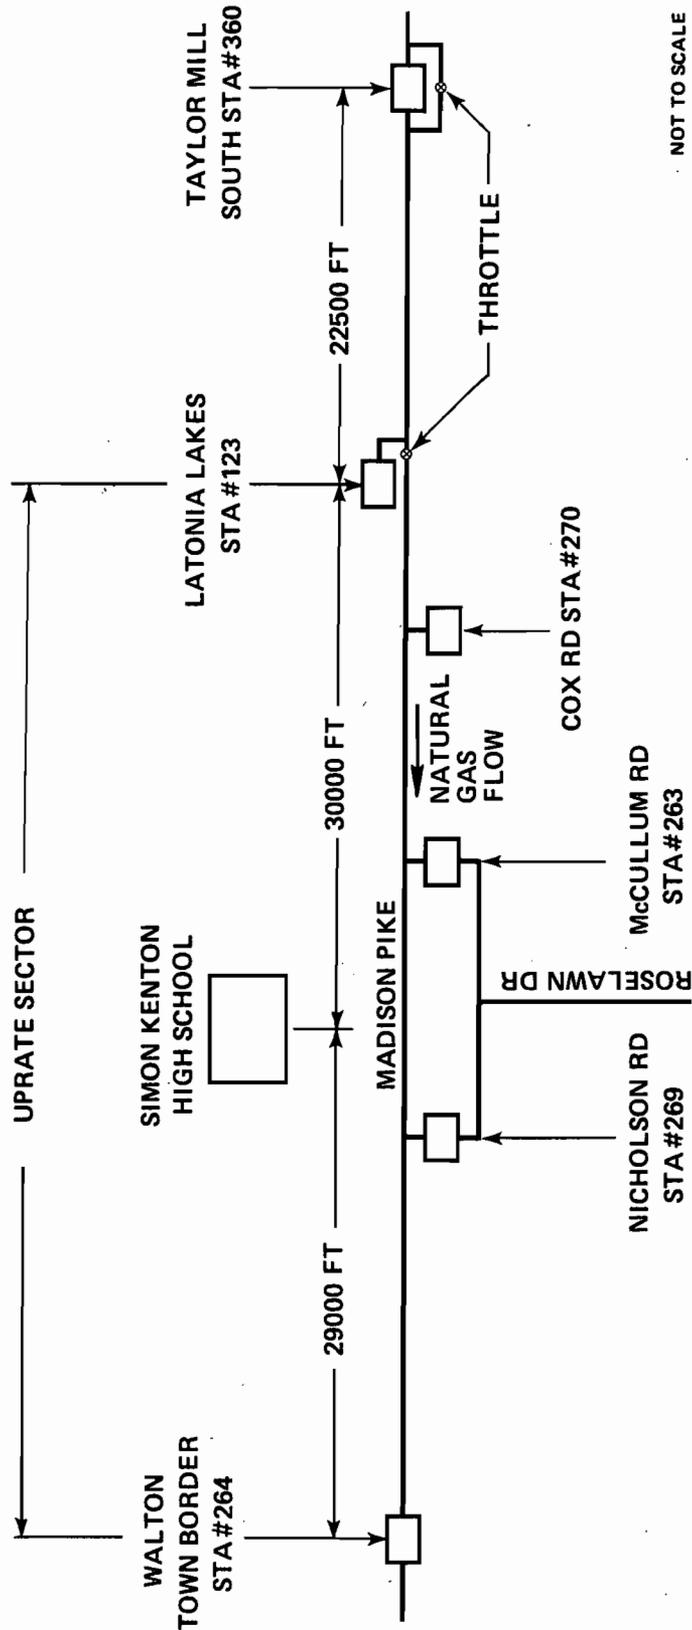
Figure 1.--Plan view of updated pipeline section.

On the morning of October 9, 1980, employees of the Union Light, Heat and Power Company (gas company) were uprating 1/ a 4-inch-diameter gas main from the gas system's station 123 to station 264 in Independence, Kentucky. (See figure 1.) The gas main's operating pressure was being increased from 60 to 200 psig in increments of
