Overpressurization of Natural Gas Distribution System,
Explosions, and Fires in
Merrimack Valley, Massachusetts
September 13, 2018

Accident Report

NTSB/PAR-19/02
PB2019-101365

Pipeline Accident Report

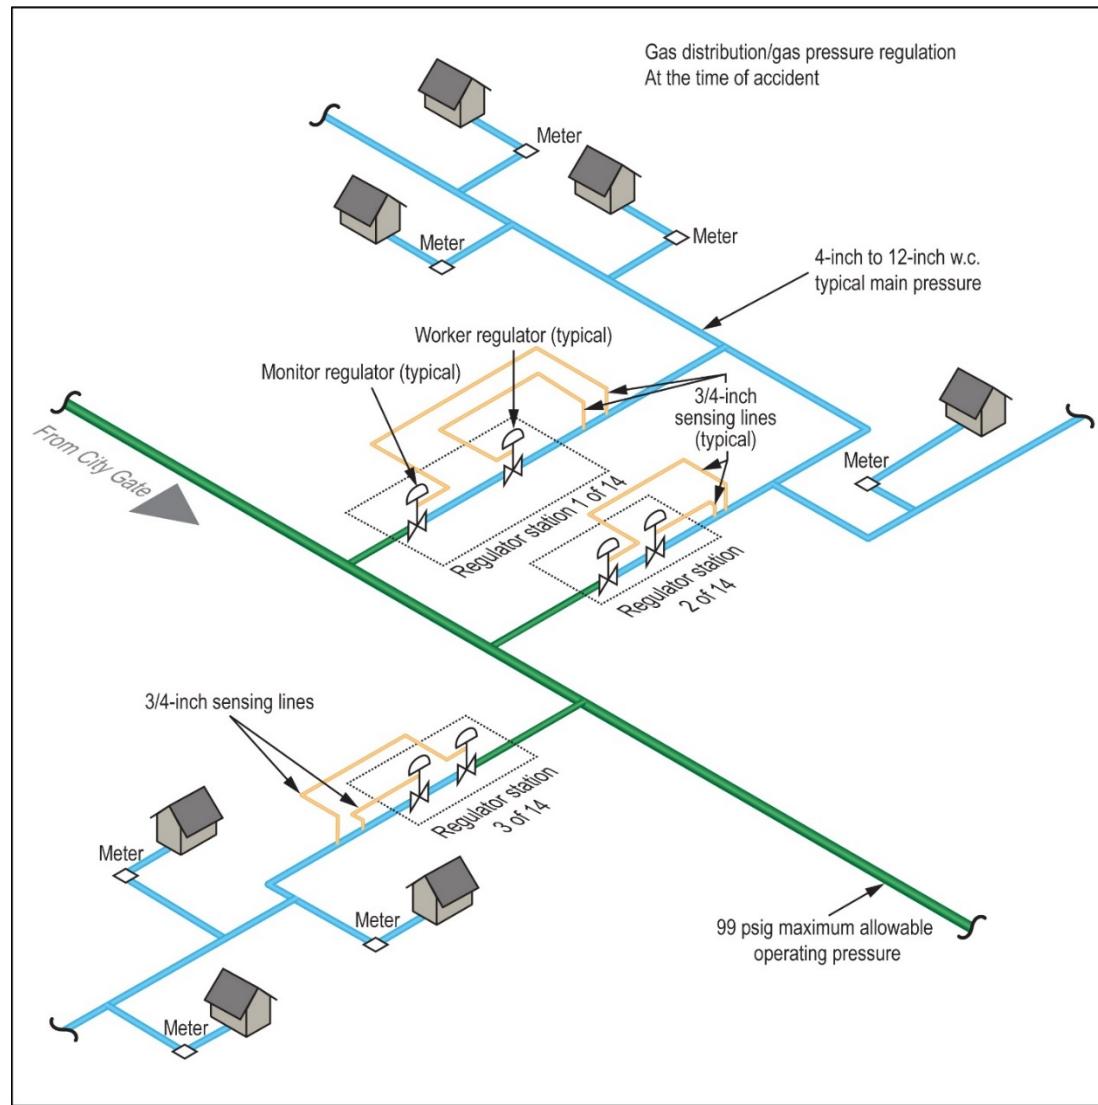
Since the regulator stations are the primary means of pressure control in the low-pressure systems, an overpressure condition in a natural gas distribution system could affect all customers served by the system. This is an inherent weakness of a low-pressure natural gas distribution system.

Figure 3. Typical configuration of the Merrimack Valley low-pressure natural gas distribution system.

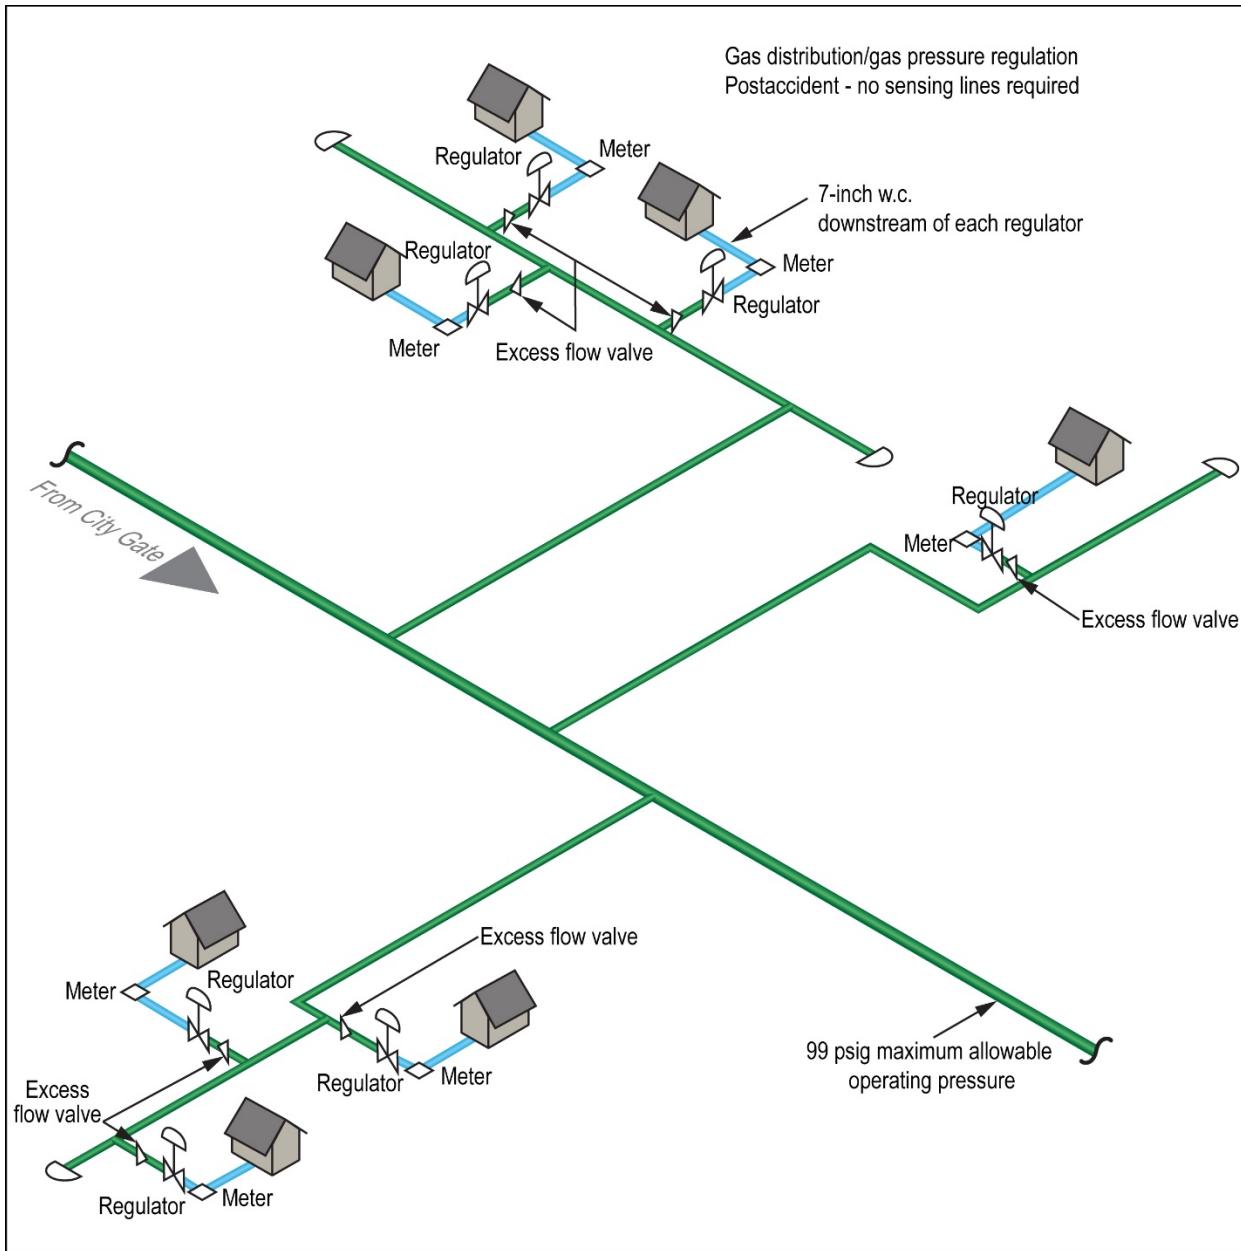
In a high-pressure natural gas distribution system, the natural gas pressure in the main is substantially higher than that required by the customer. A pressure regulator is installed at each meter to reduce the pressure. These regulators incorporate an overpressure protection device to prevent overpressurization of the customer's piping and appliances should the regulator fail. Additionally, excess flow valves are installed in the service line.⁷ Because each customer's service in a high-pressure natural gas distribution system is protected by an excess flow valve and a pressure regulator, it is highly unlikely that an overpressure condition in the main would impact multiple customers. Figure 4 shows a typical high-pressure natural gas distribution system. This is the type of natural gas distribution system that was installed postaccident in the Merrimack Valley.

Figure 4. Typical configuration of high-pressure natural gas distribution system installed postaccident.

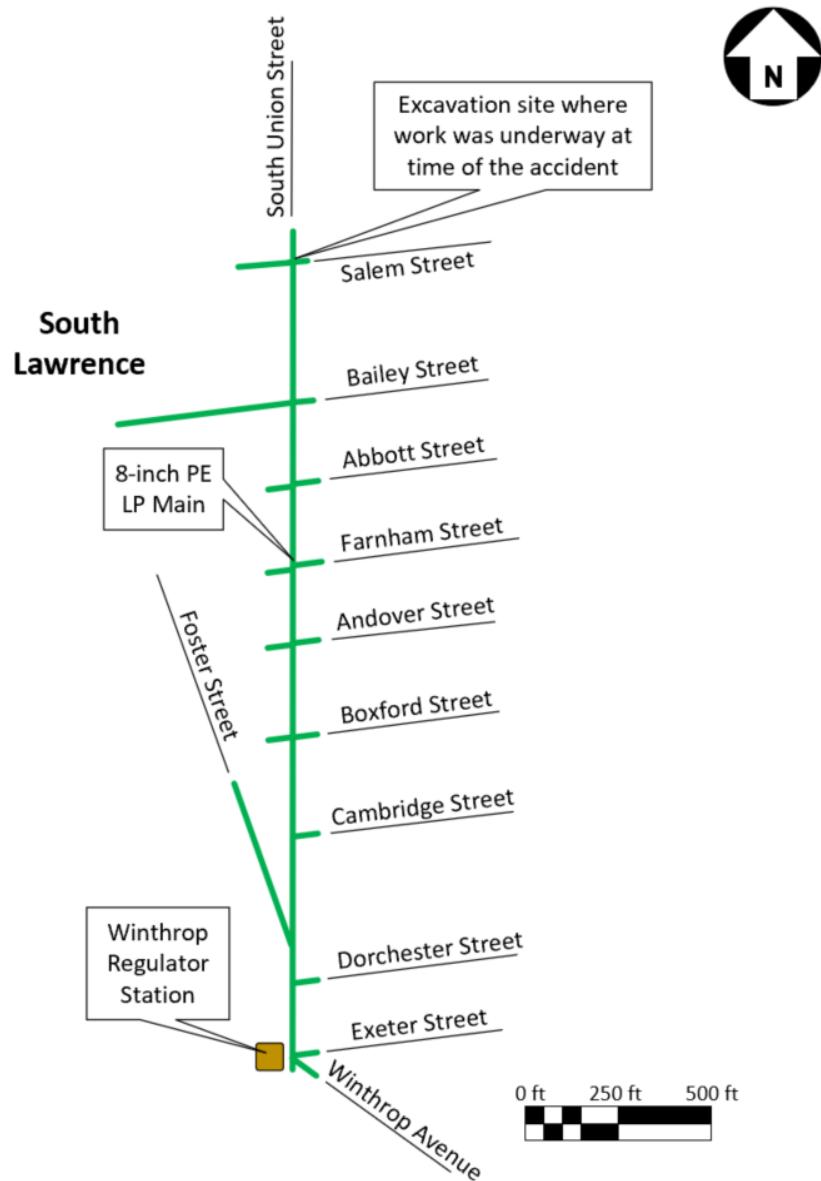
Figure 7 shows the area of the replacement of the natural gas main in South Lawrence along South Union Street with the cross-street tie-ins. The work on the day of the accident was at the north end of the project at Salem Street. The Winthrop Avenue regulator station is at the south end of the project.

Figure 7. Areas along South Union Street with tie-ins impacted by the project.

The first stage of the project involved the installation of the polyethylene main, which was completed in late 2016. The regulator sensing lines at the Winthrop Avenue regulator station remained attached to the cast iron main, where they controlled natural gas flow through the Winthrop Avenue regulator station into both the cast iron and polyethylene mains, which were connected in the low-pressure natural gas distribution system. (See figure 8.)

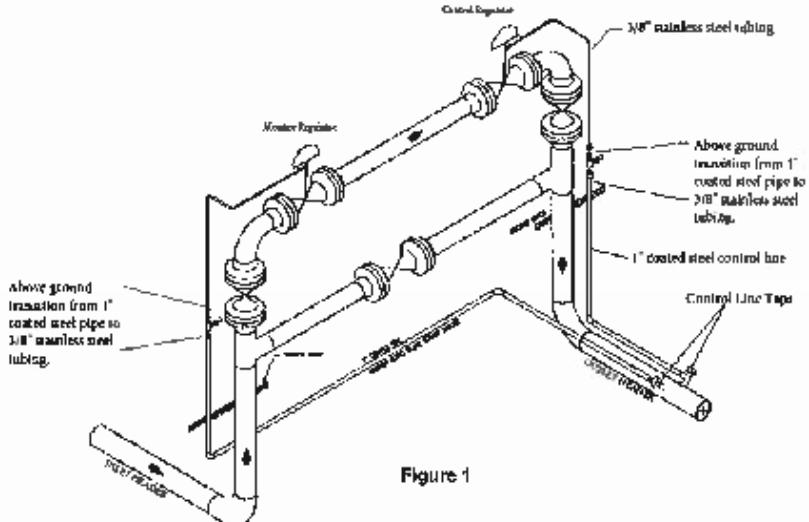
Figure 1 is a schematic drawing showing a regulator setting with control lines extending below grade.

Other lines if damaged, such as telemetry sensing lines and electric lines to equipment at the City Gate/Town Border/POD, District Plant Regulator or Customer M&R station, may also result in pressure monitoring and control issues, which may lead to a catastrophic event.
