NATIONAL TRANSPORTATION SAFETY BOARD

# PIPELINE ACCIDENT REPORT

LOW-PRESSURE NATURAL GAS  
DISTRIBUTION SYSTEM

BURLINGTON, IOWA

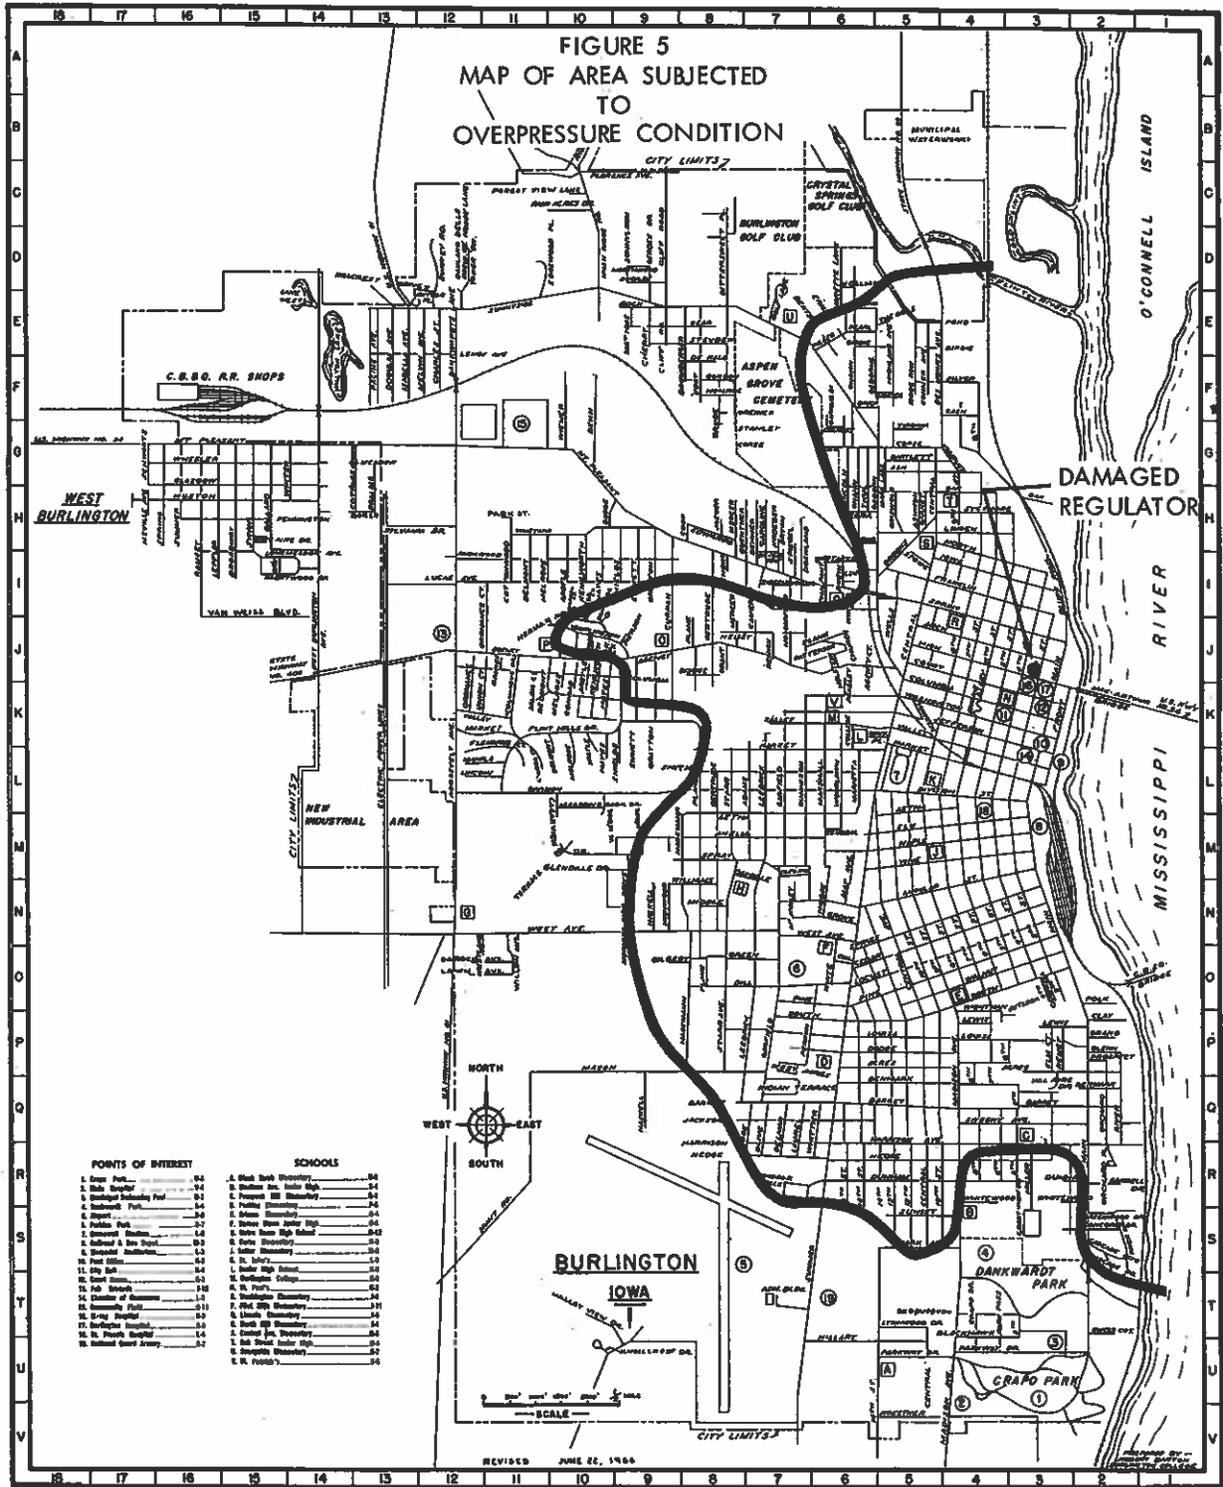
There were no fatalities, but two firemen suffered minor injuries. The combined firefighting force answered 54 alarms. There were no explosions, but six houses were damaged by fire to the point where they were uninhabitable, and 42 other houses suffered fire damage exceeding \$50. The Burlington Fire Department estimated the property damage at \$80,000. The fires were mainly in and around the gas ranges, gas hot water heaters, and heating equipment. The high pilot lights and burner flames caused by the high-pressure gas ignited combustible materials near these appliances, such as kitchen curtains and cabinets. In some of the more badly damaged houses, the fires spread from the immediate area of the ranges and heating units to other parts of the buildings. All of the damage was confined to the inside of the houses. Figures 6 and 7 (Pages 14 and 15.) indicate the damage sustained by the houses.
