PIPELINE ACCIDENT REPORT

COLONIAL PIPELINE COMPANY
PETROLEUM PRODUCTS DIVISION
JACKSONVILLE, MARYLAND
SEPTEMBER 3, 1970

REPORT NUMBER: NTSB-PAR-71-2

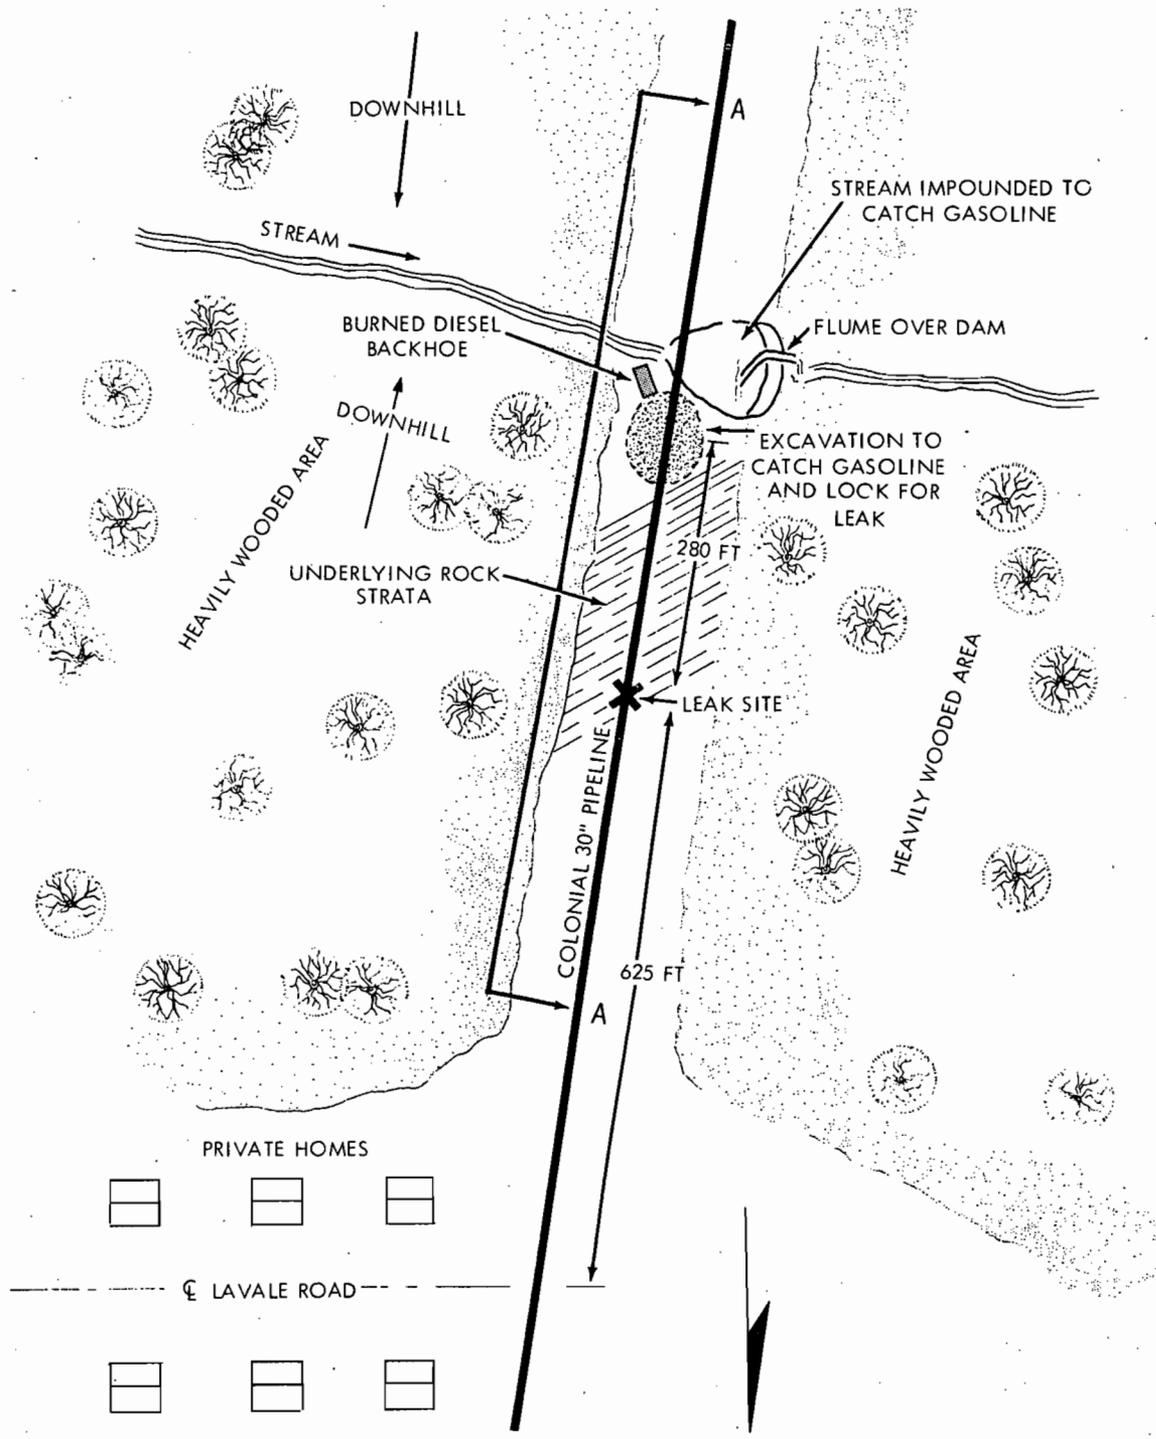
This accident took place 4 miles North of Jacksonville, Maryland, in a rural, sparsely populated area. The terrain is wooded with gently rolling hills, and the 30-inch pipeline owned by Colonial lies northeast and southwest across a small valley at the bottom of which is a small stream. The line crests over the hill from the southwest, 63 feet above the stream, travels down the slope under the stream and back up to the top of the next hill 70 feet above the stream. The stream flows from east to west across the pipeline, meanders in a westerly direction, flowing under Route 146 (Jarrettsville Pike) and joins Parker Branch some 300 yards away toward the west. Parker Branch is one of several tributaries of the Little Gunpowder Falls River, a larger body of water which ultimately empties into the Chesapeake Bay. (See Figures 1 and 2.)

FIGURE 1
SITE OF JACKSONVILLE, MARYLAND
PIPELINE ACCIDENT
OF SEPTEMBER 3, 1970

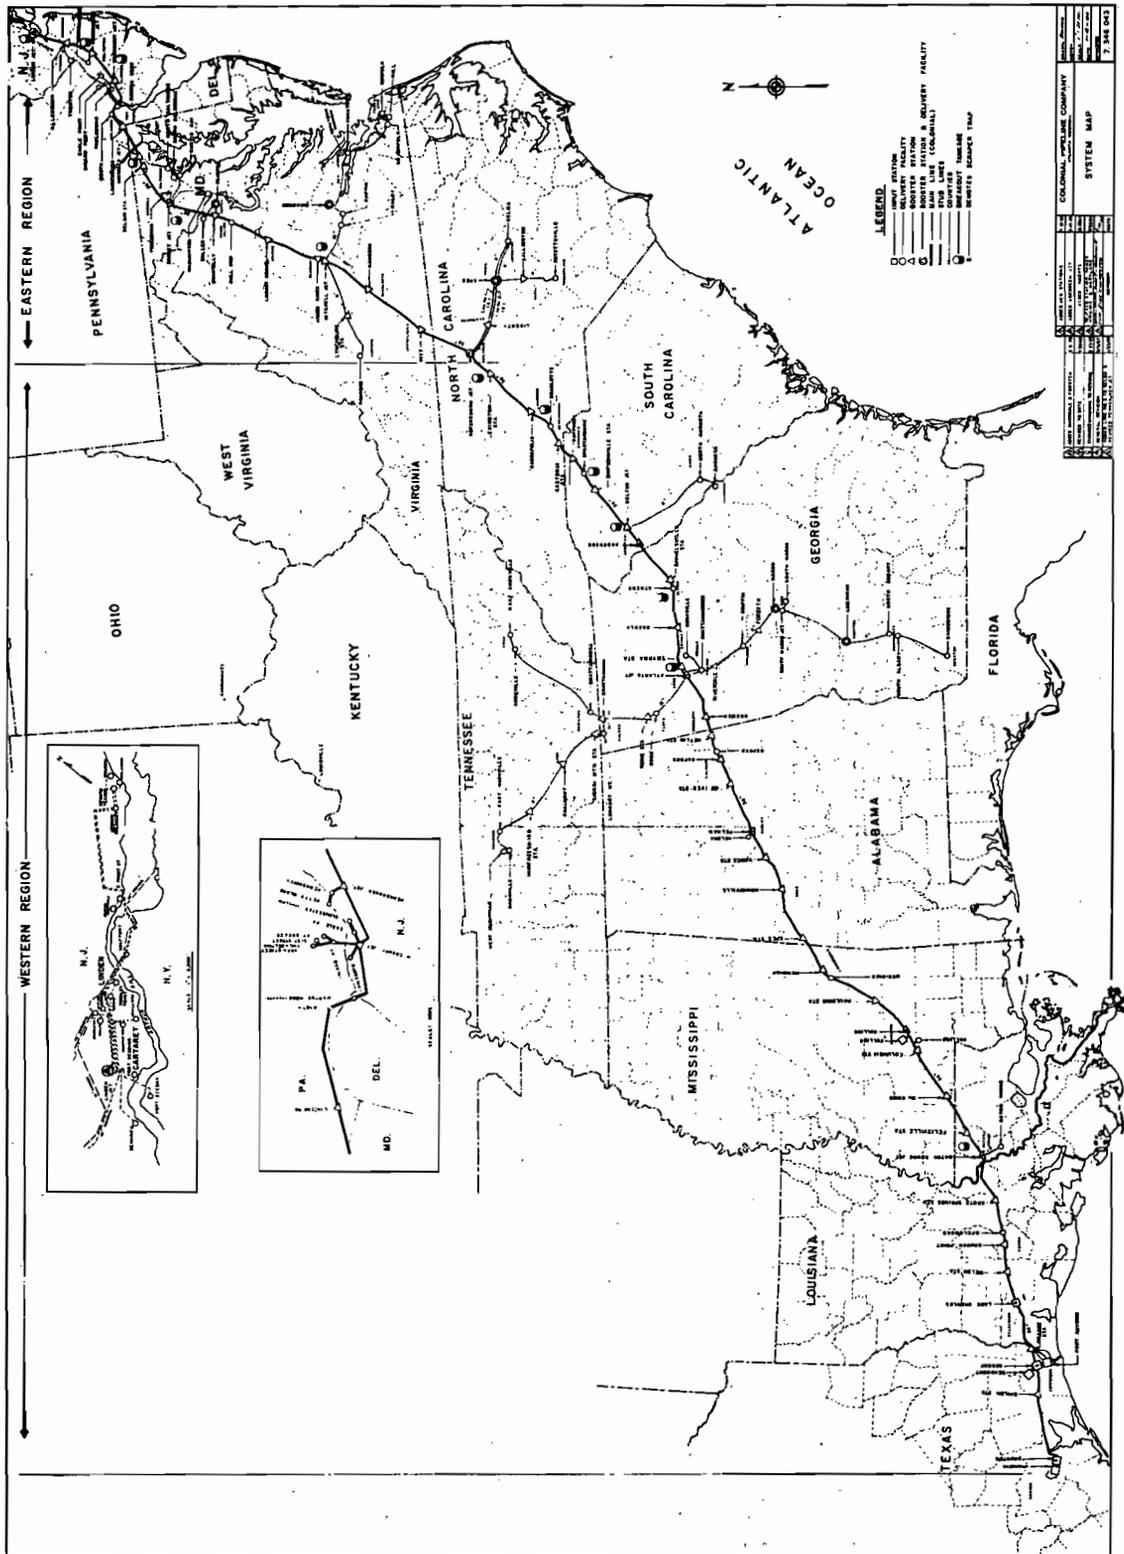
This pipeline, completed in 1964, extends more than 1,500 miles from Houston, Texas, to Linden, New Jersey. The capacity of the line is now 1,150,000 barrels per day (48,300,000 gallons of petroleum products per day). (See Figure 3.)

FIGURE 3
 COLONIAL PIPELINE SYSTEM MAP
