**PIPELINE ACCIDENT REPORT
PHILLIPS PIPE LINE COMPANY
PROPANE GAS EXPLOSION
FRANKLIN COUNTY, MISSOURI
DECEMBER 9, 1970**

**NATIONAL TRANSPORTATION SAFETY BOARD
Washington, D. C. 20591
REPORT NUMBER NTSB-PAR-72-1**

FRANKLIN COUNTY, MISSOURI

DECEMBER 9, 1970

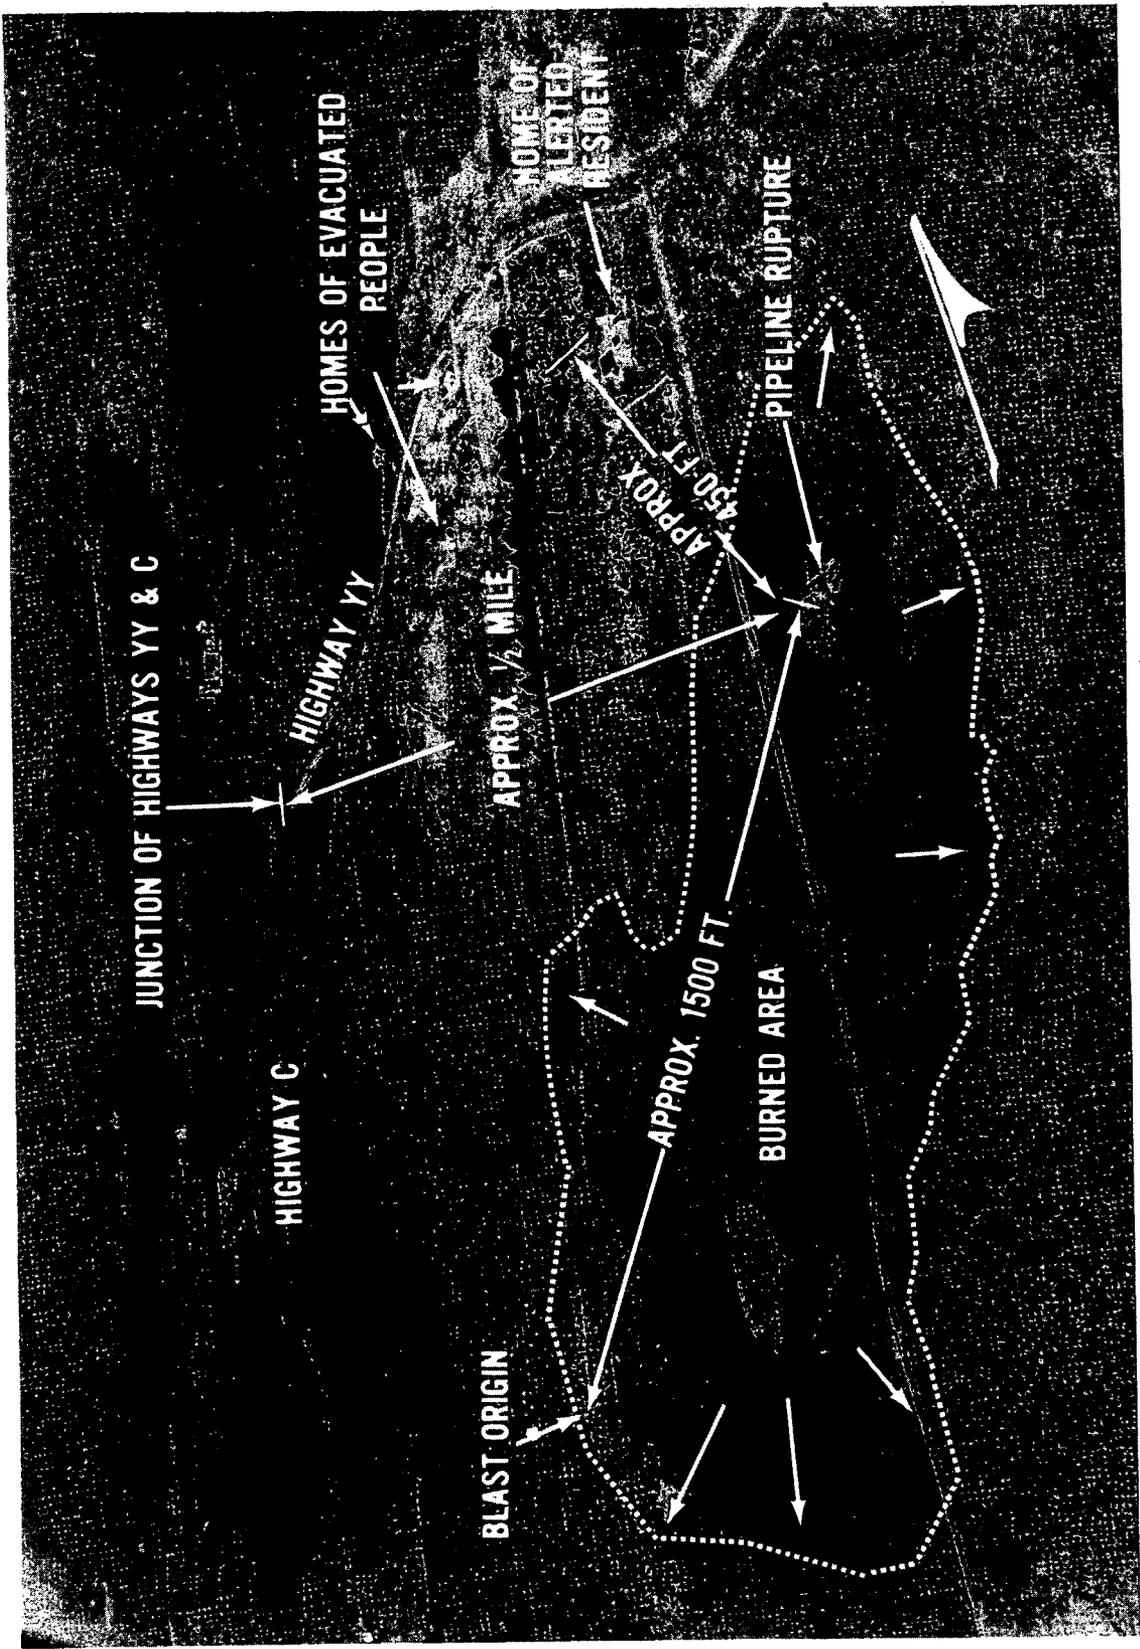
Figure 1 Overall View of Accident Area Showing Rupture Site, Explosion Origin and Residents' Houses

south to form a shallow valley. A few widely separated farmhouses are located in the valley itself and eight or more modern houses are on the rim of the valley along an east-west highway designated YY. An 8-inch pipeline, owned by the Phillips Pipe Line Company, extends through the area in an east-west direction roughly parallel to, and 500 feet south of highway YY at the point of the leak. (See Figure 1.)

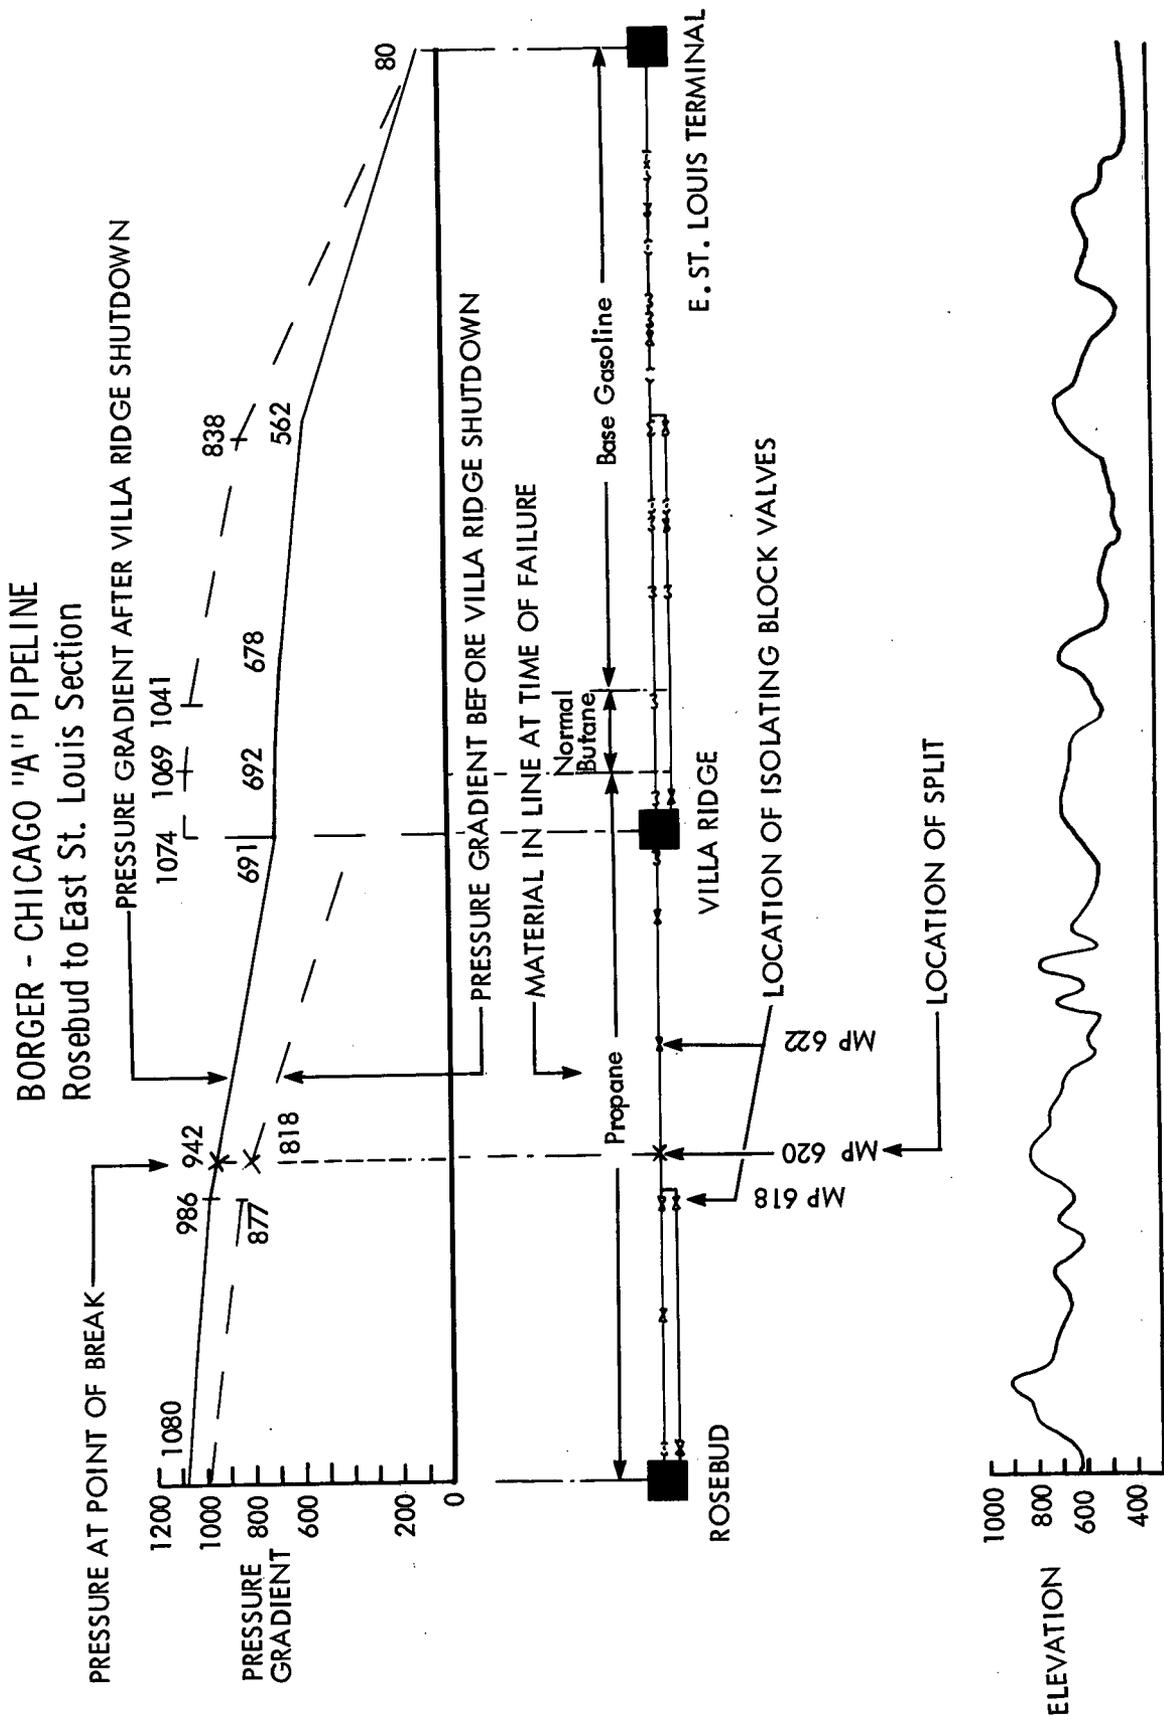
Figure 5 Hydraulic Gradient Between Rosebud and Villa Ridge Pump Stations

At 10 p.m. the Phillips pipeline dispatcher in Bartlesville was making his routine hourly check on the "A" line to observe and record the flow rates and station pressures and verify normal operation. For the past several hours the pipeline had been running full; all booster stations from Paola eastward across the State of Missouri were running, near-maximum flow rates prevailed, and near-maximum pressures existed. Paola Station in Kansas was pumping at 920 p.s.i.g., Harrisonville Station in Missouri was pumping at 790 p.s.i.g., Syracuse Station in Missouri was pumping at 914 p.s.i.g., Jefferson City Station in Missouri was pumping at 846 p.s.i.g., Rosebud Station in Missouri was pumping at 1,006 p.s.i.g., and Villa Ridge Station in Missouri was pumping at 1,074 p.s.i.g. An almost solid stream of LPG was packed into the pipeline which was pumping at 1,500 barrels (63,000 gallons) per hour. (See Figure 5.)

At 10:07 p.m., a hazardous vapor alarm light flashed on the dispatcher's control console indicating that Villa Ridge Station in Franklin County, Missouri, had experienced a hazardous vapor condition in the pumphouse and would automatically shut down within 3 minutes. At 10:10 p.m. when this occurred, the pipeline stream bypassed Villa Ridge Station and the pressure gradient changed rapidly from Rosebud Station to the terminal at East St. Louis. The pressure between Rosebud and Villa Ridge Stations increased, while that between Villa Ridge and East St. Louis decreased. The pressure at the point of rupture, about halfway between Rosebud and Villa Ridge, increased from 818 p.s.i.g. to 942 p.s.i.g. This section of the line had not been subjected to a pressure this high in the recent past.

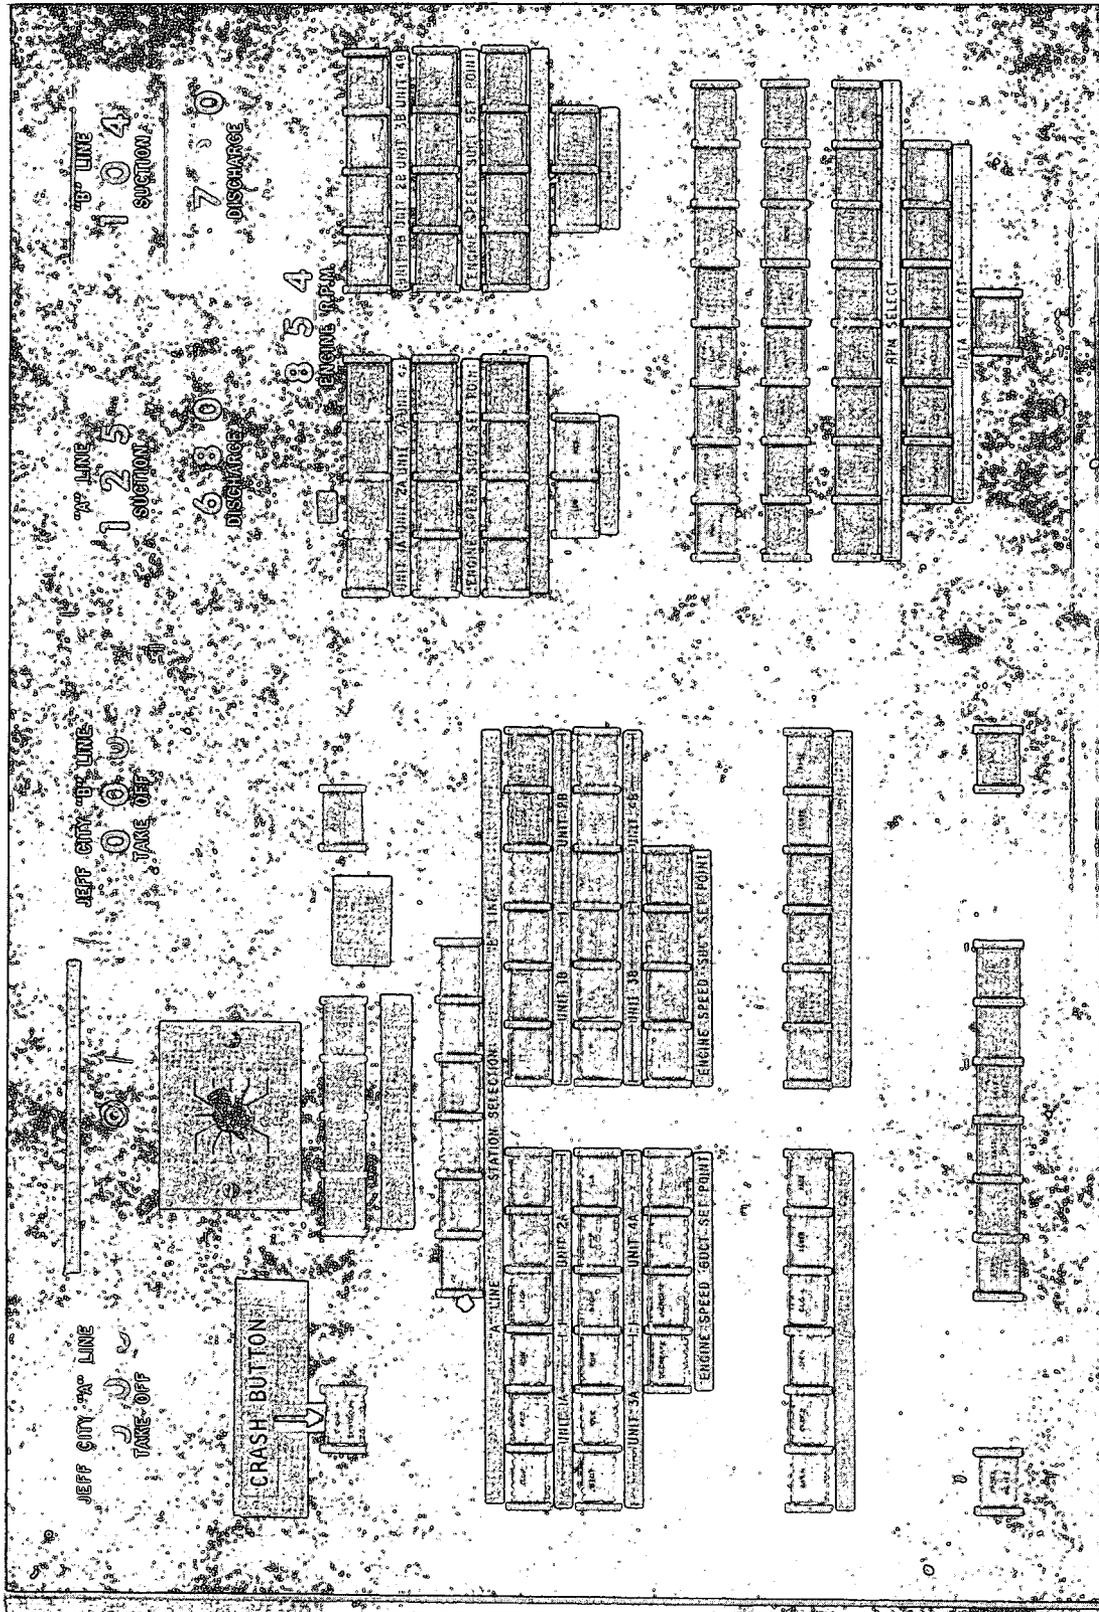
Figure 6 Dispatchers Control Console Showing the "Crash Button"

A "crash down" procedure designed to shut down each unattended pump station in the event of fire was not utilized. This rapid shutdown procedure for the entire pipeline system requires between 20 and 30 seconds for each station so activated. The dispatcher had never been instructed in or studied this particular method of "crashing down" the entire pipeline. No procedure for shutting down the entire pipeline by using the station crash button was contemplated by Phillips and no instructions to that effect were issued. The intent of the crash button is for station shutdown due to fire. (See Figure 6.)
