**CONSOLIDATED GAS SUPPLY CORPORATION  
PROPANE PIPELINE RUPTURE AND FIRE**

**RUFF CREEK, PENNSYLVANIA**

**JULY 20, 1977**

**REPORT NUMBER: NTSB-PAR-78-1**

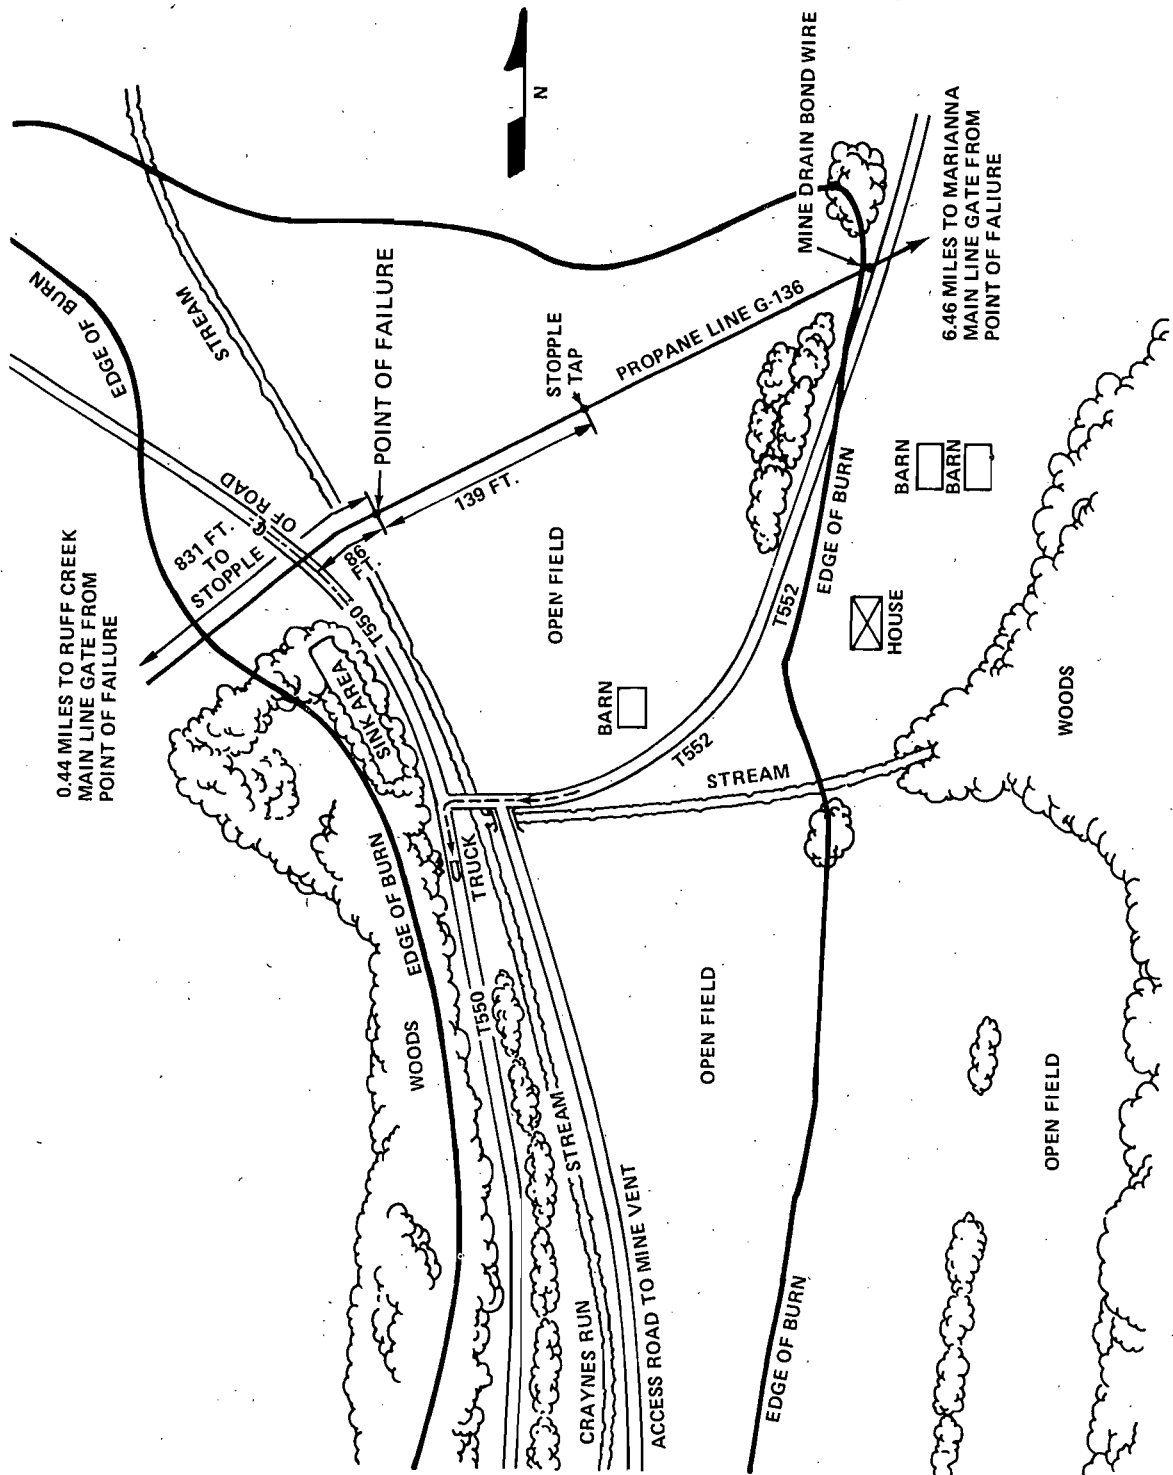
Figure 3. Plan of accident site.

At 9:05 a.m., 4 1/2 hours after the pipeline failure, the first crew from Consolidated arrived at the accident site. At that time, the 40-foot-high flames from the burning propane vapors were confined to a small area directly over the break in the pipeline. The break was 86 feet east of township road T-550, and 33 feet east of the Craynes Run stream. (See figure 3.)

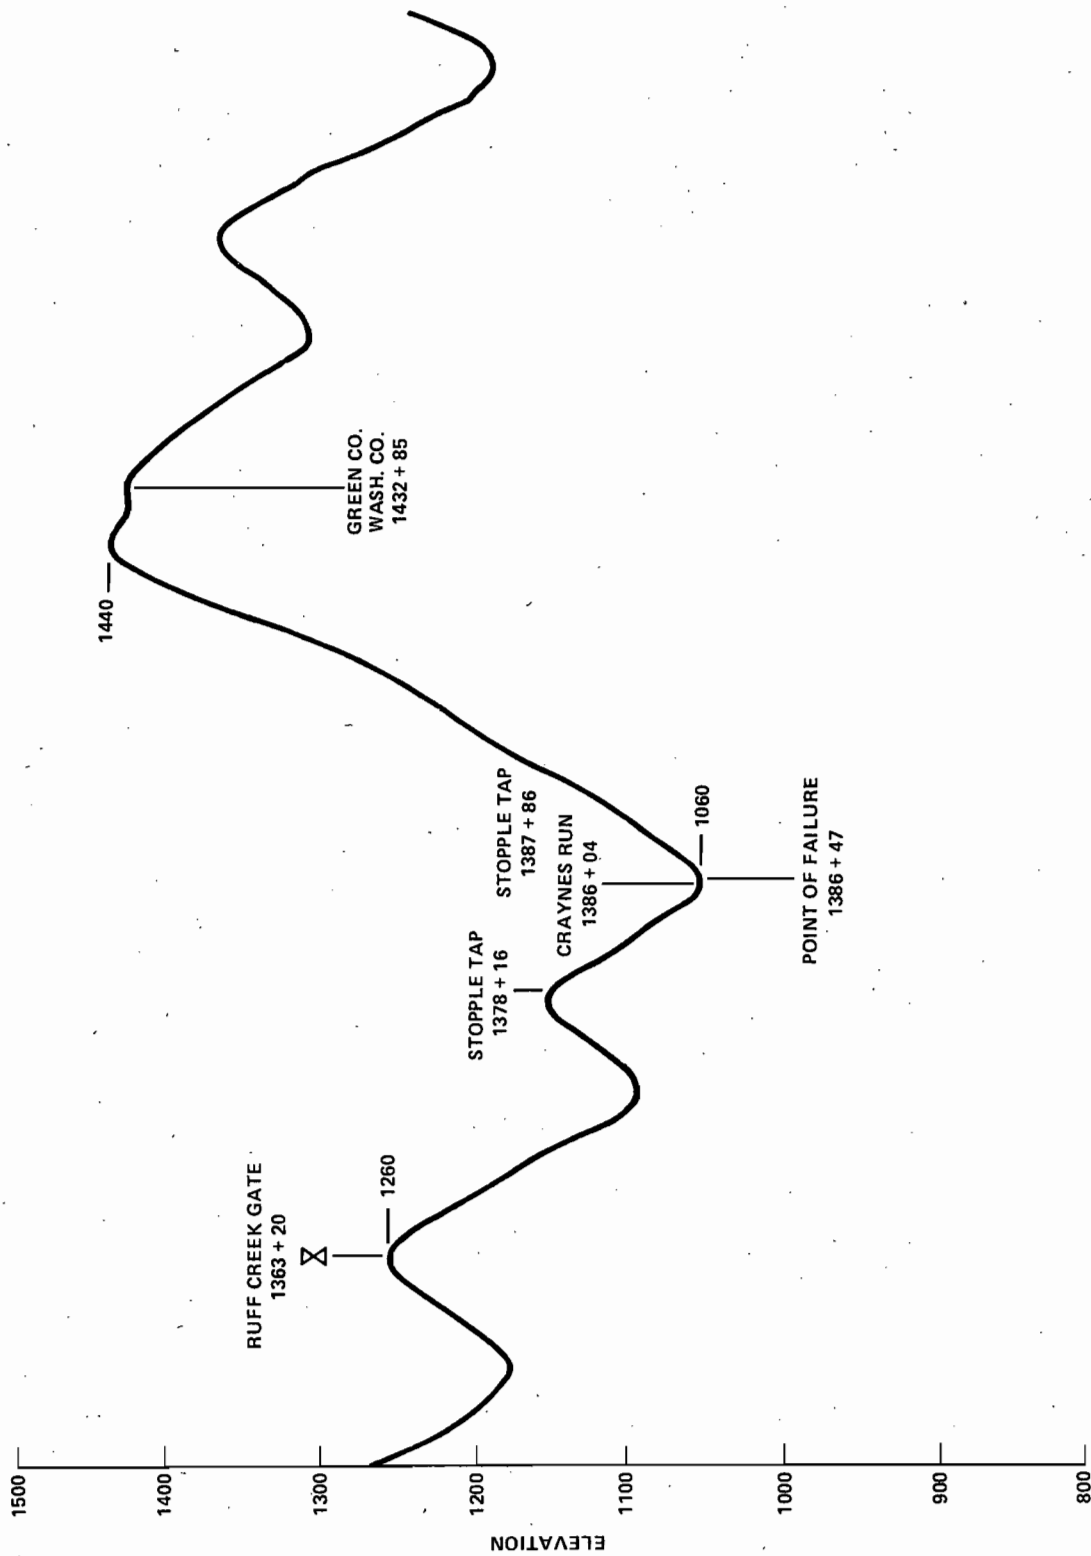
Figure 4. Topographic view of pipeline route.

At 2:45 p.m., the stopple equipment arrived and was first installed northeast of the line break because that location was closer to the rupture. The setting of the first stopple was completed at 5:15 p.m. (See figure 4.)

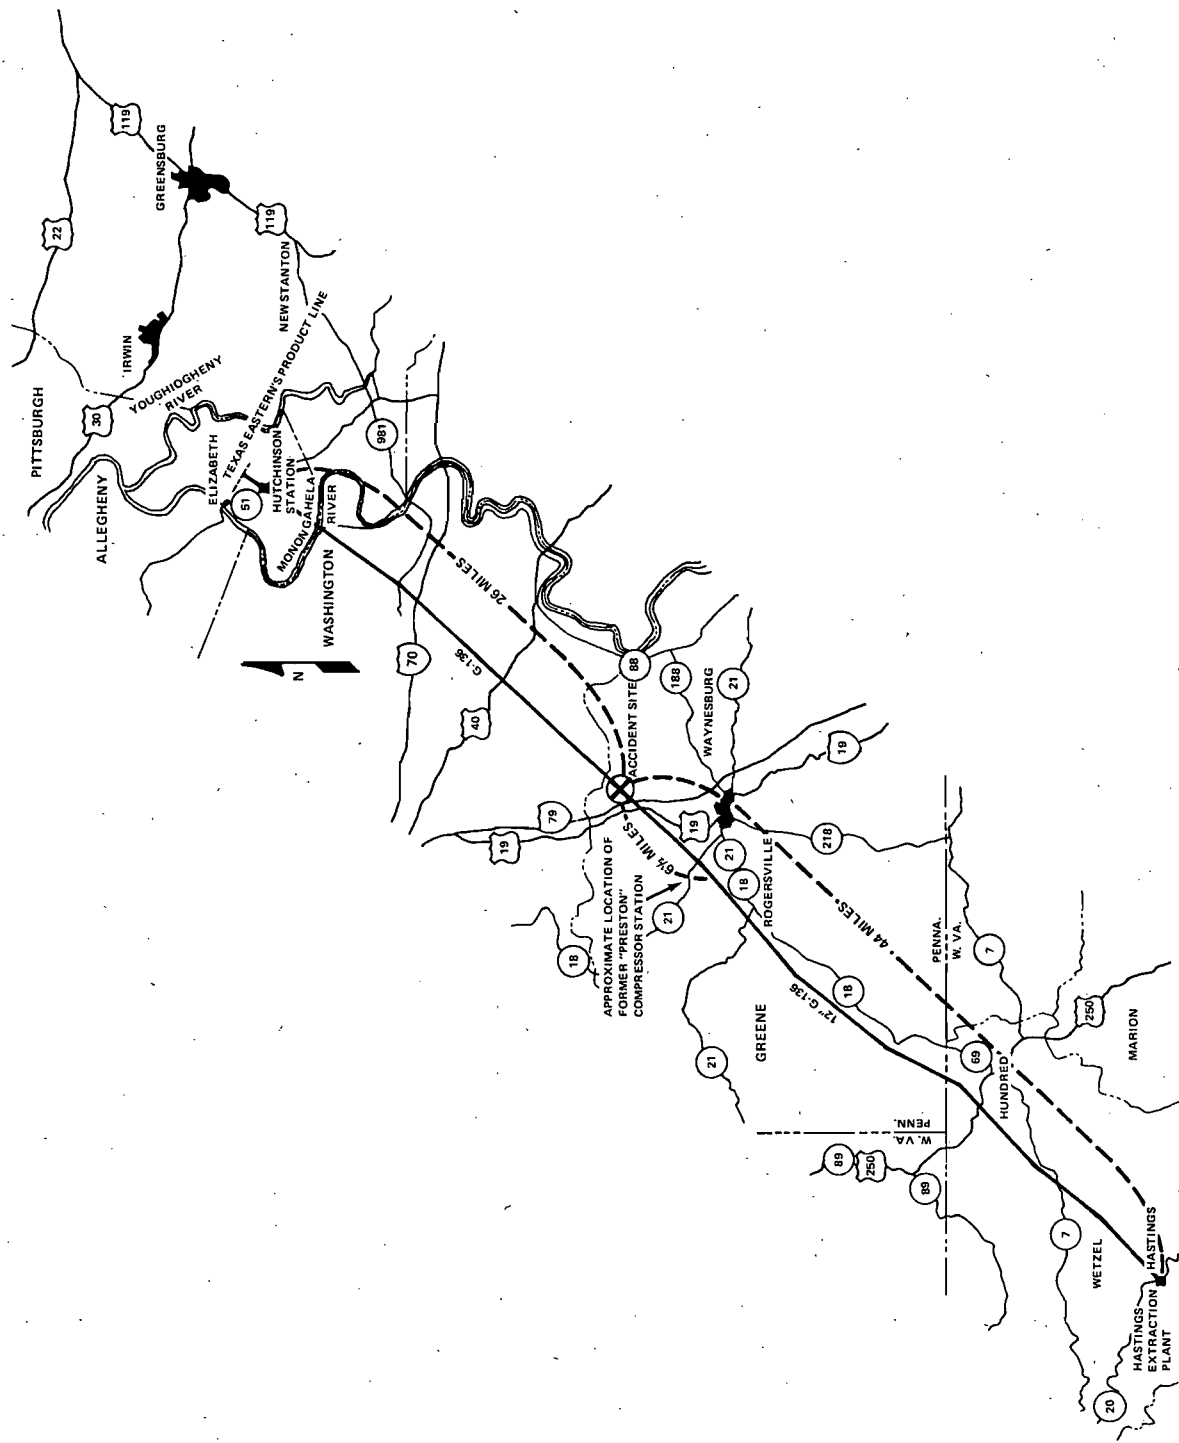
Figure 6. Plan view of pipeline route.

The 70-mile-long, 12-inch propane pipeline extended from Consolidated's Hastings Extraction Plant at Hastings, Wetzel County, West Virginia, to its Hutchinson Pump Station near Elizabeth, Allegheny County, Pennsylvania. (See figure 6.) At the pump station the propane is metered and then delivered to the Texas Eastern's pipeline system for transportation to New York State.

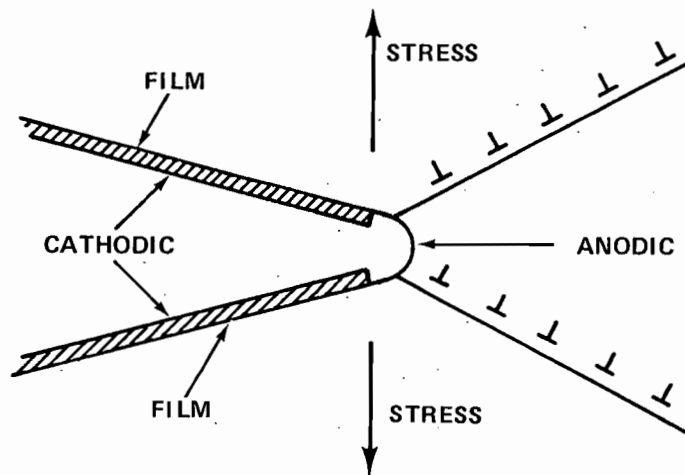
Stress-corrosion cracking is a time-dependent mechanism that depends upon local environmental conditions that are not generally easily changed. One of the many theories which have been advanced to explain the mechanism of SCC is the electrochemical theory. It contends that galvanic cells are established between metal grains, and anodic paths are established by heterogeneous phases. While stressed in tension, the alloy is exposed to a corrosive environment and the ensuing localized electrochemical dissolution of metal, combined with localized plastic deformation, opens up a crack. Protective films that form at the tip of the crack rupture from sustained tensile stress, thereby exposing fresh material to the corrosive environment to begin the cycle again. Figure 13 shows a schematic diagram <sup>5/</sup> of the process:

Figure 13. Galvanic cell formation at crack tip allows electrochemical dissolution of metal at tip.
