# **NATIONAL TRANSPORTATION SAFETY BOARD**

## **PIPELINE ACCIDENT REPORT**

**KANSAS PUBLIC SERVICE COMPANY, INC.  
EXPLOSION AND FIRE  
LAWRENCE, KANSAS  
DECEMBER 15, 1977**

**REPORT NUMBER: NTSB-PAR-78-4**

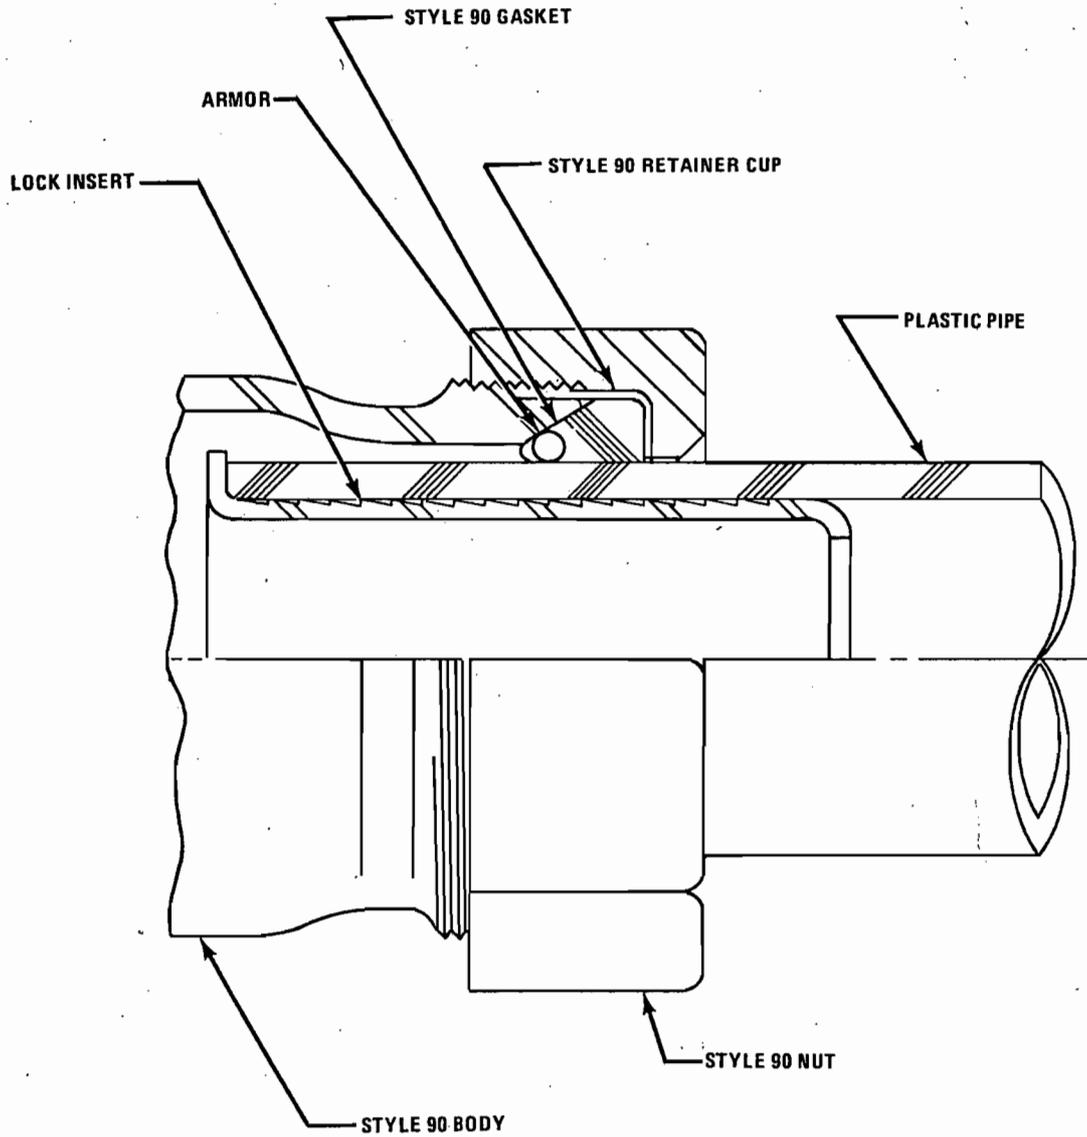
APPENDIX F

New Dresser Style 90 compression coupling redesigned for Dresser lock insert.

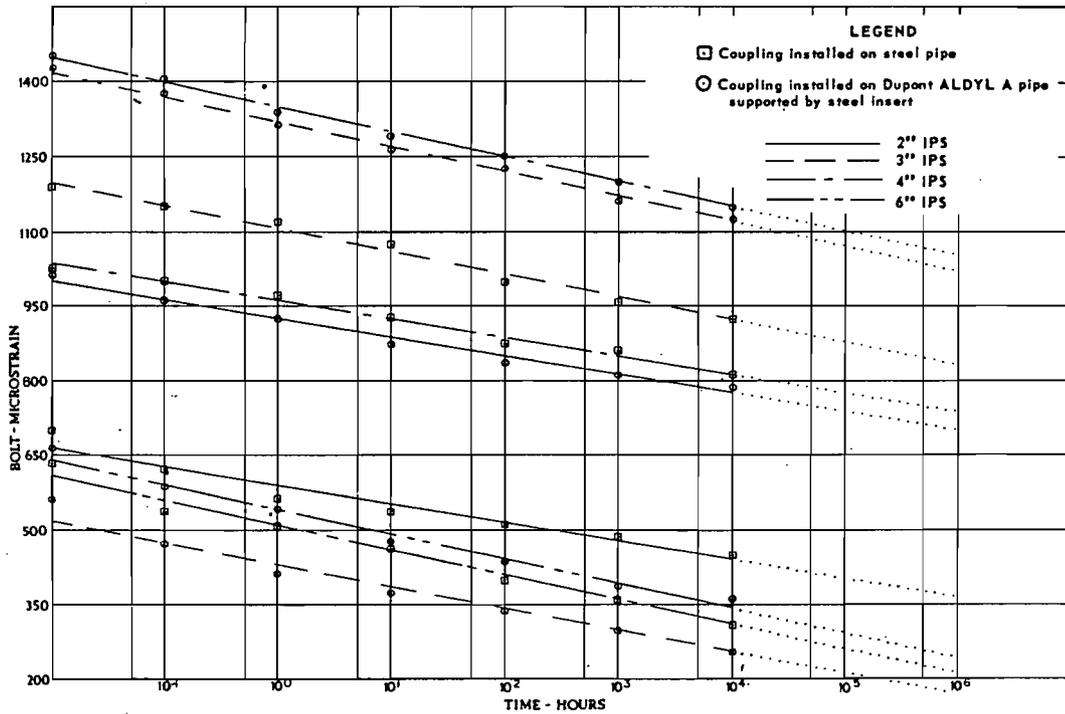
Figure 3. Comparison, DRESSER® Style 38 Coupling Installed on Schedule 40 Steel Pipe and on Dupont ALDYL® A Pipe Supported by Steel Insert.

The curves shown in Fig. 3 represent stress relaxation of the gasket on steel pipe and gasket-pipe combination on the PE pipe carried through 10,000 hours to date. Of

interest is the high degree of parallelism between the curves, indicating the same order of magnitude of relaxation between the elastomer bearing on steel pipe and on internally supported polyethylene pipe. The difference between the two pipe materials as they affect the performance of the gasket seal appears from Fig. 3 to be negligible, and it is apparent that the higher the initial gasket loading, the more reliable will be the seal in terms of remaining gasket pressure after extended periods of time. These relaxation curves were derived from a time-bolt strain relationship which must, of course, bring up the question of the actual gasket pressure.

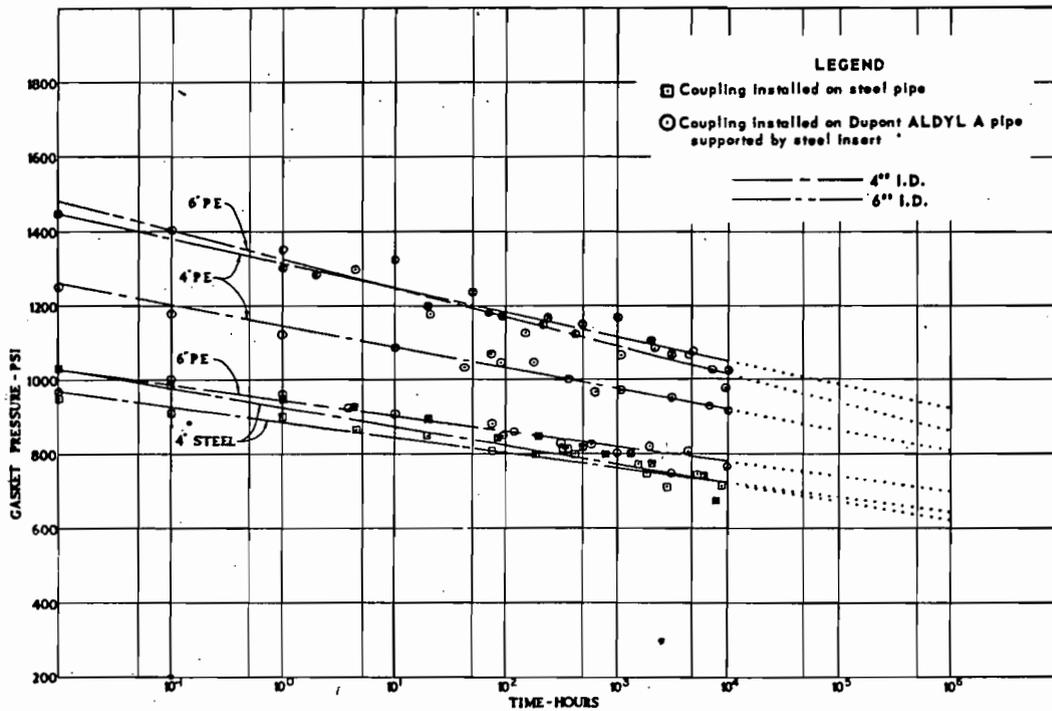
Figure 6. Comparison, DRESSER® Style 38 Coupling Installed on Steel Pipe and on Dupont ALDYL® A Pipe Supported by Steel Insert.

The same 4-inch polyethylene pipe and Style 38 coupling shown on figure 6 of appendix G has an initial gasket pressure of 1,260 psi. After 1 hour there was a 9-percent reduction in gasket pressure to 1,150 psi. After 10,000 hours (a little over 1 year) there was a 26 percent reduction in gasket pressure from its initial pressure to 930 psi.

The separately instrumented cylinders were used as pipe ends and internal supporting inserts for PE pipe on which were installed bolted compression type couplings (Fig. 5). The graph (Fig. 6) shows the result of the 10,000 hour test whereby stress relaxation is plotted against gasket pressure. The results here are similar to those shown

in Fig. 3, indicating no appreciable difference between the gasket relaxation of the bolted coupling installed on du Pont Aldyl "A" PE pipe compared to a similar installation on steel pipe.

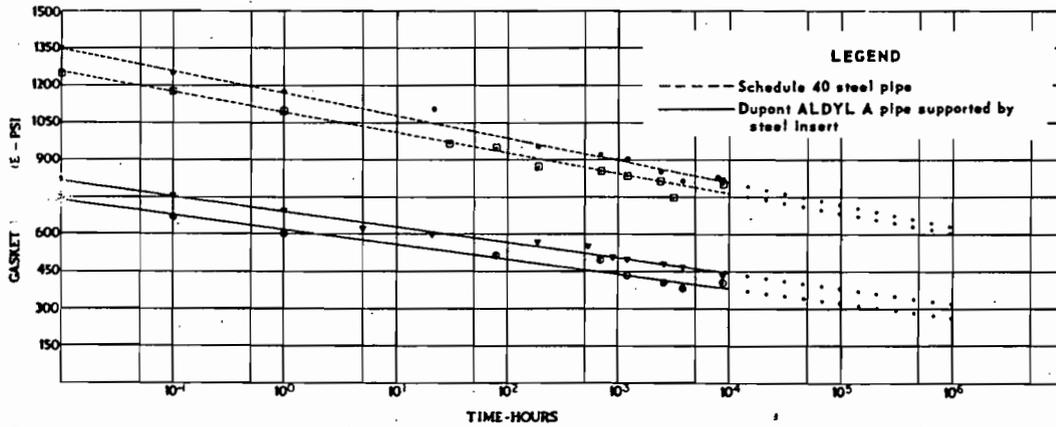
Figure 8. Comparison, Dresser POSI-HOLD® 700 Coupling Installed on Schedule 40 Steel Pipe and on Dupont ALDYL® A Pipe Supported by Steel Insert.

mains. This coupling will use as its sealing mechanism a highly loaded elastomeric seal. Fig. 7 shows a cross section of this mechanical coupling without the locking feature. Initial loading of the gasket is accomplished by introducing hydraulic pressure in the annular space between the two coupling shell halves, which deforms the inner shell, bringing the gasket into highly loaded contact with the coupling body and pipe. Using the strain gage calibrated transducer, this coupling was set up and tested over a 10,000 hour period on both steel pipe and internally reinforced polyethylene pipe. The results for this 10,000 hour test are plotted on Fig. 8. We find here that these results confirm the two previously conducted tests in that the difference in gasket relaxation varies only insignificantly between a coupling installed on steel pipe and one installed on the Aldyl "A" material.
