# **NATIONAL TRANSPORTATION SAFETY BOARD**

## **PIPELINE ACCIDENT REPORT**

**PACIFIC GAS & ELECTRIC COMPANY  
NATURAL GAS PIPELINE PUNCTURE  
SAN FRANCISCO, CALIFORNIA  
AUGUST 25, 1981**

**NTSB-PAR-82-1**

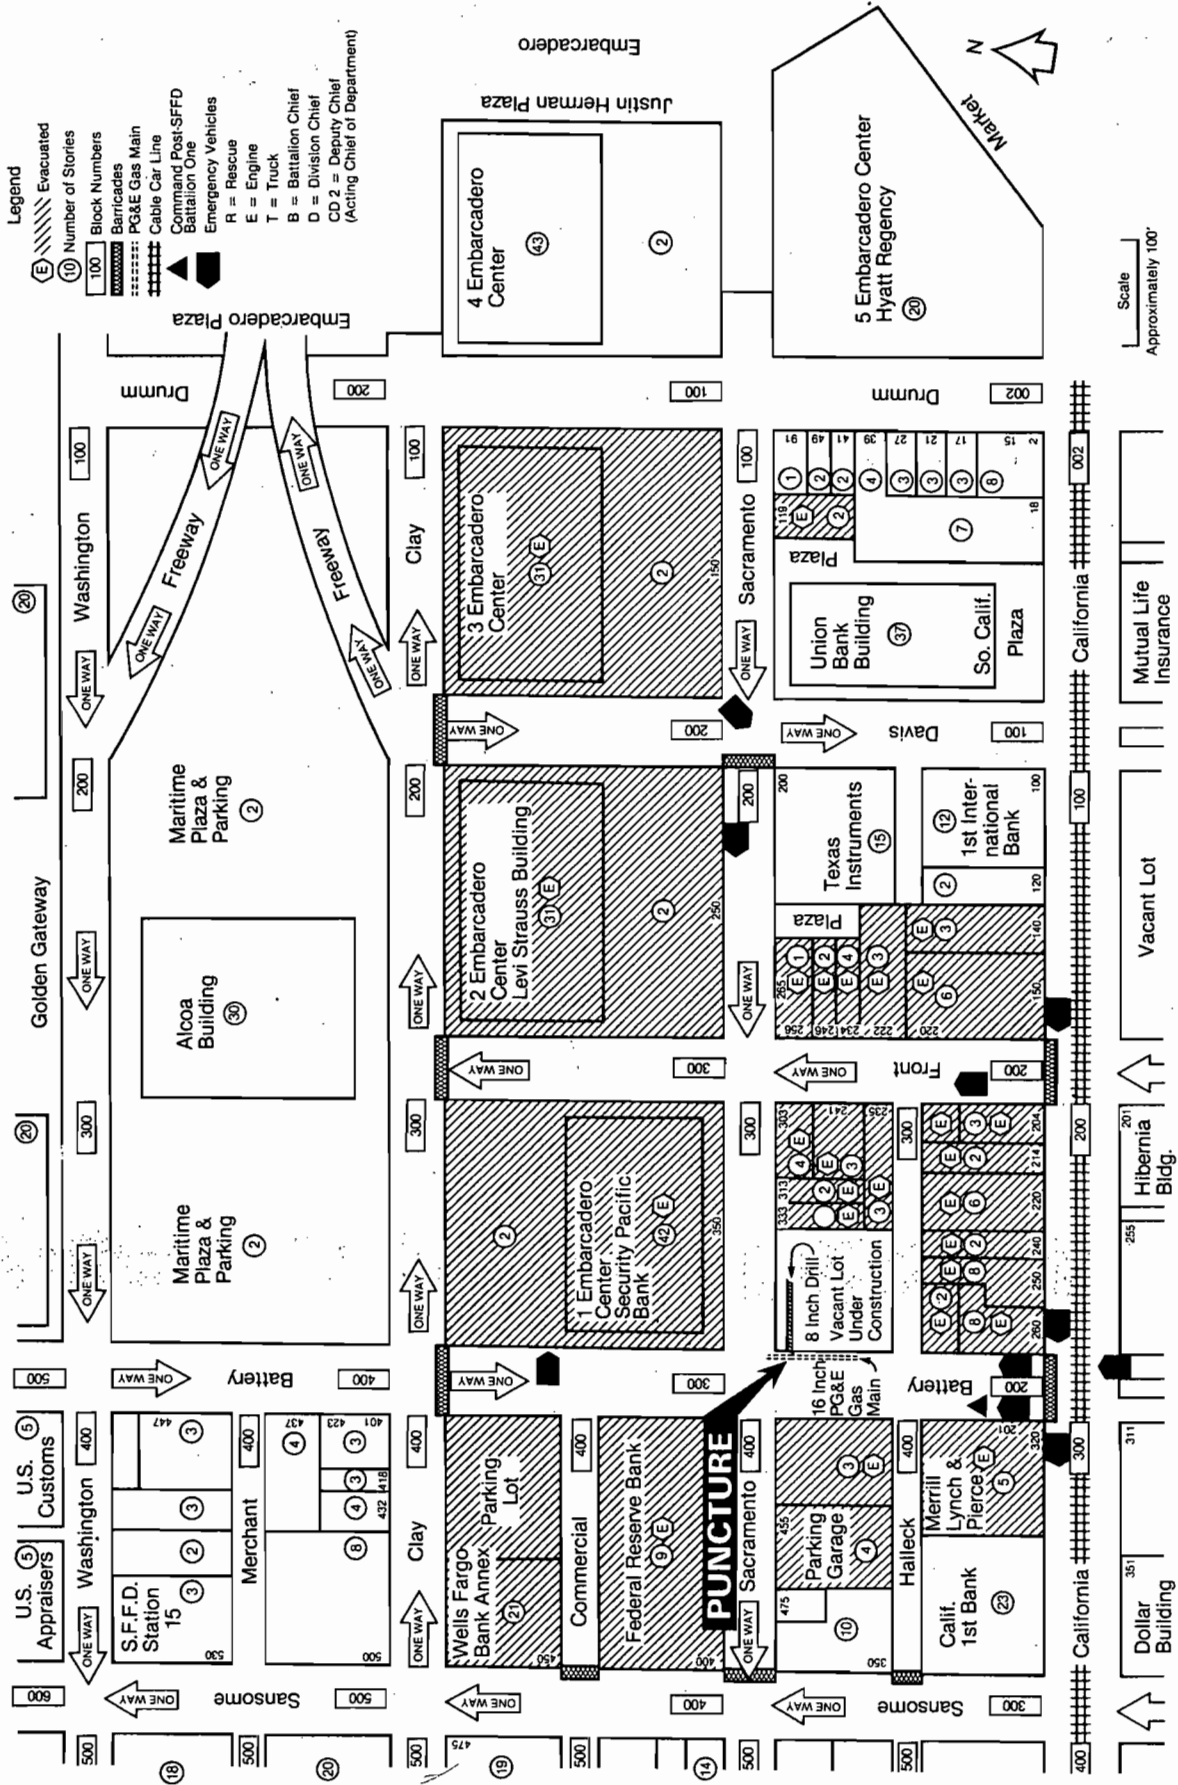
Figure 1.—Accident area, downtown San Francisco.

Turner Construction Company (Turner) had contracted to build a high-rise office building at a site bounded by Halleck, Battery, and Sacramento Streets in downtown San Francisco, California. (See figure 1.) On August 25, 1981, a construction crew of J. H. Pomeroy, Inc. (Pomeroy), a subcontractor for Turner, was excavating for the foundation of the proposed building. The crew had driven steel sheet piles into the ground around the periphery of the site. Before the crew could continue to deepen the excavation in the area encompassed by the sheet piles, it was necessary to drill holes through the piles extending below the adjacent street to set anchors or tiebacks which would later be attached to the sheet piles to hold them in place when excavation resumed (see figure 2). The 8-inch holes were to be drilled at a 30-degree angle with the horizontal pavement.

Escaping gas was blowing toward Embarcadero Building No. 1, located on the north side of Sacramento Street across from the excavation site. (See figure 1.) The evacuation of the 42-story Embarcadero Building No. 1 without the use of elevators was commenced immediately and was completed within 17 minutes, at approximately 2:00 p.m. PG & E personnel used gas detectors to check the building for gas, and firemen and PG & E personnel also utilized gas detectors to check nearby buildings, surveying primarily Embarcadero No. 1 and Embarcadero No. 2. They initially obtained readings of 3-percent gas concentrations, which approached the lower combustible limit. Because Embarcadero operations personnel had promptly shut down the street level and podium level air intake systems to preclude additional gas being drawn into the buildings, the concentration of gas in the buildings soon diminished. Because a combustible mixture of gas never existed in Embarcadero Building No. 2 and no gas was ever detected in Embarcadero No. 3, these buildings were evacuated with the use of elevators. Some 35 persons, including 20 fire safety directors, <sup>2/</sup> helped supervise the evacuation. Complete evacuation of the entire Embarcadero Center, which contained half of the estimated 30,000 persons evacuated from buildings in the area, was completed within 45 minutes. The buildings were then searched to verify that all persons had been evacuated.
