PIPELINE ACCIDENT REPORT

MISSOURI POWER AND LIGHT COMPANY
NATURAL GAS FIRES
CENTRALIA, MISSOURI
JANUARY 28, 1982

NTSB-PAR-82-3

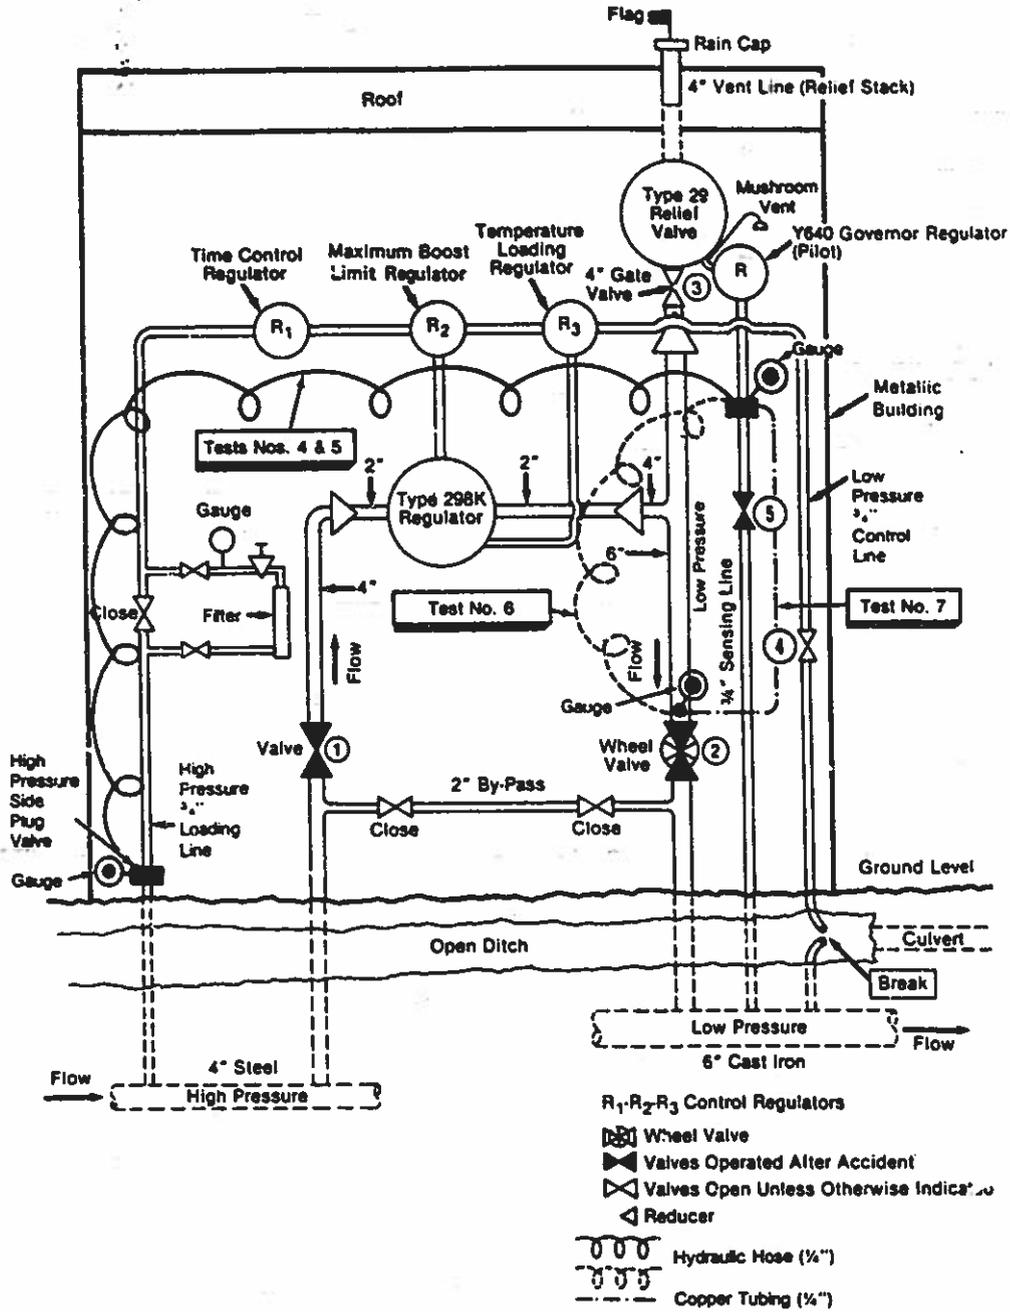
May 7, 1932 Test.

The hydraulic hose was replaced by a 3/8-inch CTS x 13 foot long copper tube and connected from the 6-inch downstream line tap to the governor regulator sensing line. Fittings had full 1/4-inch bores. Keeping valve Nos. 2 and 5 closed, valve No. 1 was slowly opened and the relief valve started to open between 9 and 10 inches of W.C. and held at 35 inches of W.C. during full flow. The gauge above valve No. 2 stabilized at 38 inches of W.C., (very turbulent but stable.) During this test, the inlet pressure to the 298-K regulator dropped from 48 1/2 to 45 1/2 psig. After completion of the tests, valves No. 1, 2, and 4, 5 were left closed and the hydraulic hose and copper line were removed.
