**PB92-916501
NTSB/PAR-92/01**

PIPELINE ACCIDENT REPORT

**NATURAL GAS EXPLOSION AND FIRE
DEPARTMENT OF DEFENSE/ARMY
FORT BENJAMIN HARRISON
INDIANAPOLIS, INDIANA
DECEMBER 9, 1990**

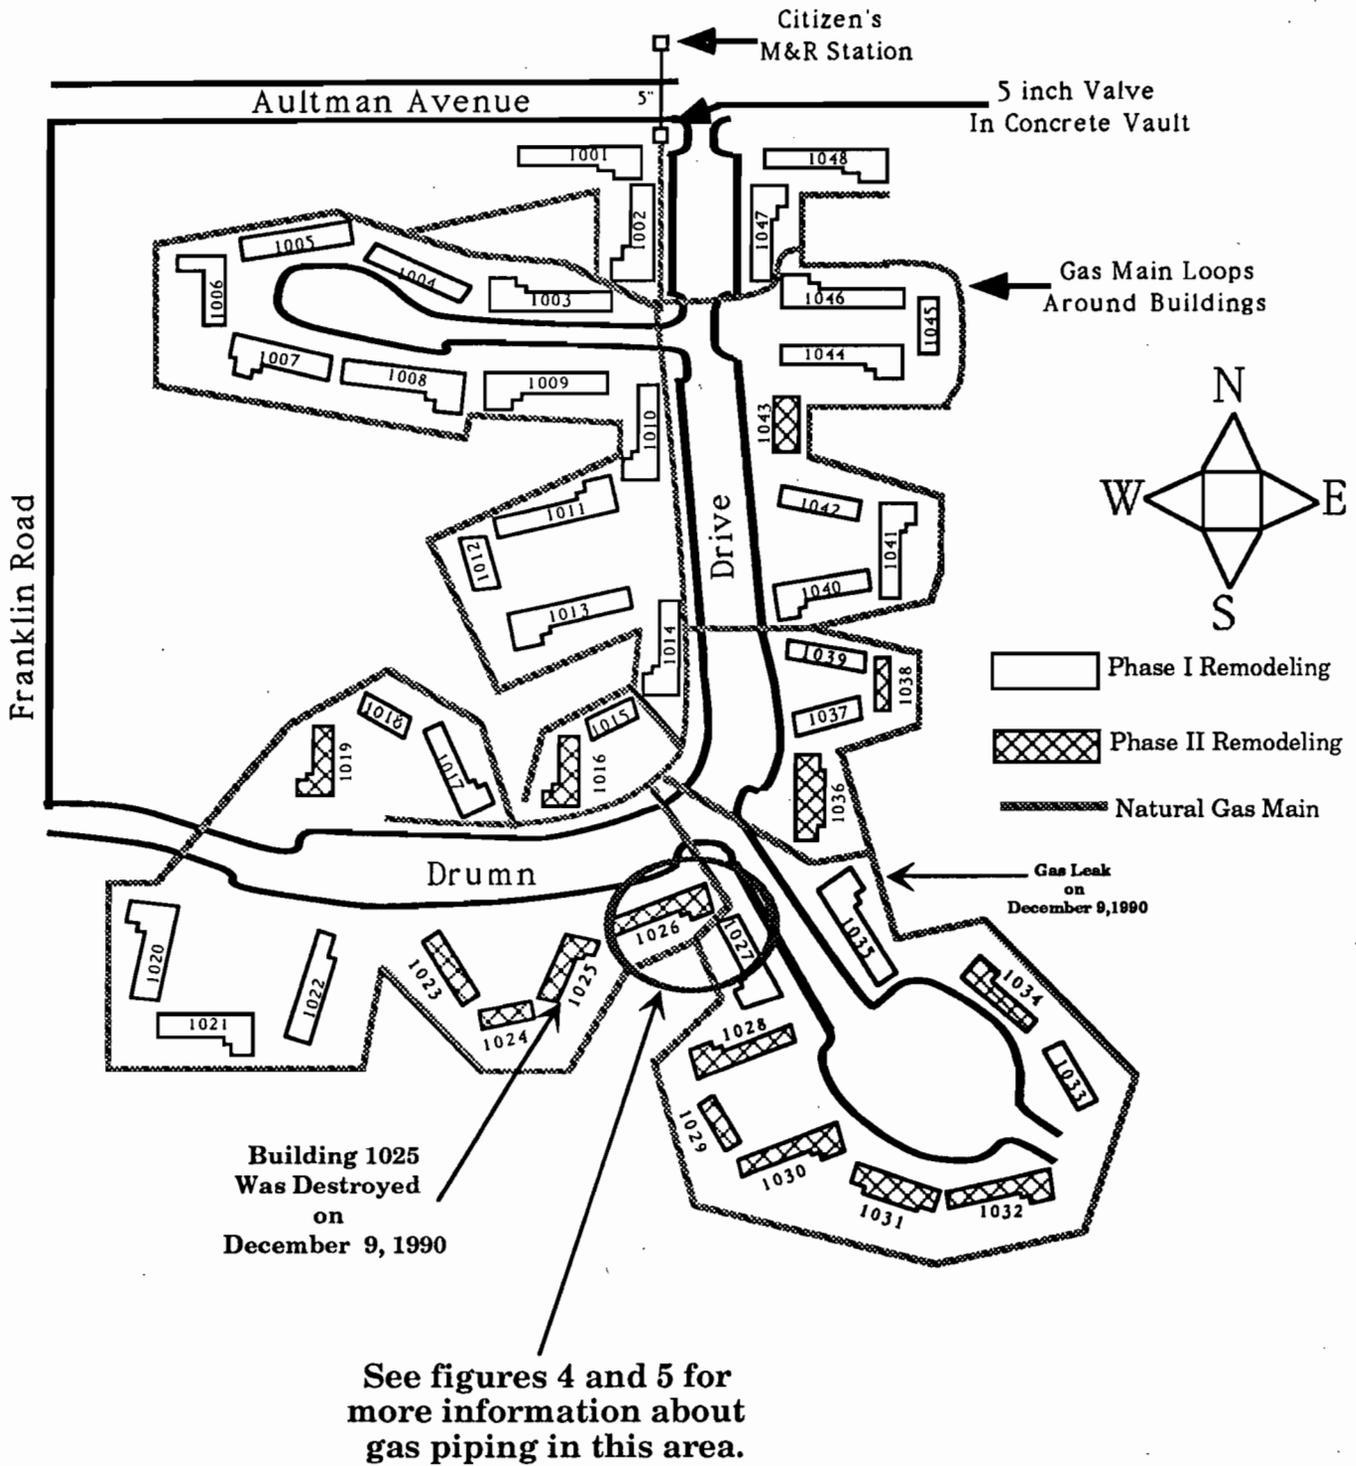
Figure 1.--Schematic of Harrison Village, Fort Benjamin Harrison.

At 5:42 p.m. on December 9, 1990, an occupant of Harrison Village ¹ (village), a residential housing complex within the Army's Fort Benjamin Harrison (Fort) near Indianapolis, Indiana, telephoned the Fort's fire department to report the odor of natural gas behind apartment 1035 B on Drumn Drive. (See figure 1.) The Fort's fire department dispatched firefighters, including the assistant fire chief, who served as the incident commander. They arrived at 5:47 p.m. and using a combustible gas indicator, confirmed the presence of gas both outside and inside some of the five apartments in building 1035.
