NATIONAL TRANSPORTATION SAFETY BOARD

PIPELINE ACCIDENT REPORT

UGI UTILITIES, INC., NATURAL GAS DISTRIBUTION
PIPELINE EXPLOSION AND FIRE
ALLENTOWN, PENNSYLVANIA
JUNE 9, 1994

**Adopted: February 26, 1996
Notation 6652**

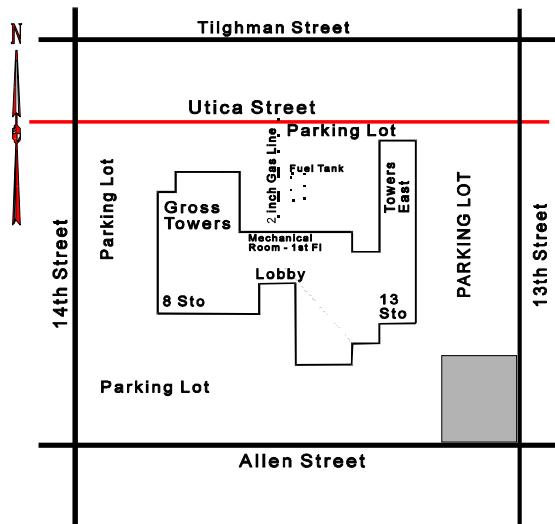
Figure 1. Accident Location

About 6:45 p.m. on June 9, 1994, a 2-inch-diameter steel gas service line that had been exposed during excavation separated at a compression coupling¹ about 5 feet north of the north wall of the John T. Gross Towers (Gross Towers), an eight-story retirement home. Gross Towers, located at 14th and Allen Streets (1339 Allen Street), is one of several subsidized-rent residence buildings operated by the Allentown Housing Authority (housing authority) in Allentown, Pennsylvania. Towers East, a 13-story building that is connected to Gross Towers, is also a rent-subsidy building for senior citizens that is operated by the housing authority. (See figure 1.)
