Pipeline Investigation Report: NTSB/PIR-22/02

Enbridge Inc. Natural Gas Transmission Pipeline Rupture and Fire

Danville, Kentucky
August 1, 2019

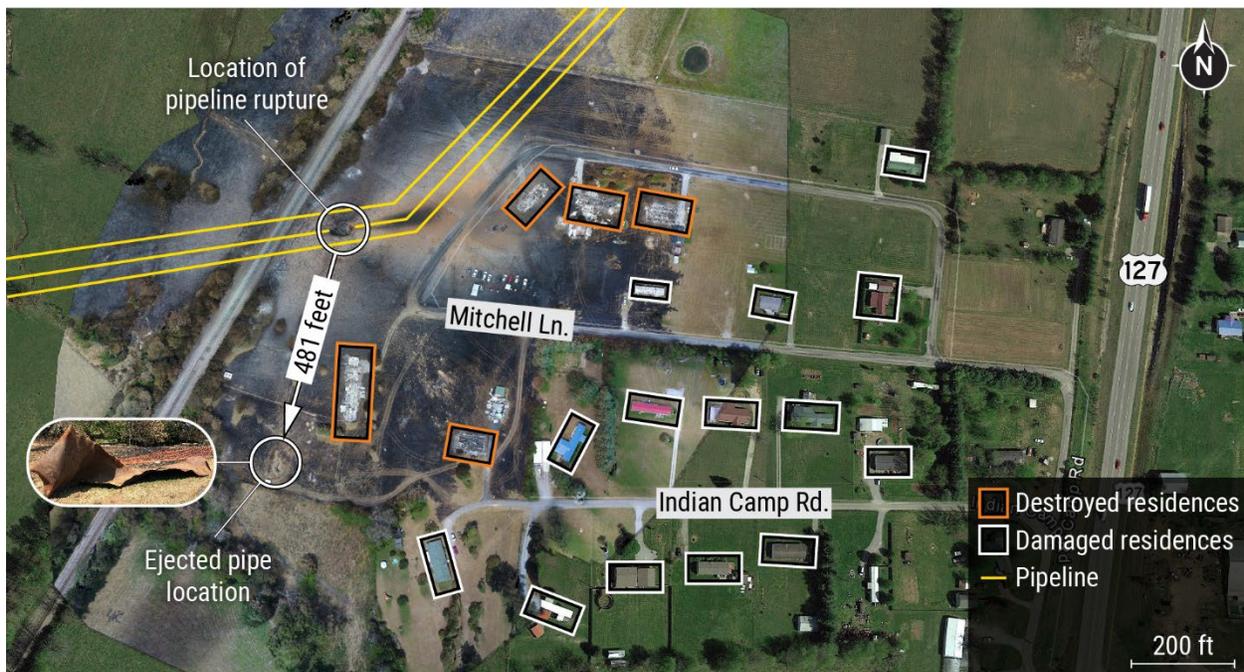
On August 1, 2019, at 1:23 a.m. local time, a 30-inch-diameter natural gas transmission pipeline, Line 15, owned and operated by Enbridge Inc. (Enbridge), ruptured near Danville, Kentucky.¹ As a result of the rupture, 1 person was fatally injured, 6 people were hospitalized, and over 75 residents were evacuated from the Indian Camp Subdivision, a residential community. The rupture released about 101.5 million cubic feet of natural gas and ejected a 33.2-foot-long section of pipeline that landed about 481 feet southwest of the rupture site. The releasing gas ignited and burned. Five residences in the subdivision were destroyed by fires, and an additional 14 were damaged. (See figure 1.) A nearby railroad track owned and operated by the Norfolk Southern Corporation sustained fire damage.

Figure 1. Aerial view of the Indian Camp Subdivision overlaid on Google Earth image.

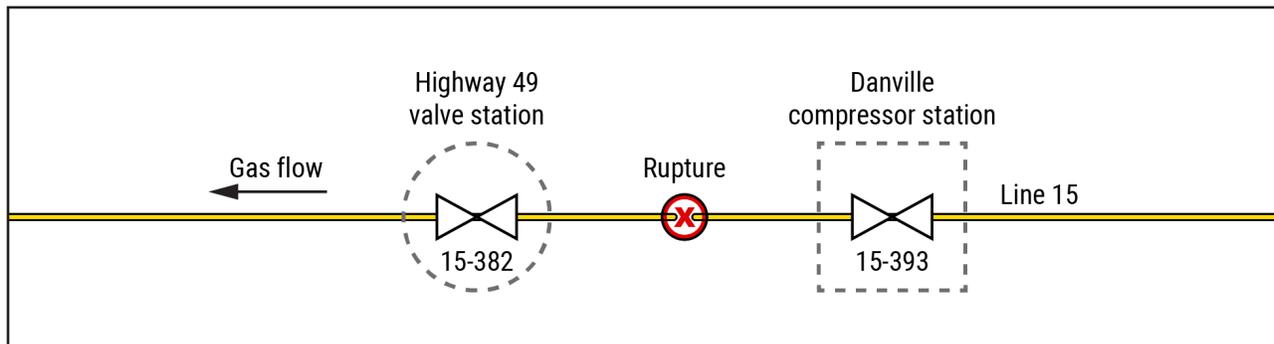
To isolate the affected pipeline segment, Enbridge personnel needed to close valves manually at the Danville CS (valve 15-393) and at a valve station located near Highway 49 (valve 15-382). (See figure 2).

Figure 2. Process flow diagram for pipeline isolation.

from the station, and saw a low-pressure alarm at the CS, he did not act to close the manual valve at the CS until instructed by the area supervisor. The station operator manually closed valve 15-393 at 1:39 a.m., isolating the affected pipeline segment on the north side of the rupture.

The Enbridge employee sent to manually close valve 15-382 arrived at the Highway 49 valve station at 2:13 a.m. and confirmed valve 15-382 was the correct valve to close by checking Enbridge's Stanford Area Emergency Response Manual (2015), which was in his company vehicle. The employee closed valve 15-382, completing isolation of the ruptured segment at 2:19 a.m. The total time from the rupture to isolation was 56 minutes. Table 1 provides a detailed timeline of Enbridge's emergency response actions.

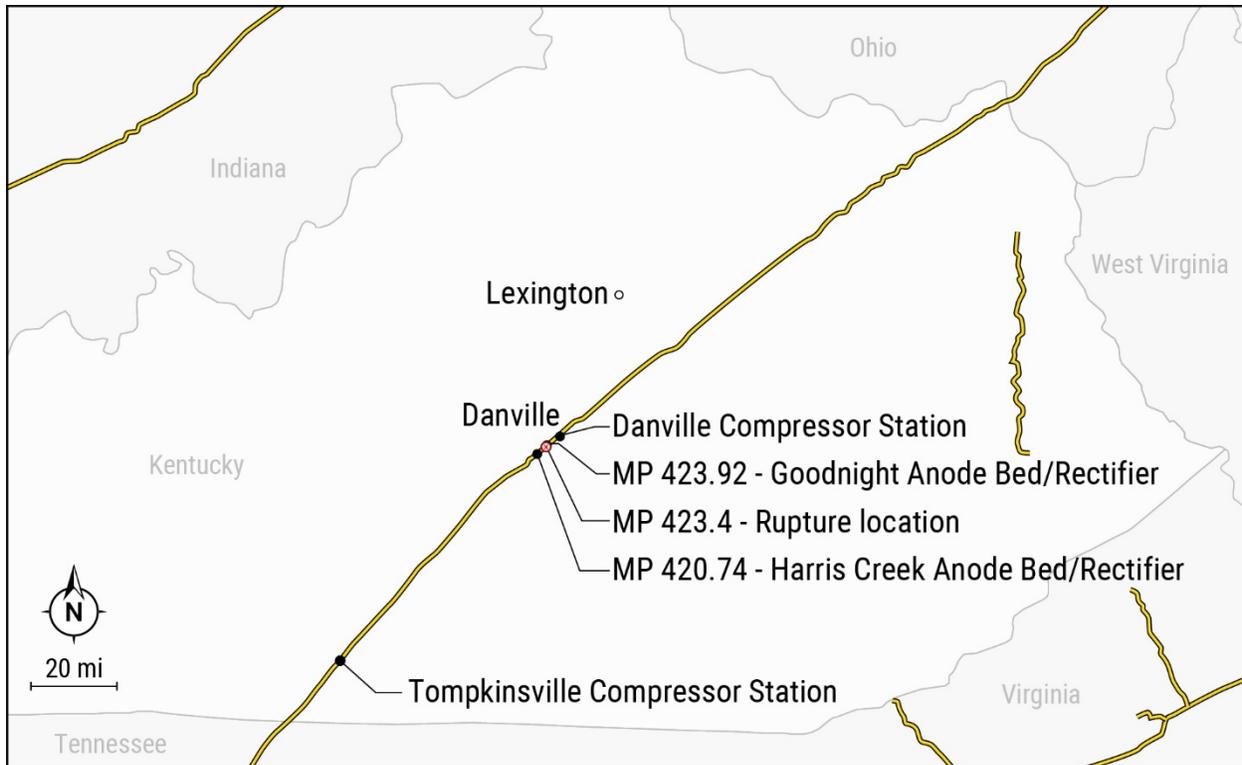
External corrosion is controlled on Line 15 by impressed-current cathodic protection and design elements such as coating.²⁶ Between the Tompkinsville CS and the Danville CS, there are eight rectifiers. The closest rectifier and anode bed north of the accident site is at Goodnight, and the closest rectifier and anode bed to the south is at Harris Creek.²⁷ (See figure 8.) The soil in this area is primarily shale. The Enbridge corrosion technician told the NTSB that “it takes a lot more [cathodic protection] with shale,” and that shale “does lower the ability for [cathodic protection] to go through the rock.”

Figure 8. Map of the right of way for Lines 10, 15, and 25.

Investigators examined 10 years of maintenance activities related to cathodic protection at Goodnight and Harris Creek. In 2017 and 2019, the output from the Harris Creek rectifier was increased to address dropping potential readings.²⁸ These dropping potentials began in early 2014 after the flow reversal project was completed. Before the flow reversal, cathodic protection voltages were regular and consistent; after the flow reversal, technicians were unable to stabilize readings; at Harris Creek, voltages were increased by 18 percent, and the voltages at Goodnight increased by 58 percent. (See figure 9.) The plot in figure 9 shows the steady potentials up to 2013; after that, they became unstable. In 2018, a new anode was installed at Harris Creek, but it did not successfully raise potentials.

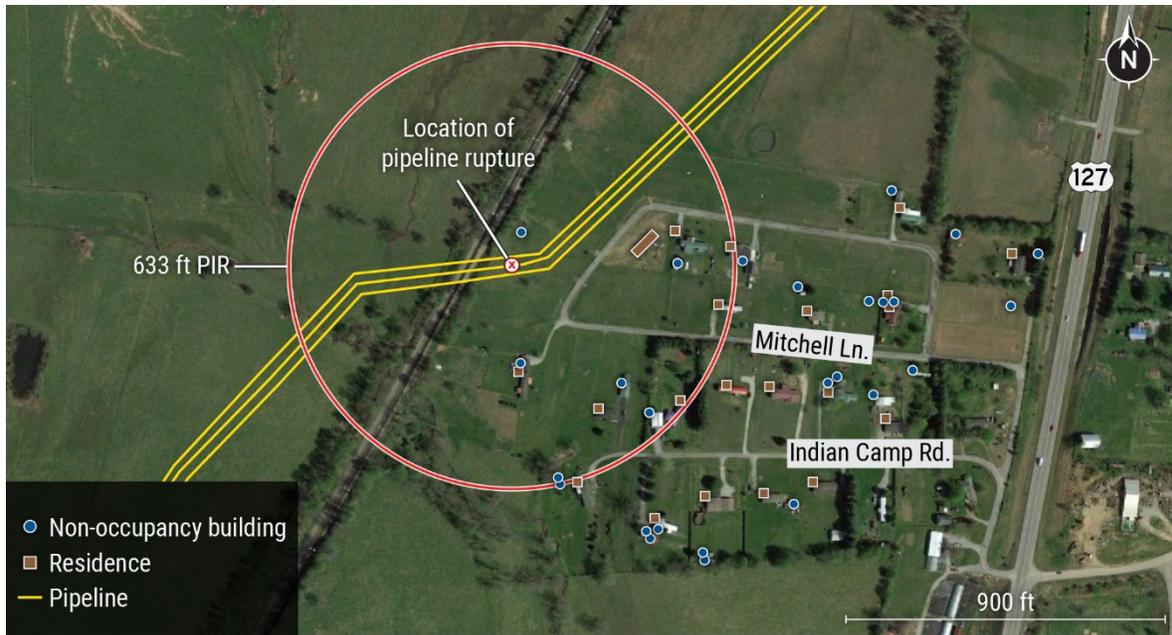
The NTSB used this mathematical equation to calculate the PIR at the rupture site to be about 633 feet. Within 633 feet of the rupture site radially (indicated by a red circle in figure 11) were seven private residences as well as other structures not designed for human occupancy, such as garages and sheds. Because the number of buildings intended for human occupancy was below 20 and no buildings met the qualifications of an identified site under 49 *CFR* 192.903, the rupture site was deemed a non-HCA via method 2.

Figure 11. Human-occupancy buildings within the potential impact radius. (Courtesy of Enbridge.)

On the date of the accident, PHMSA’s gas transmission integrity rule applied only to pipeline segments located in HCAs. As such, Enbridge was not required to implement any of the regulations in 49 *CFR* Part 192 Subpart O for the area containing the rupture site, including management of change, risk assessments, or integrity assessments. However, Enbridge voluntarily included pipeline segments that fell outside of HCAs in its integrity management program; these sections were called assessment segments. The rupture site was located within a non-HCA assessment segment known as Line 15 Valve Section 4 (L15 VS4). L15 VS4 extends from milepost 408.5 to milepost 427.5, which is all of Line 15 between the Highway 49 valve station and the Danville CS.
