Pipeline Investigation Report PIR-25-01

UGI Corporation Natural Gas-Fueled Explosion and Fire

West Reading, Pennsylvania
March 24, 2023

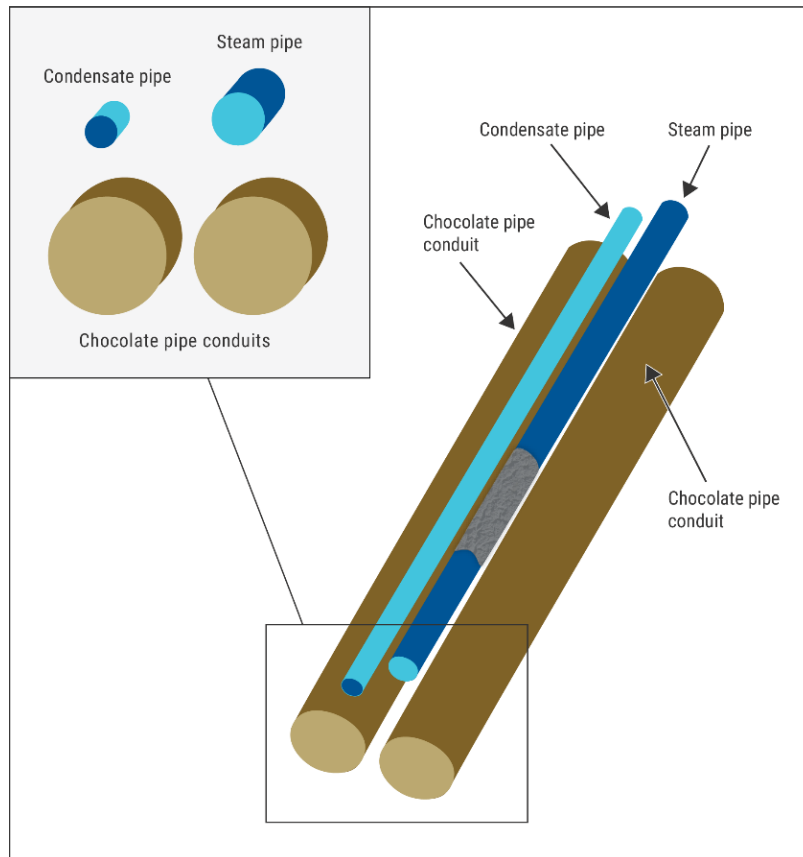
Figure 3. Arrangement of Palmer-owned pipes.

Pennsylvania. In West Reading, Building 1 was used for candy production and as corporate headquarters, and Building 2 was used for candy production. Palmer-owned pipes (private pipes) ran underneath Cherry Street between Buildings 1 and 2: a steam pipe that delivered steam from the boiler to heat areas of Building 2, a condensate pipe that channeled condensation back to the boiler, and two conduits that together contained six supply pipes that delivered liquid chocolate from storage tanks in the basement of Building 2 to production areas in Building 1.⁵ One conduit contained four chocolate supply pipes, and the other conduit contained two chocolate pipes. (See figure 3.) Electric heat tape affixed to the outside of the chocolate pipes kept the chocolate from solidifying in the pipes. The top of the steam pipe was about 1.5 feet below the road surface.⁶

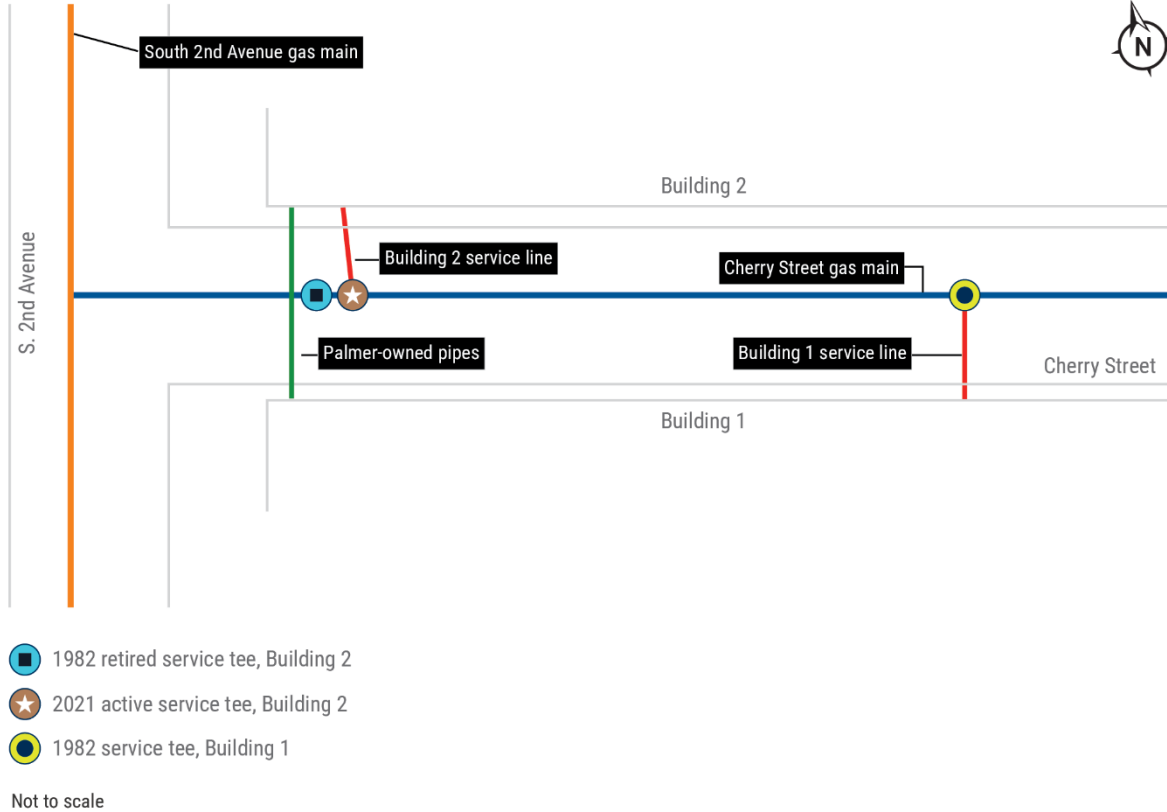
Figure 4. Natural gas distribution system and Palmer-owned pipes.

Two years before this accident, on February 16, 2021, a UGI crew conducted a routine inspection of the Building 2 gas meter, which at the time was in the basement.⁷ The crew detected gas inside the basement of Building 2 and at the service curb valve outside the building. UGI recorded this as a “grade C” leak, which required immediate attention or repair, and began a project to replace the service line and service tee from the Cherry Street gas main to Building 2 and to move the meter outdoors as required by UGI procedures. The service tee joined the service line to the main. The alignment of the private pipes and natural gas distribution system assets after the replacement project is shown in figure 4.

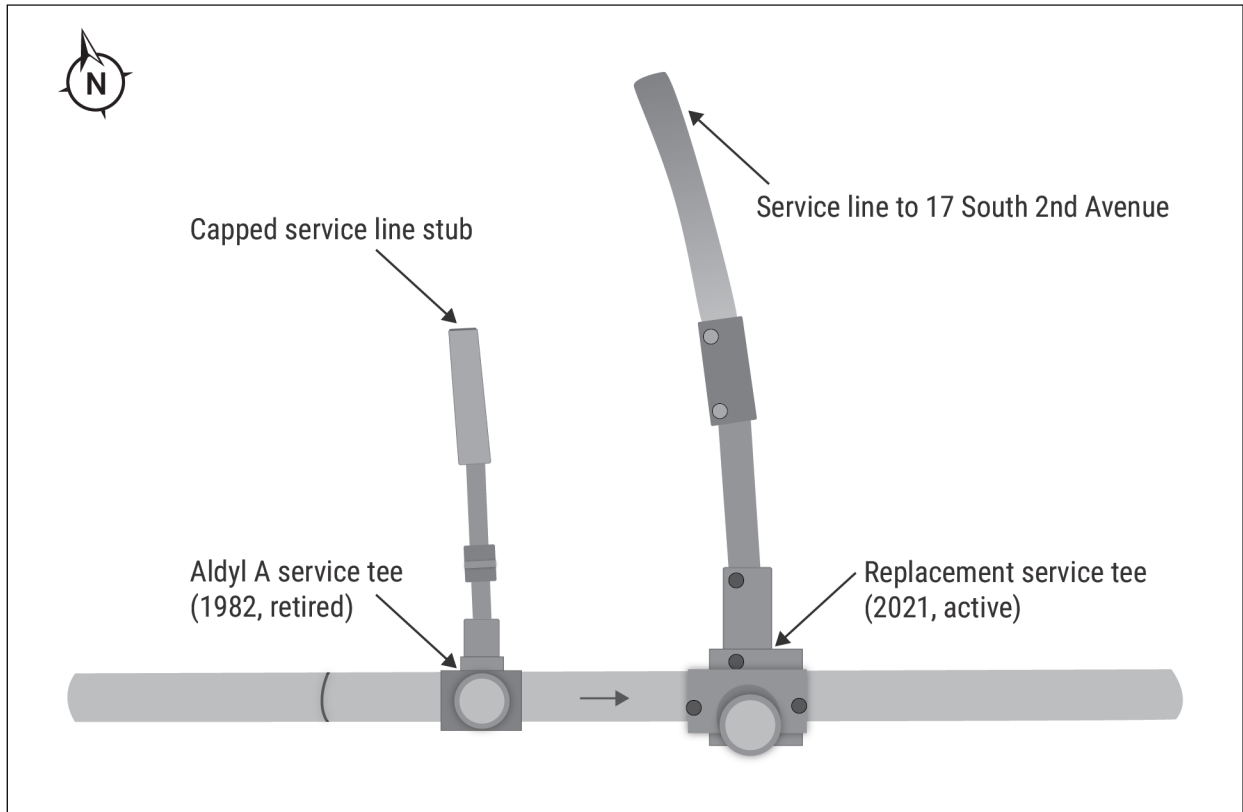
Figure 5. Cherry Street gas main and Building 2 service tees, viewed from above.

The crew continued the excavation and completed the retirement of the original service line and tee and installation of the new service line and tee to the east of the old ones.¹⁰ (See section 1.5.1 for a description of the typical process.) (See figure 5.) Upon completion of the project, the 1982 service line stub and tee remained attached to the gas main and exposed internally to full gas system pressure. UGI's standard and common industry practice for replacement of a service line and tee is to cap the tee and leave the tee attached to the main, exposed to full gas system pressure, and to install a new tee and service line nearby.

A review of PA One Call records indicated that no further work exposed the original service tee after February 16, 2021.

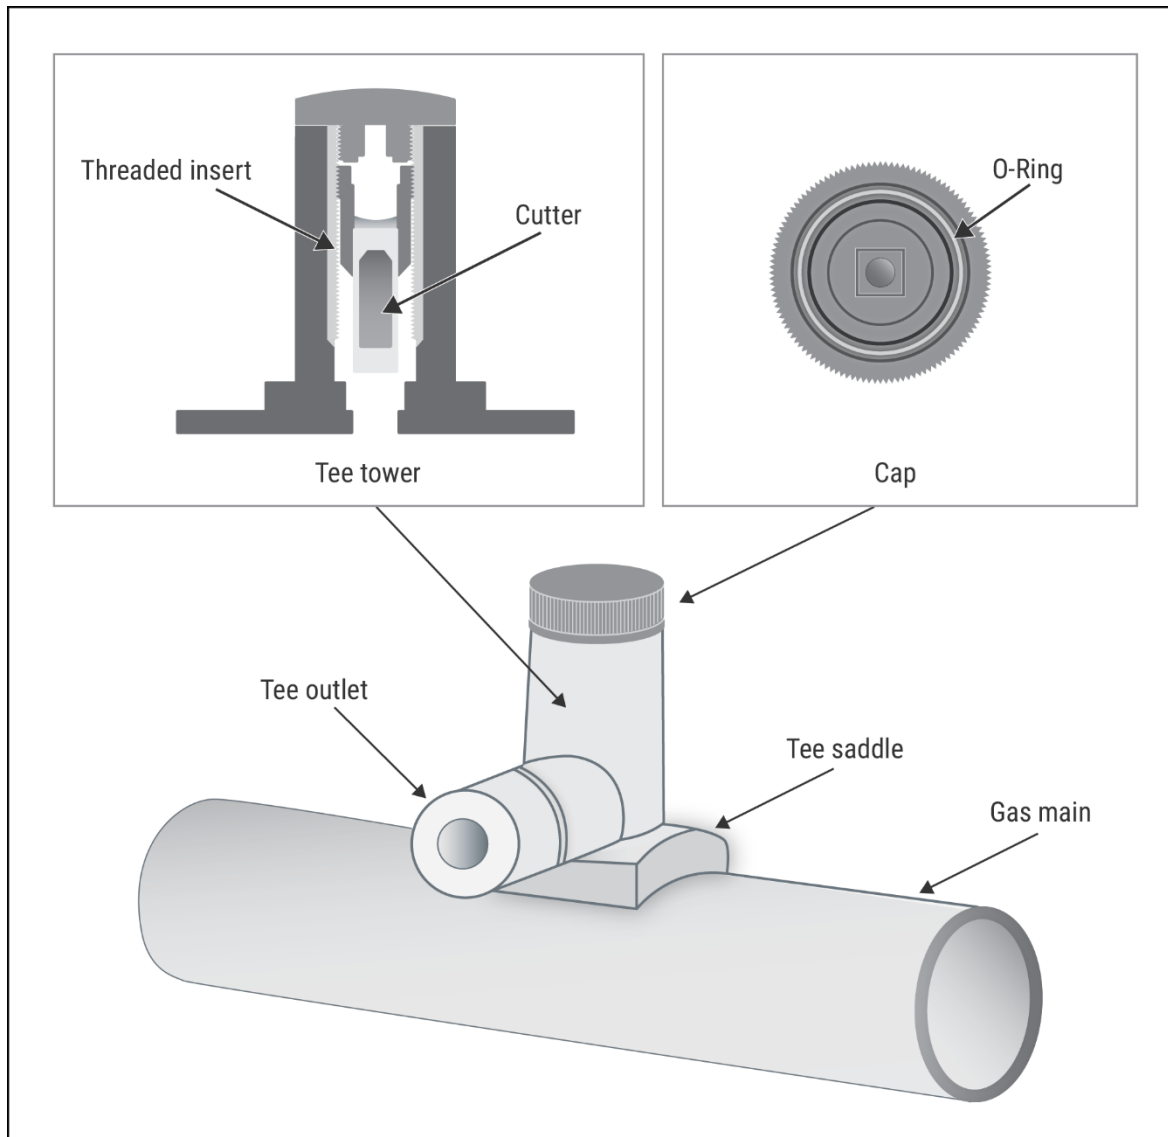
Figure 7. Aldyl A service tee and its components.

These tees were designed to perform three functions: (1) form a leak-free connection with the gas main, (2) form a leak-free connection to downstream service line piping, and (3) perforate the gas main to allow gas to enter the service line. The first function was accomplished by saddle fusing the tee to the gas main.²⁷ To complete the second function, service line piping and fittings were attached to the tee's outlet. Once a leak-free connection was established, the third function was accomplished using a cutter that was housed in the tower of the service tee. To complete this function, the cutter was lowered using a wrench until its tip cut a circular hole in the top of the gas main. The cutter was next raised to clear the cut hole and allow gas to enter the service line. The tee was then sealed by installing a threaded cap with rubber O-ring on top of the tee's tower. (See figure 7.)

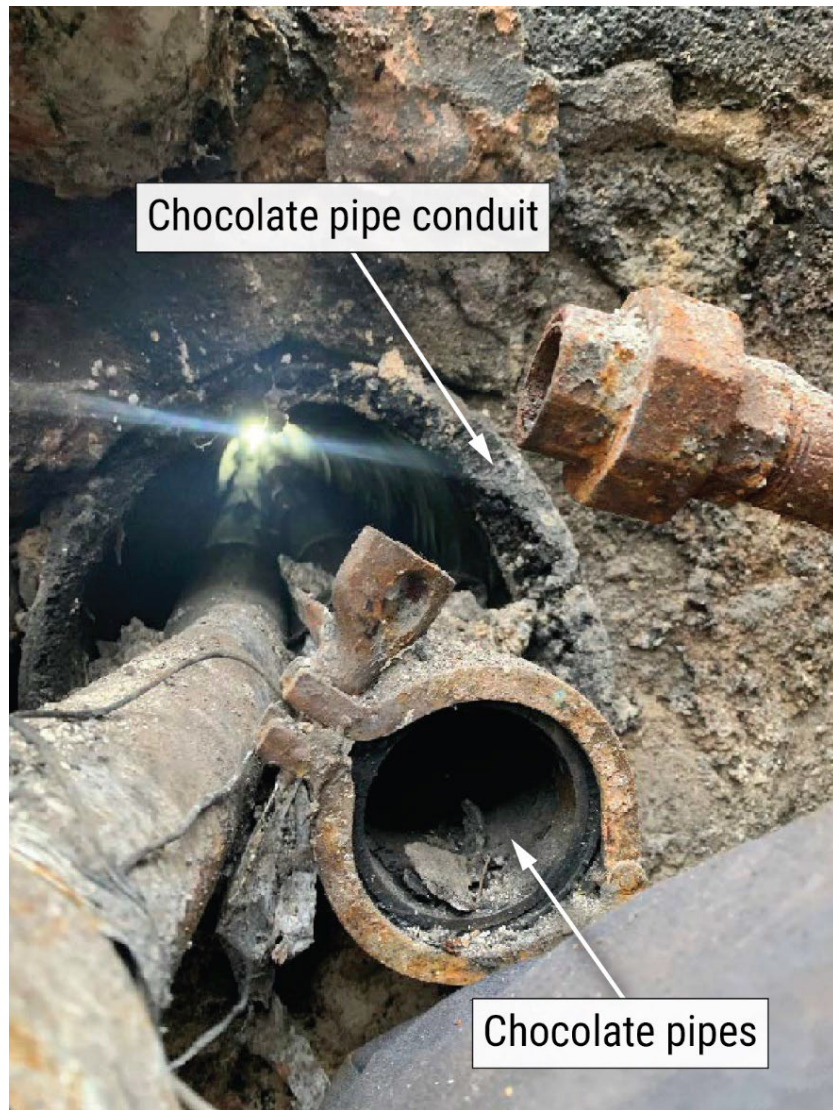
Figure 12. A view of one of the chocolate pipe conduits from the Building 2 basement.

Also on April 26, the Pennsylvania State Police deputy fire marshal visually inspected what remained of the Building 2 basement. Investigators in the basement of Building 1 pointed a flashlight through the chocolate pipe conduits toward the Building 2 basement to see whether air flow through the conduits could have been obstructed by insulation or other material. The deputy fire marshal observed light through the conduits. (See figure 12.)
