Pipeline Investigation Report PIR-26-01

Atmos Energy Corporation Natural Gas-Fueled Home Explosions and Fires

Jackson, Mississippi

January 24, 2024, and January 27, 2024

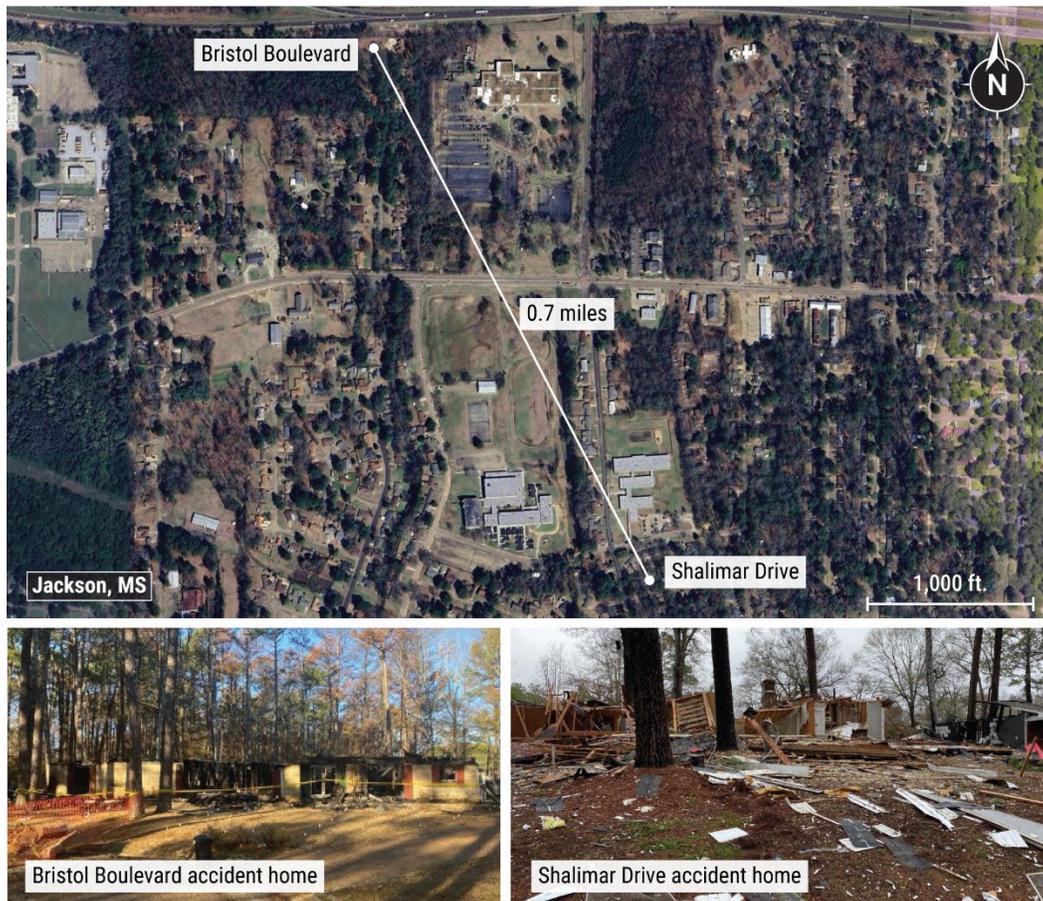
Figure 1. Map and photographs of the accident locations. (Courtesy of Google Earth, the Pipeline and Hazardous Materials Safety Administration, and the Mississippi Public Service Commission [clockwise from the top].)

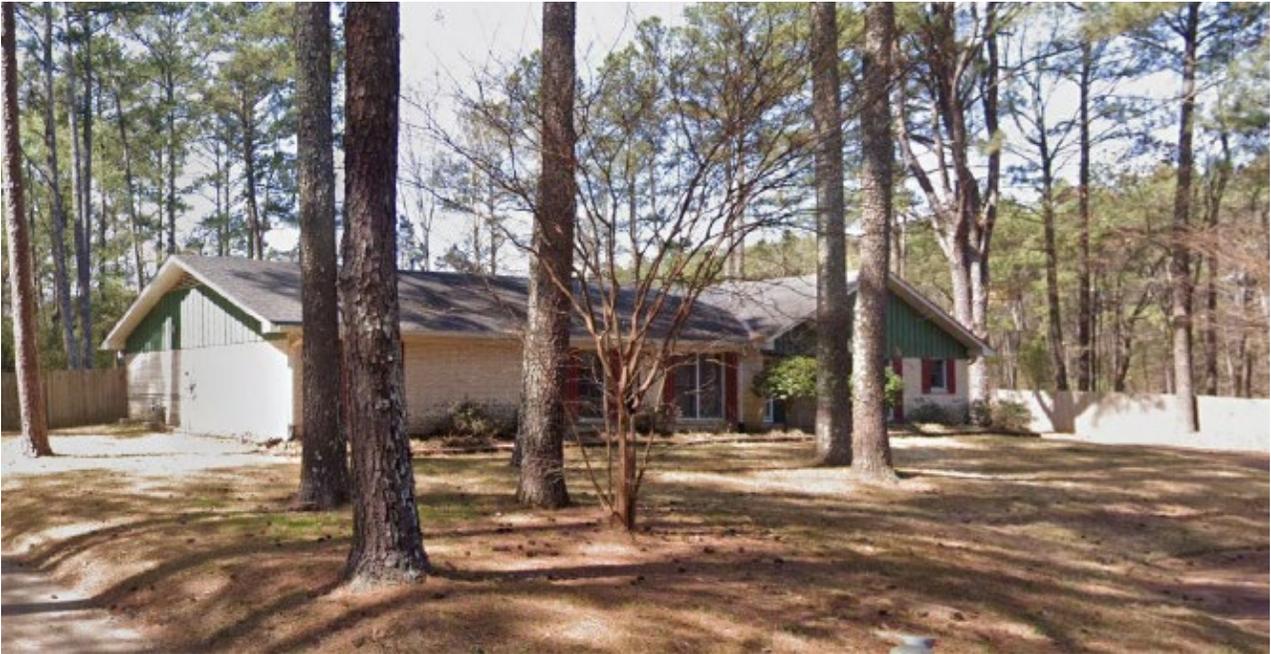
Figure 2. The Bristol Boulevard accident home before the explosion. (Courtesy of Google Maps.)

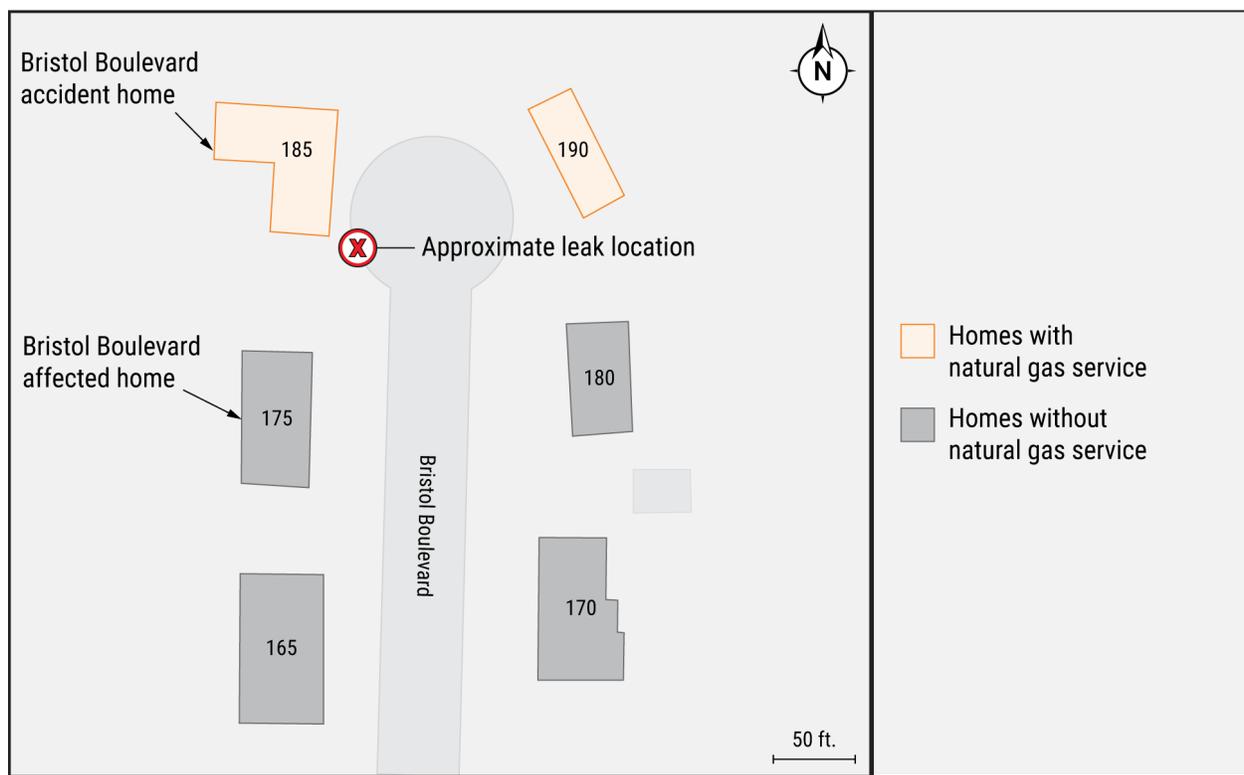
Figure 3. The Bristol Boulevard accident neighborhood.

Further pressure testing pinpointed the leak on the Dresser Style 90 straight compression coupling at the connection between the compression coupling and the service line to the home at 190 Bristol Boulevard. The compression coupling had not completely separated from the service line; the leak occurred in the space between the partially separated components. Figure 3, figure 10, and figure 11 show the approximate leak location.

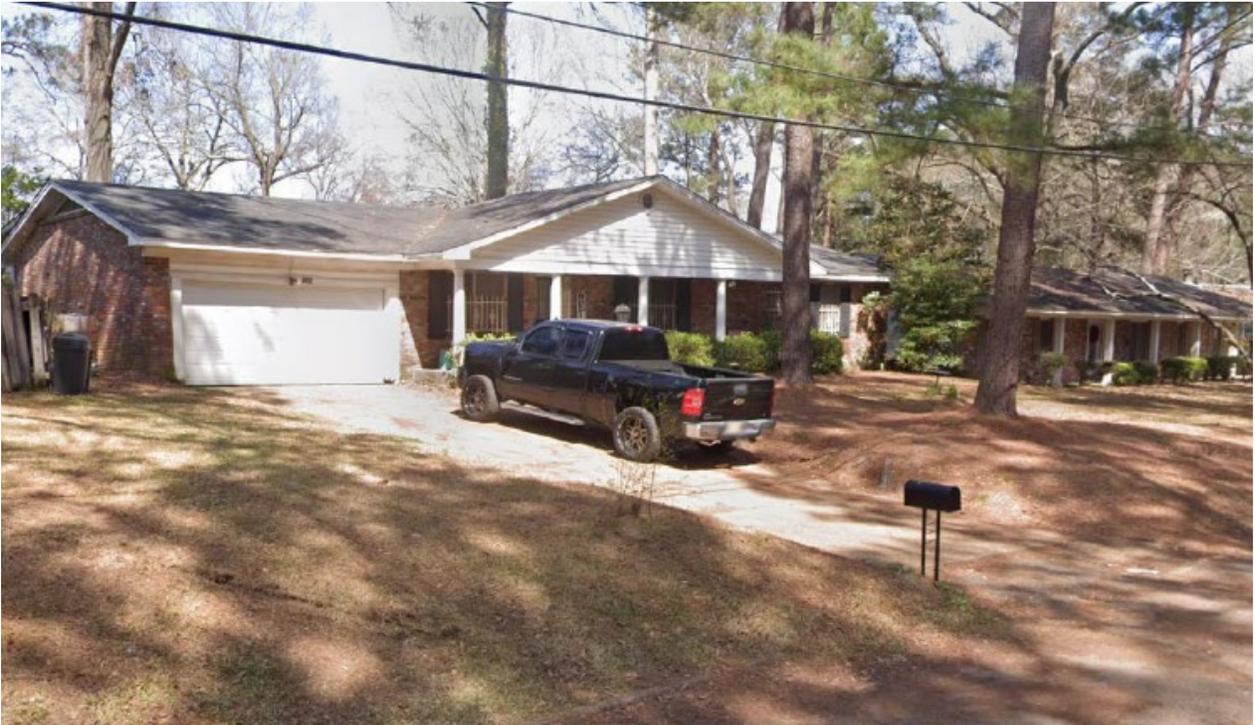
Figure 5. The Shalimar Drive accident home before the explosion. (Courtesy of Google Maps.)

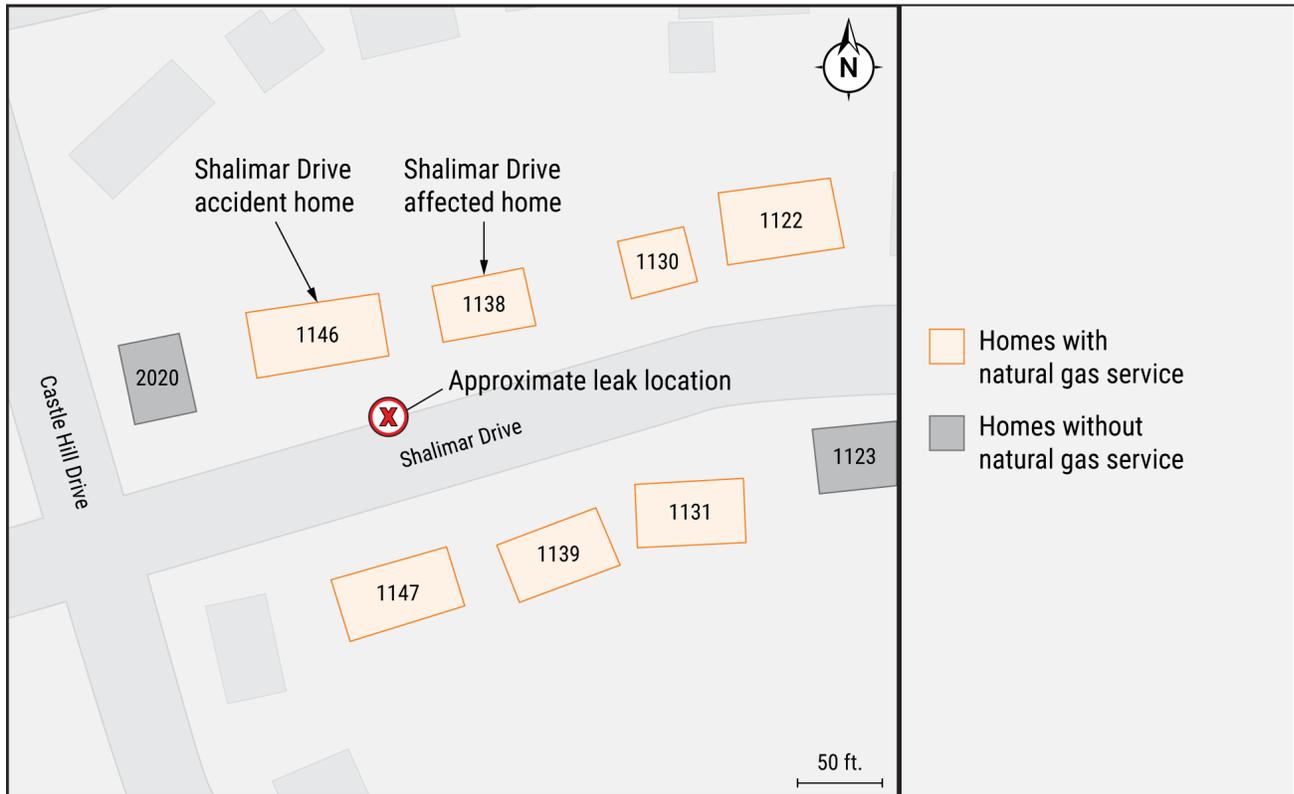
Figure 6. The Shalimar Drive accident neighborhood.

on the Dresser Style 90 elbow compression coupling at the connection between the compression coupling and the service line to the home at 1147 Shalimar Drive. The compression coupling had not completely separated from the service line; the leak occurred in the space between the partially separated components. Figure 6, figure 12, and figure 13 show the approximate leak location.

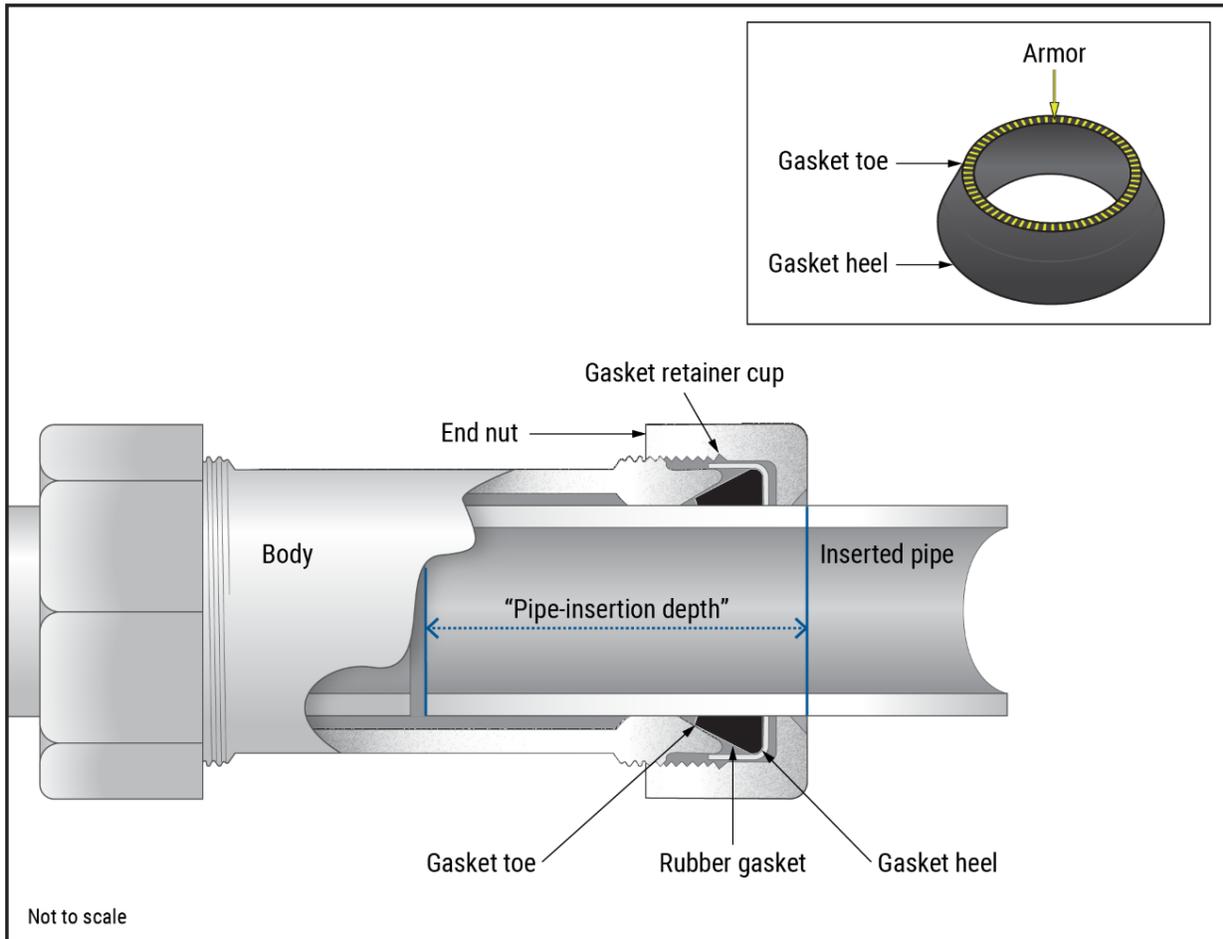
Figure 9. A Dresser Style 90 compression coupling.

The NTSB examined the gasket on the Dresser Style 90 straight compression coupling from the home at 190 Bristol Boulevard.⁴⁹ Mechanical testing showed that the rubber in the gasket had not significantly degraded while in use.⁵⁰ The gasket toe contained armor, as designed.⁵¹ (See figure 9.) The spacing between the windings of this armor measured approximately 0.02 inches, which roughly matched the spacing

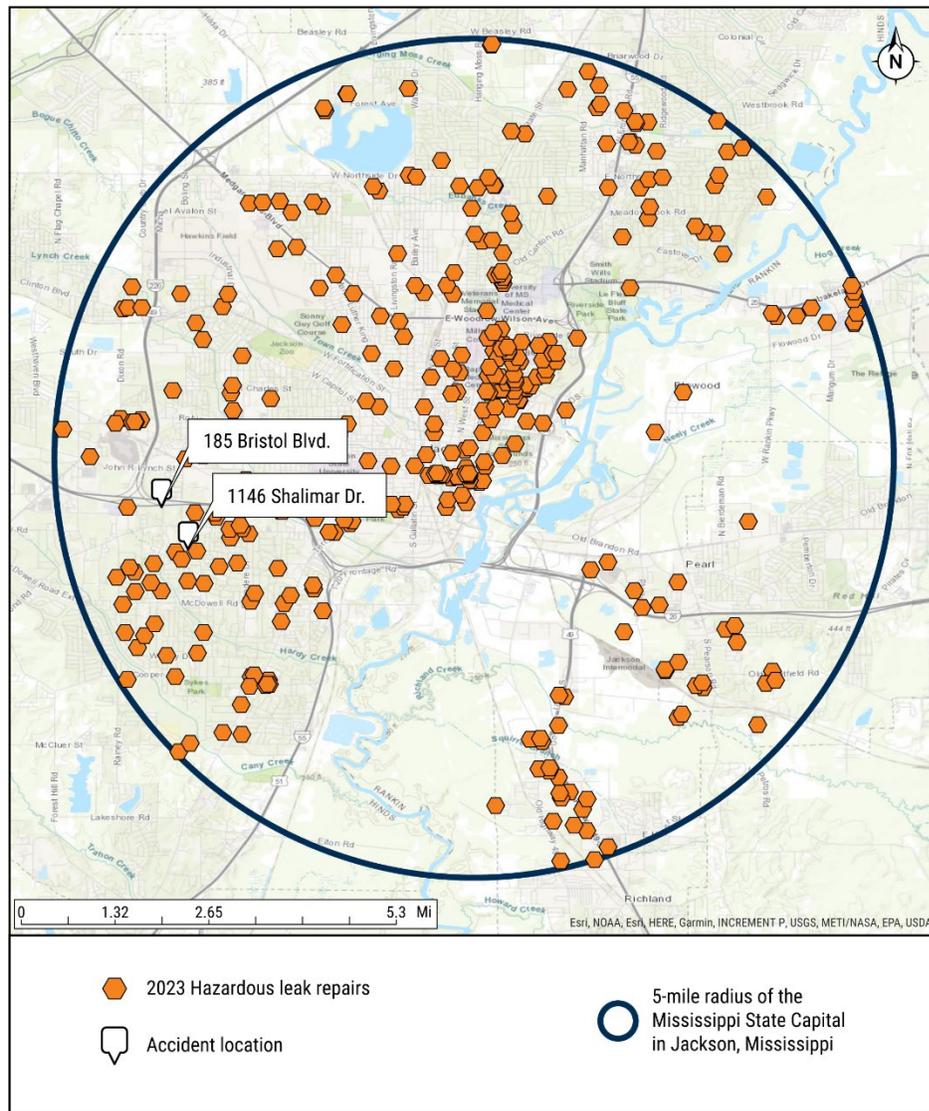
Atmos's procedures stated that leak management was accomplished by leak surveying and involved locating, grading (or classifying), repairing, and monitoring leaks. In 2023, the year before the two Jackson accidents, Atmos repaired 182 hazardous (grade 1) leaks in Jackson. (See figure 20.) (As discussed in section 1.1, this report's references to leaks refer to belowground leaks unless otherwise noted.)

Figure 20. Map of hazardous leaks within a 5-mile radius of Jackson that Atmos repaired in 2023. (Courtesy of ESRI ArcGIS and Atmos with NTSB annotations.)

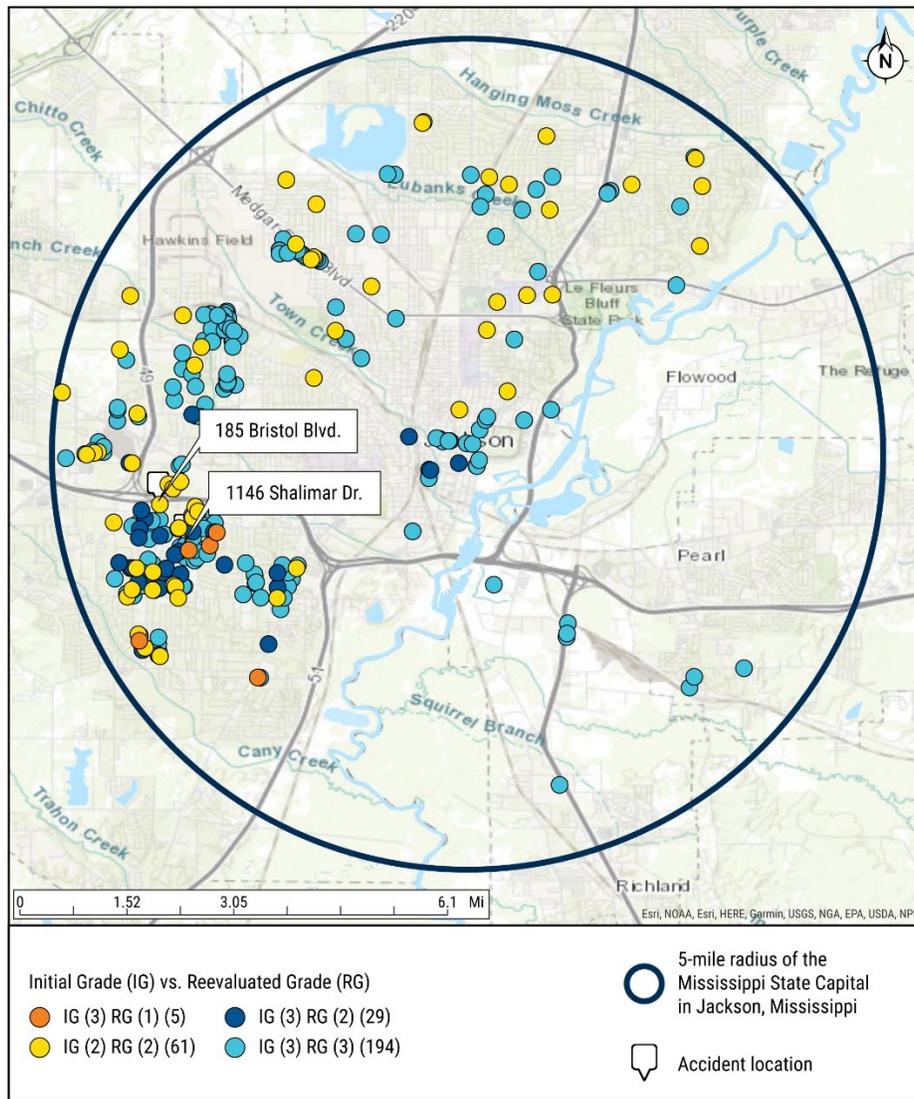
classified several leaks as grade 3 leaks that upon reevaluation in the field met the criteria for grade 1 or grade 2 leaks.⁷² Figure 21 shows a map of the 289 open leaks in Jackson as of January 24, 2024, including the two accident locations, and the grade 3 leaks that met the criteria for higher grade leaks when Atmos reevaluated them.⁷³

Figure 21. Map of open leaks within a 5-mile radius of Jackson on January 24, 2024, including leaks that later met criteria for higher grade leaks. (Courtesy of ESRI ArcGIS and Atmos with NTSB annotations.)

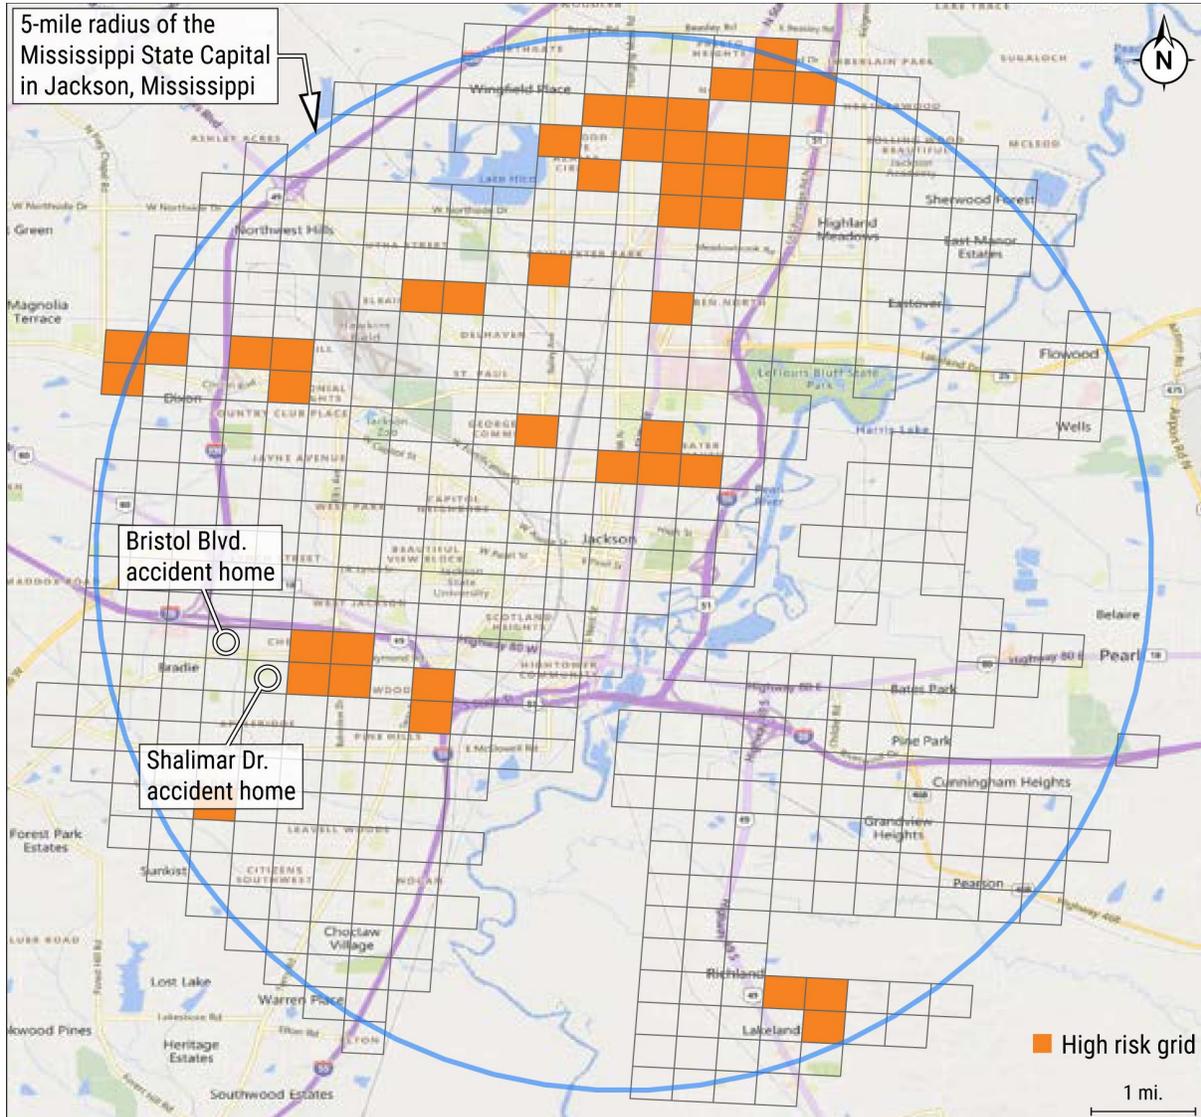
identify the accident locations as high risk.¹⁰² The risk model output was a listing of high-risk grids, not a pictographic display as shown below. The NTSB developed this figure using a listing of the high-risk grids in Jackson.

Figure 22. Map of the Atmos risk model's high-risk grids in Jackson as of January 24, 2024. (Courtesy of Atmos with NTSB annotations.)

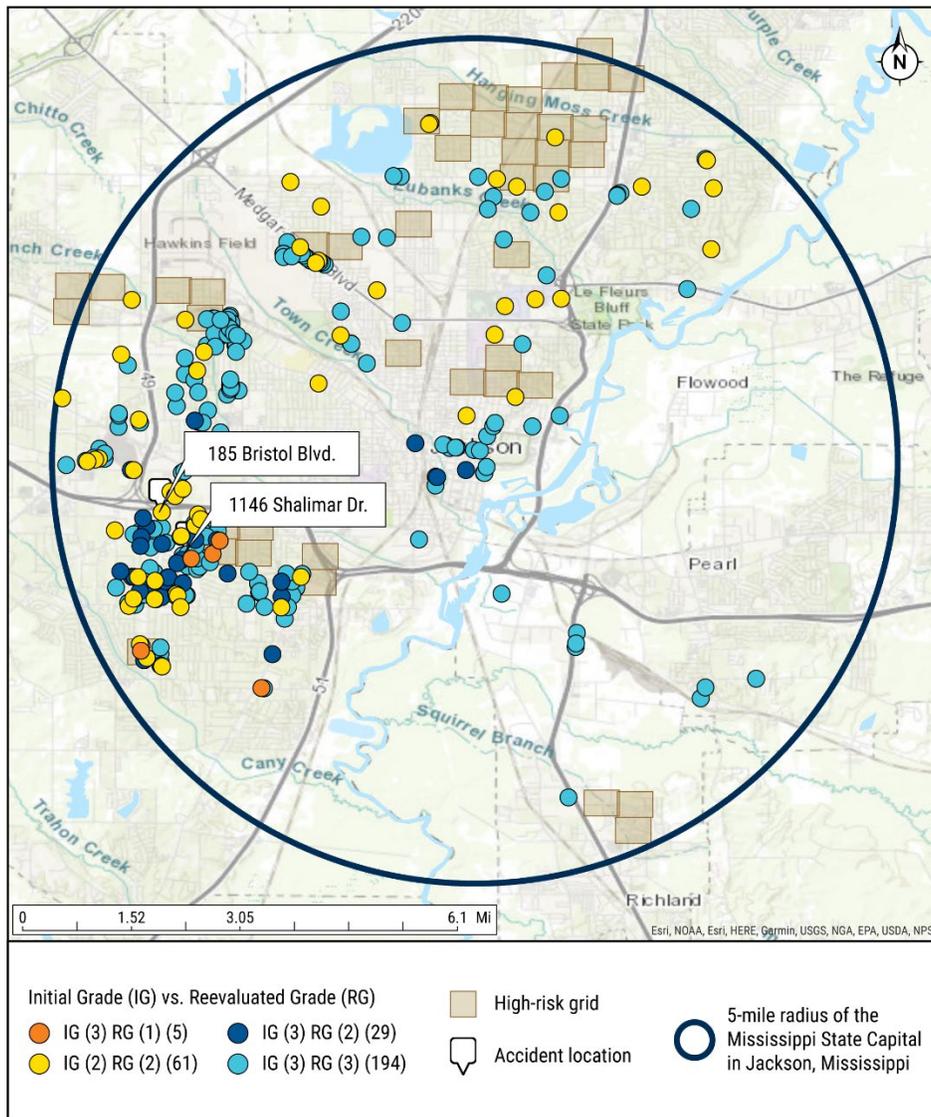
radius of Jackson, including the accident leaks. On January 24, 2024, the Bristol Boulevard accident occurred. Three days later, on January 27, 2024, the Shalimar Drive accident occurred. Although these two catastrophic accidents were confirmed risks to Atmos's system, resulting from (open) leaks that Atmos was aware of, its risk model did not rank the accident locations as high risk. Figure 24 shows the open, nonhazardous leaks within a 5-mile radius of Jackson as of January 24, 2024, overlaid with the Atmos risk model's high-risk grids that were current on that date; not many of the open, nonhazardous leaks, including the accident leaks, are in high-risk grids. The figure also shows the grade 3 leaks that met the criteria for higher grade leaks (grade 1 and grade 2 leaks) when Atmos reevaluated them.¹²⁶

Figure 24. Map of open, nonhazardous leaks within a 5-mile radius of Jackson as of January 24, 2024, including leaks that later met criteria for higher grade leaks, overlaid with Atmos high-risk grids current on that date. (Courtesy of ESRI ArcGIS and Atmos with NTSB annotations.)
