# National Transportation Safety Board

## Railroad Accident Brief

Accident No: DCA-02-FR-013  
Railroad: Norfolk Southern Railway  
Train: Train 15T  
Location: Farragut, Tennessee  
Accident date and time: September 15, 2002, 11:20 a.m. eastern daylight time  
Type of Accident: Derailment  
Fatalities/Injuries: No fatalities or serious injuries  
Property Damage: \$1.02 million

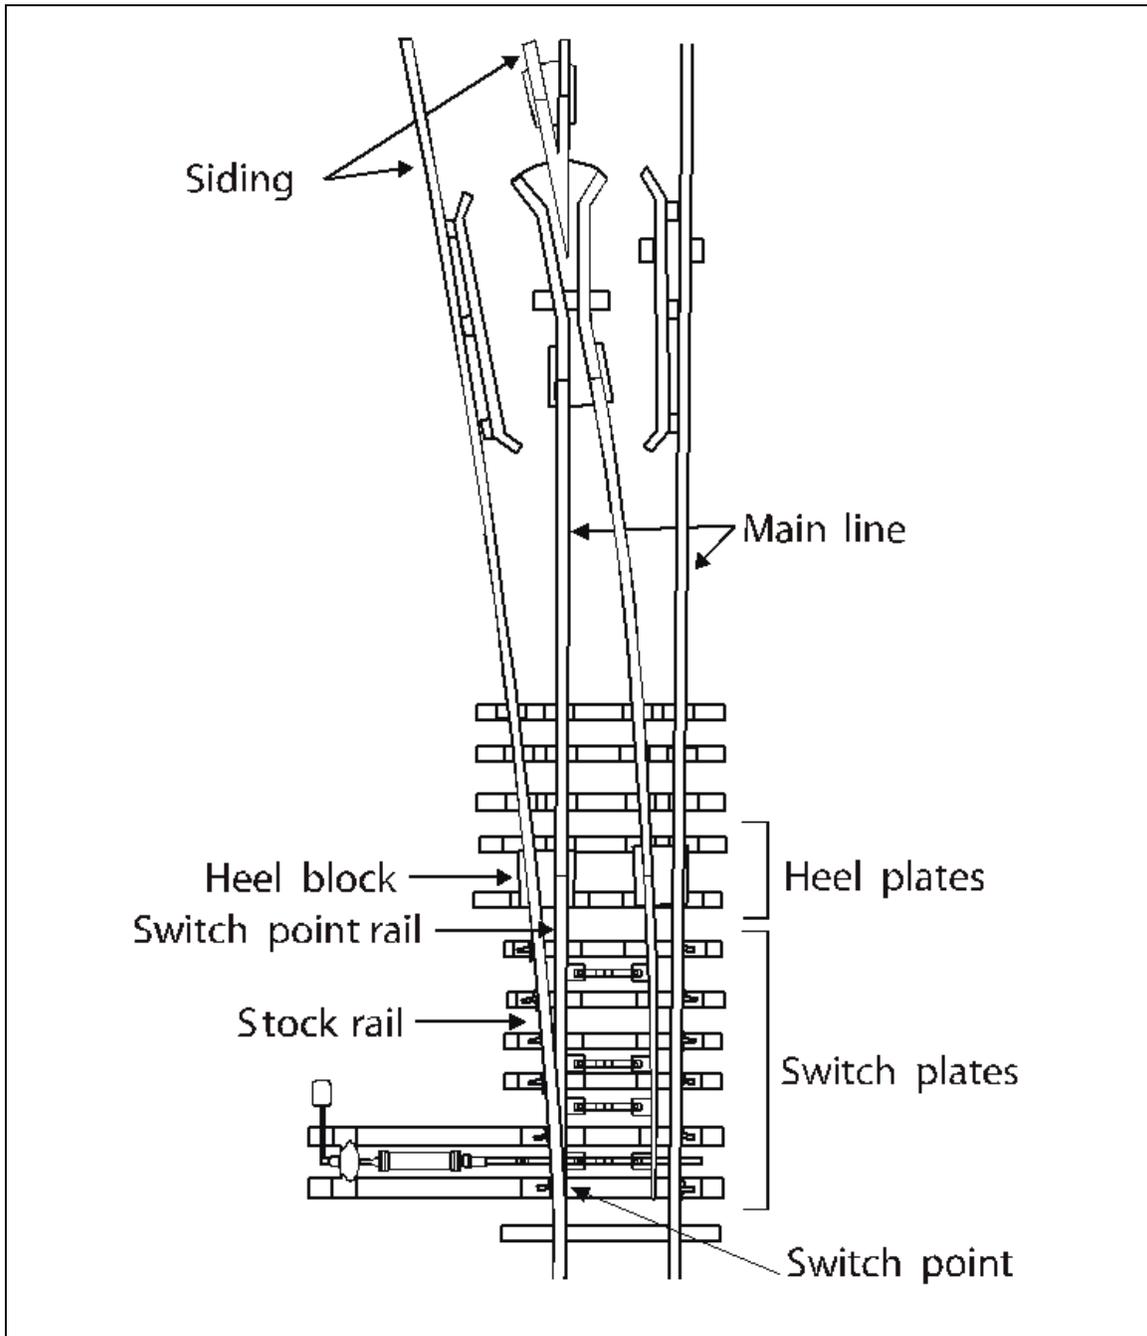
Figure 4. Diagram of a switch and turnout

The signal maintainer said that when he arrived at the switch, he noted that the points appeared to be properly positioned. He said that he visually inspected the switch and noticed that the switch plates,<sup>5</sup> while not really dry, “looked like they could use a little oil.” He said that he put oil on each switch plate. He walked from the heel block to the switch point and did not see anything unusual. (See Figure 4.)
