National Transportation Safety Board

Railroad Accident Brief

CSXT Petroleum Crude Oil Train Derailment and Hazardous Materials Release

Accident No.:	DCA14FR008
Location:	Lynchburg, Virginia
Date:	April 30, 2014
Time:	1:54 p.m. eastern daylight time
Train:	CSXT Train K08227
Railroad:	CSX Transportation (CSXT)
Property Damage:	\$1,224,000
Injuries:	0
Fatalities:	0
Type of Accident:	Derailment with hazardous materials and fire

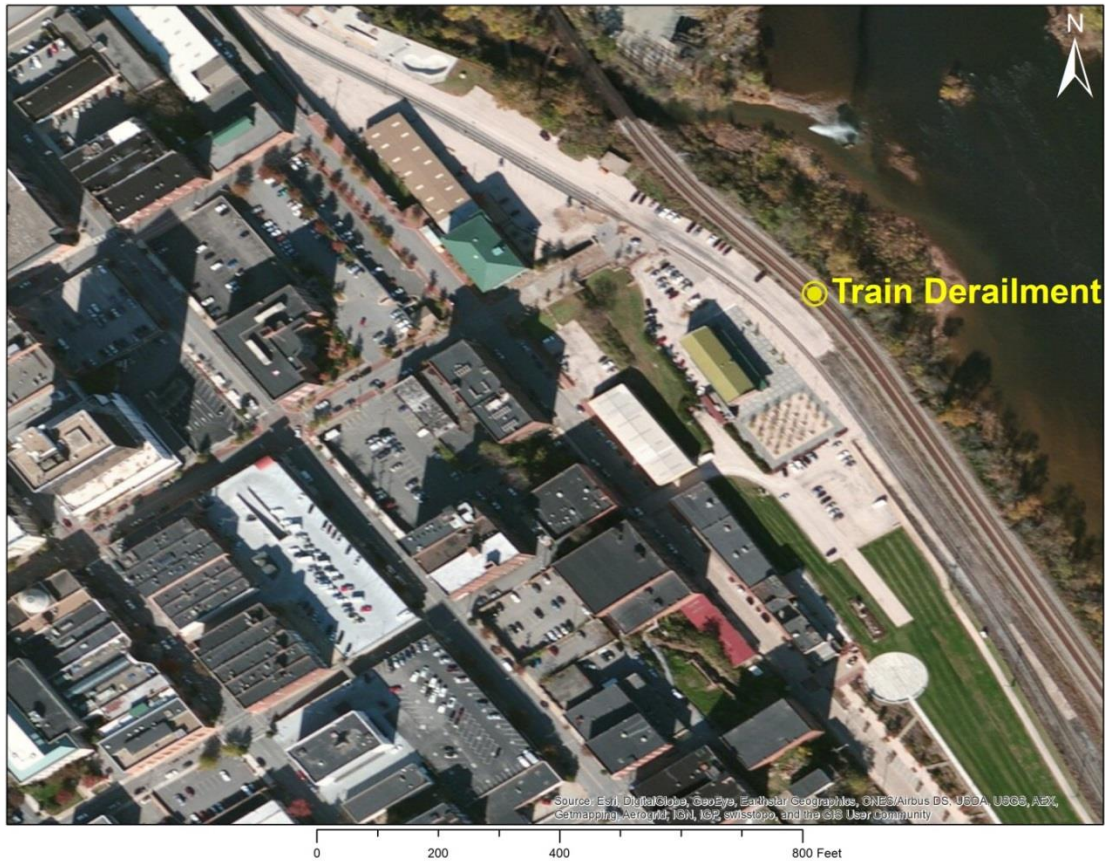
Figure 2. Derailment site in Lynchburg, Virginia.

The derailment resulted in a large fire along the James River. The Lynchburg Fire Department ordered the evacuation of about six blocks along the riverfront and south of the derailment area, affecting about 350 residents and 20 businesses. (See figure 2.)
