**Derailment of CN Freight Train U70691-18 With Subsequent  
Hazardous Materials Release and Fire  
Cherry Valley, Illinois  
June 19, 2009**

**NTSB/RAR-12/01  
PB2012-916301**

# Railroad Accident Report

**Abstract:** About 8:36 p.m., central daylight time, on Friday, June 19, 2009, eastbound Canadian National Railway Company freight train U70691-18, traveling at 36 mph, derailed at a highway/rail grade crossing in Cherry Valley, Illinois. The train consisted of 2 locomotives and 114 cars, 19 of which derailed. All of the derailed cars were tank cars carrying denatured fuel ethanol, a flammable liquid. Thirteen of the derailed tank cars were breached or lost product and caught fire. At the time of the derailment, several motor vehicles were stopped on either side of the grade crossing waiting for the train to pass. As a result of the fire that erupted after the derailment, a passenger in one of the stopped cars was fatally injured, two passengers in the same car received serious injuries, and five occupants of other cars waiting at the highway/rail crossing were injured. Two responding firefighters also sustained minor injuries. The release of ethanol and the resulting fire prom

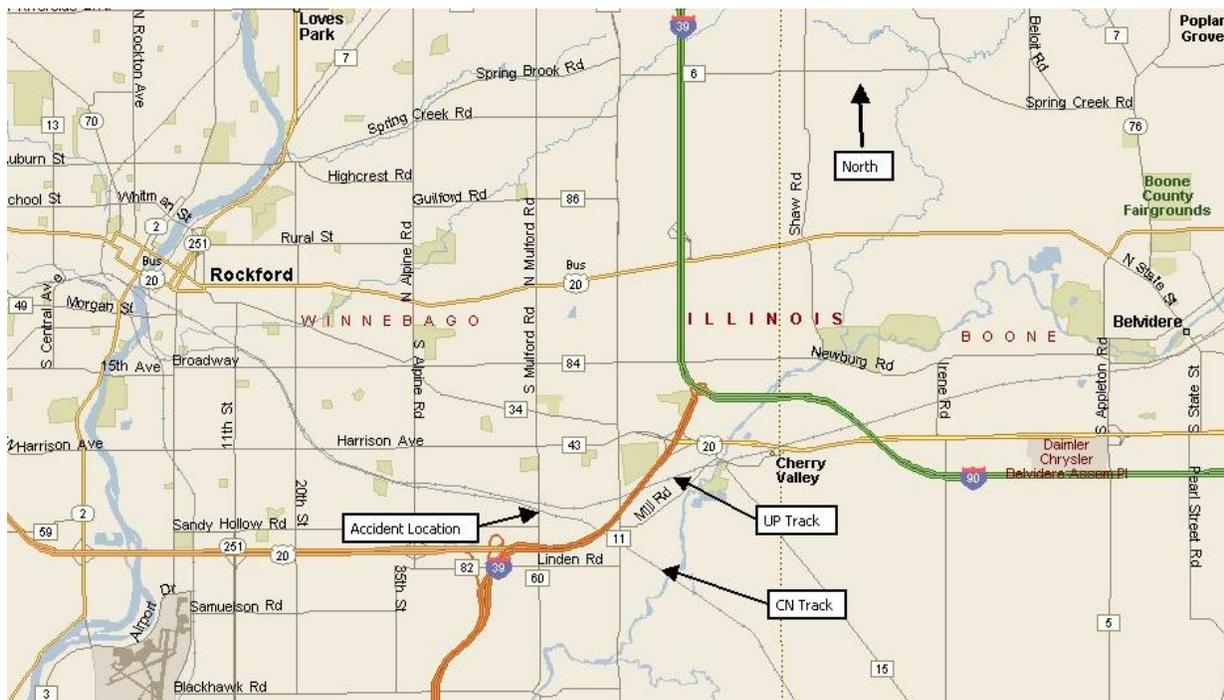
**Figure 6.** Accident site.

The area in which the accident occurred included residential as well as light industrial properties. About 480 feet north of the CN's main track was an east/west UP industrial lead track that paralleled the CN track for about 1/2 mile and that crossed Mulford Road to the north of the CN crossing. (See figure 6.)

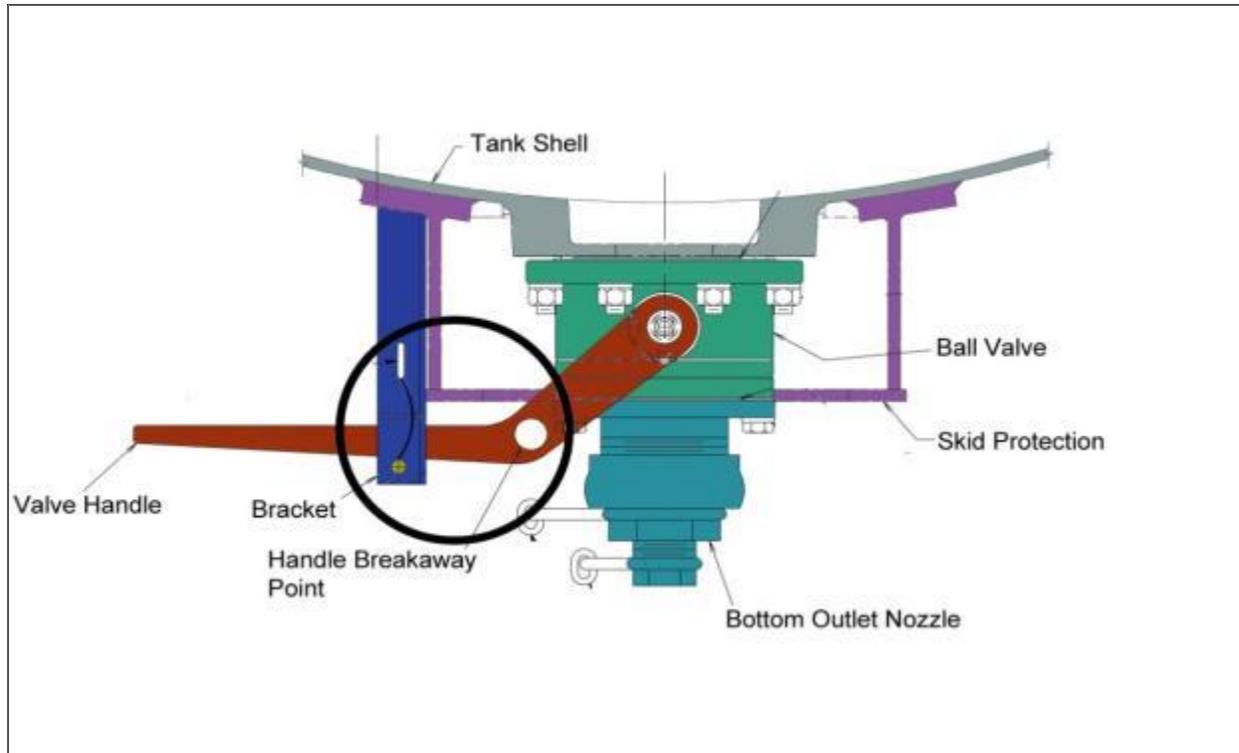
The cars owned by CIT Rail (CITX and CTCX) were originally constructed with outlet valves oriented so that the valve handles operated longitudinally. On June 4, 2008, Trinity Tank Car filed an R-1, “Report of Tank Repairs, Alteration or Conversion,” with the FRA for the CIT Rail cars, indicating that the outlet valves on those cars had been rotated 90 degrees such that the handle operated in the transverse direction rather than in the longitudinal direction. A hole in the valve handle was designed to weaken the handle and cause it to break away on impact to allow the valve to remain closed. (See figure 7.)

**Figure 7.** Bottom outlet valve configuration, as modified from original design, for derailed CITX and CTCX cars. (Not to scale) The operating handle securing bracket is circled. (Adapted from a Trinity Tank Car drawing)

One of the derailed cars with an open bottom outlet valve was a car owned by CIT Rail with a bottom outlet valve and handle configuration that had been modified from the original design. The bottom outlet valve handle on the car was constructed with a breakaway point that was designed to allow the handle to break free in an accident without causing the valve to open. But the valve operating handle was too robust and failed to break away when the handle struck the ground or another object. (See figure 7.) Instead, the retaining bracket broke, and the intact handle, though bent, opened the valve and allowed lading to be released. (See figure 11.)

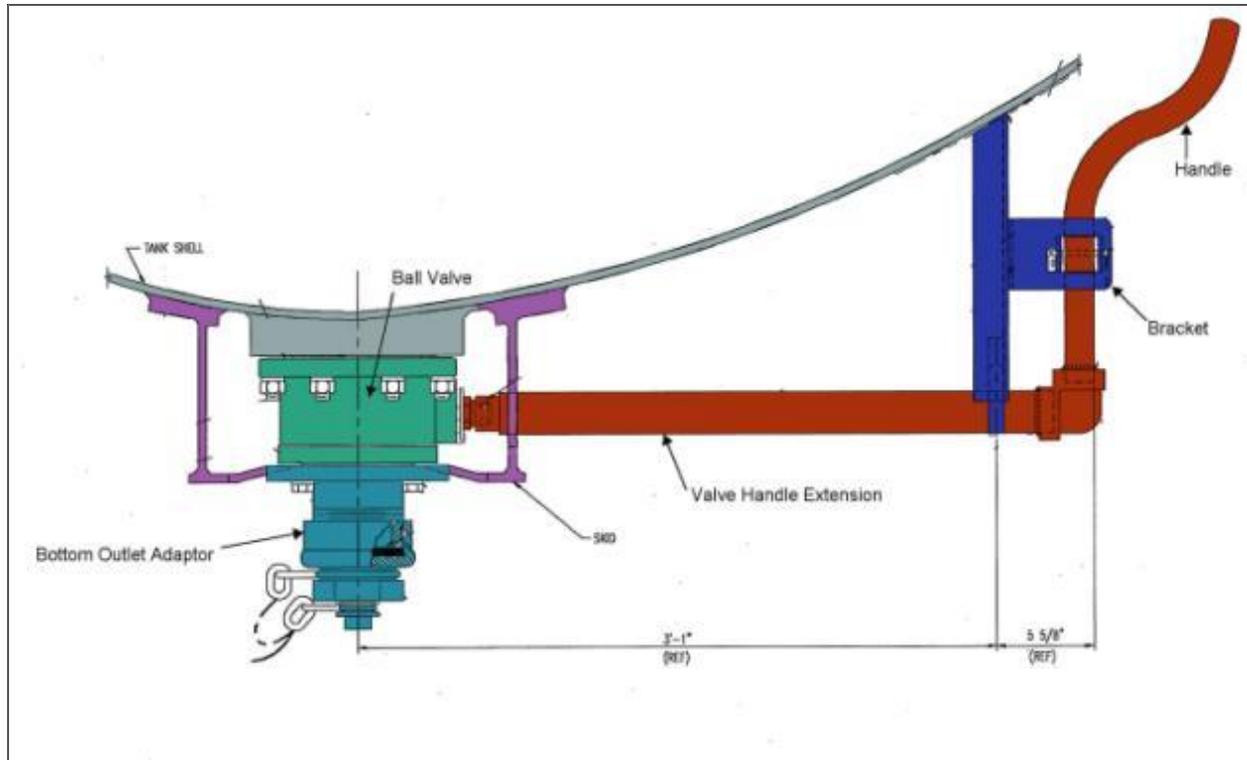
The cars owned by GE Equipment Services (NATX) and by Trinity (TILX) were equipped with a 4-inch ball valve of the type shown in figure 8. The valve operating handle extended upward along the side of the tank where it could be secured in its closed position by a bracket and retaining pin. A transversely oriented handle extension attached to the valve through a hole in the skid protection structure. The valve was opened by moving the handle longitudinally.

**Figure 8.** Bottom outlet valve arrangement (not to scale) used on derailed NATX and TILX tank cars. (Adapted from a Trinity Tank Car drawing)

The other two cars with bottom outlet valves that opened during the derailment were cars owned by GE Equipment and by Trinity that used a bottom valve handle arrangement in which the valve handle extended out from the center of the tank and then upward and was secured to the right side of the tank. Moving the handle longitudinally from the A end toward the B end of the car opened the valve. (See figure 8.) This design does not have a breakaway feature for the valve handle, instead relying on the fact that the handle extends above the bottom surface of the skid protection plate in satisfaction of the AAR standard. Postaccident inspection of the two cars revealed that bottom outlet valve handles were bent and pulled away from their retaining brackets and that the exposed ball valves were open, thus allowing release of lading through the sheared nozzles.

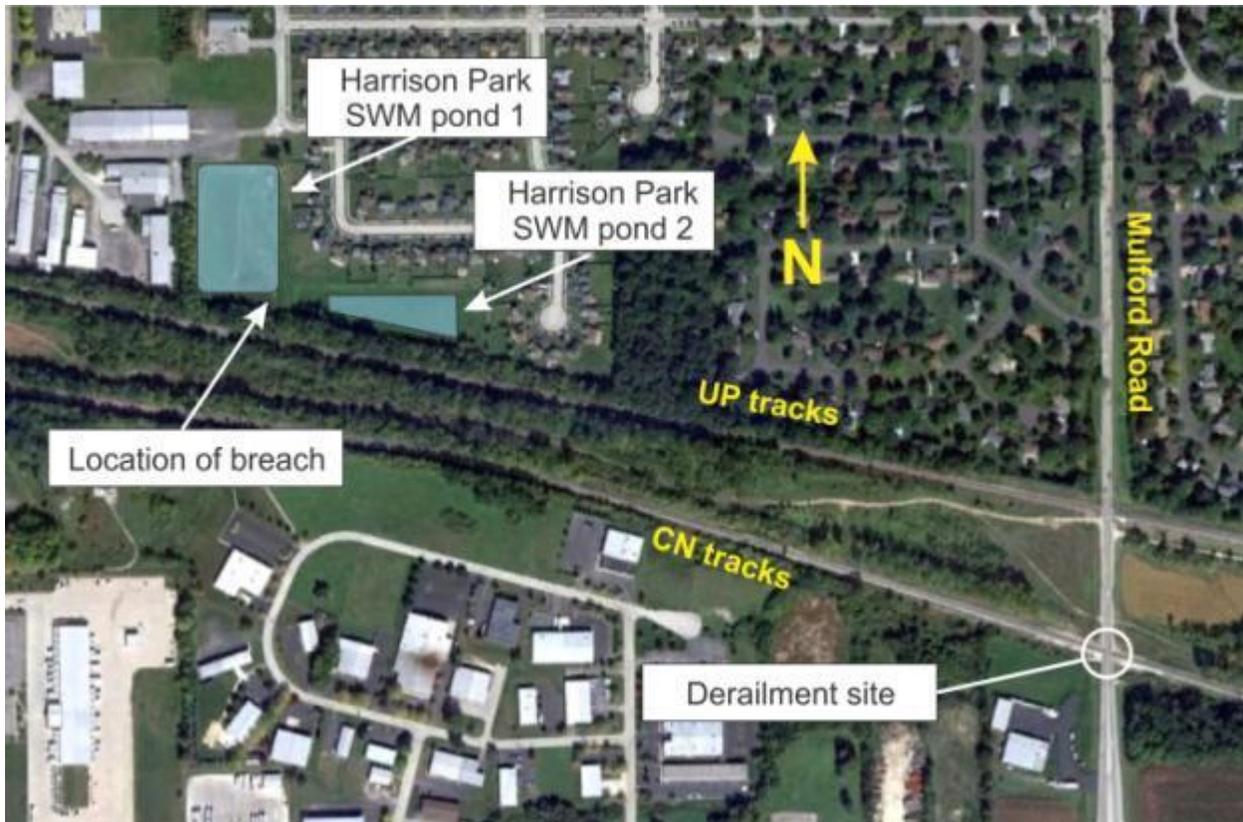
A little more than 1/2 mile northwest of the CN Mulford Road crossing, the residential subdivision of Harrison Park was the site of two storm water management (SWM) detention ponds,<sup>41</sup> both built in 1997. (See figure 15.) Based on design drawings, the larger of these, referred to in this report as SWM pond 1, measured 400 by 255 feet at the pond bottom and 458 by 306 feet at the top of the berm. According to county officials (and as is typical within municipalities) the storm sewers and inlets that were tributaries for SWM pond 1 were designed to the 10-year storm (10 percent probability of occurring in any year), while the pond itself was designed to the 100-year storm event (1 percent probability of occurring in any one year).<sup>42</sup>

**Figure 15.** Aerial view showing location of Harrison Park subdivision detention ponds in relation to accident site.

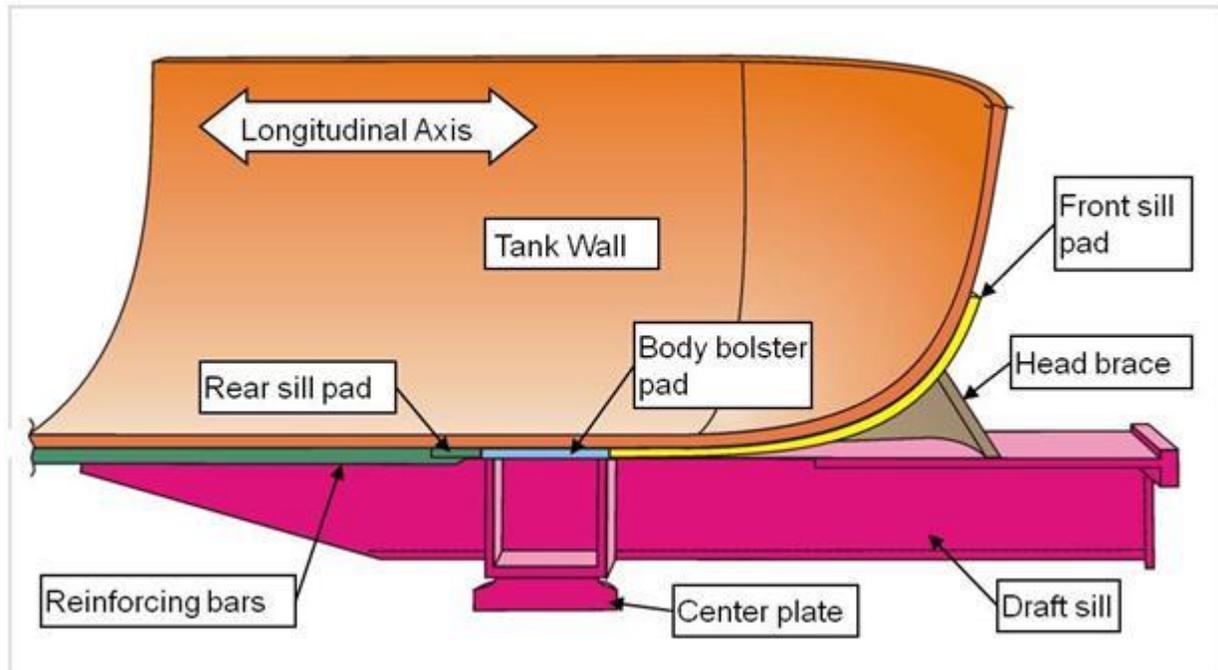
The DOT-111 tank cars involved in this accident were constructed with a draft sill design, where the draft sills<sup>50</sup> of each car were attached to steel "pads" that were attached to the tank. Because the cars did not incorporate a center sill that extended the entire length of the car, the draft sills are also referred to as "stub" sills. Body bolsters and their associated body bolster pads centered above the railcar trucks supported the tank and protected it against lateral forces. The draft sill center plate served as the attachment point between the tank car body and the truck assembly. Reinforcing bars extended underneath the tank between the draft sills on each car. (See figures 18 and 19.)

**Figure 18.** Schematic cutaway view (not to scale) of end of tank car showing major components.

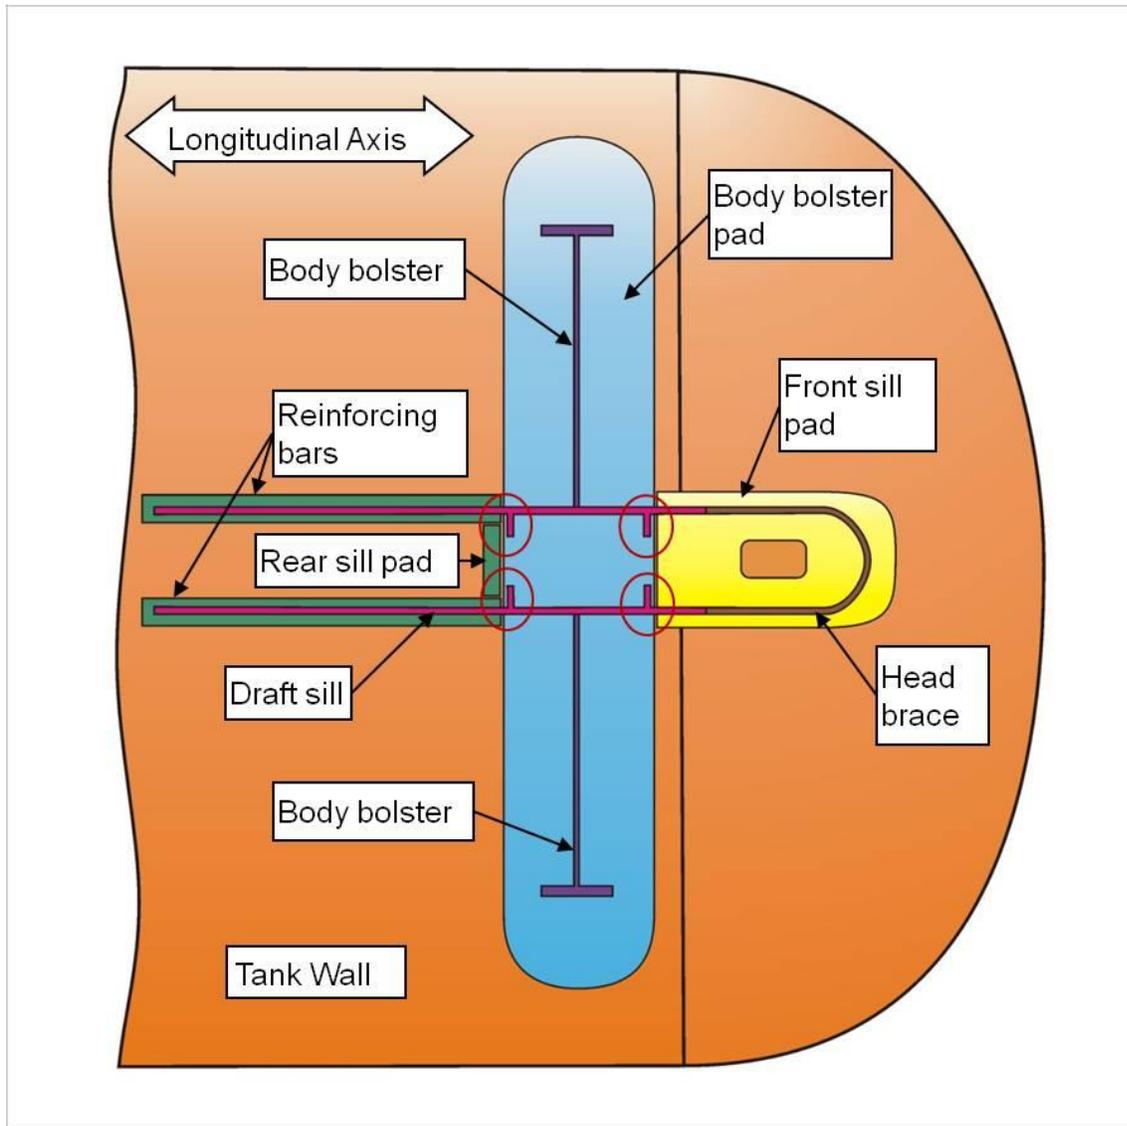
The body bolster pads and front sill pads were attached to the tank with fillet welds.<sup>51</sup> On the body bolster pads, all the edges of the pad were welded. On the front sill pad, the front and sides were welded, as were all inside edges of the rectangular cutout at the center of the front sill pad. (See figure 19.) At the rear edge of the front sill pad, a butt weld<sup>52</sup> attached the front sill pad to the body bolster pad and to the fillet weld attaching the body bolster pad to the tank shell. Fillet welds at the interior and exterior sides of the head brace attached the head brace to the front sill pad, and an exterior fillet weld attached the head brace to the draft sill. To the rear of the head brace, the draft sill was welded to the front sill pad, body bolster pad, and reinforcing bars.

**Figure 19.** Schematic drawing (not to scale) from below showing body bolster, draft sill, and head brace attachment locations to pads on underside of tank cars. Circled areas indicate where transverse portions of draft sill are welded adjacent to transverse weld of body bolster pad.

AAR standards require that the pads extend at least 1 inch transversely on either side of the draft sill attachment and must extend some distance from the head brace in the longitudinal direction as defined by a formula. However, there is no other requirement for distance that the pads extend in the longitudinal direction. In the tank cars involved in this accident, transverse portions of the draft sill attachment above the center plate were welded to the body bolster pad adjacent to the edge of the bolster pad where the pad was welded to the tank (see circled areas in figure 19). This area also corresponded to the tank circumferential fracture location. While separation of the front sill pad made tank failure more likely, the proximity of the attachment welds for the pads and the draft sill in this area provided a location where draft sill loads could be transferred directly to the tank wall rather than going first through the pads.
