Conrail Freight Train Derailment with  
Vinyl Chloride Release  
Paulsboro, New Jersey  
November 30, 2012

NTSB/RAR-14/01  
PB2014-108828

# Railroad Accident Report

**Abstract:** This report discusses the 2012 accident in which a Consolidated Rail Corporation (Conrail) train derailed while traveling over a moveable bridge in Paulsboro, New Jersey. Three tank cars containing vinyl chloride came to rest in Mantua Creek, of which one was breached and released about 20,000 gallons of vinyl chloride. On that day, 28 residents sought medical attention for possible exposure, and the train crew and many emergency responders were also exposed. Damage estimates were \$451,000 for equipment and about \$30 million for emergency response and remediation.

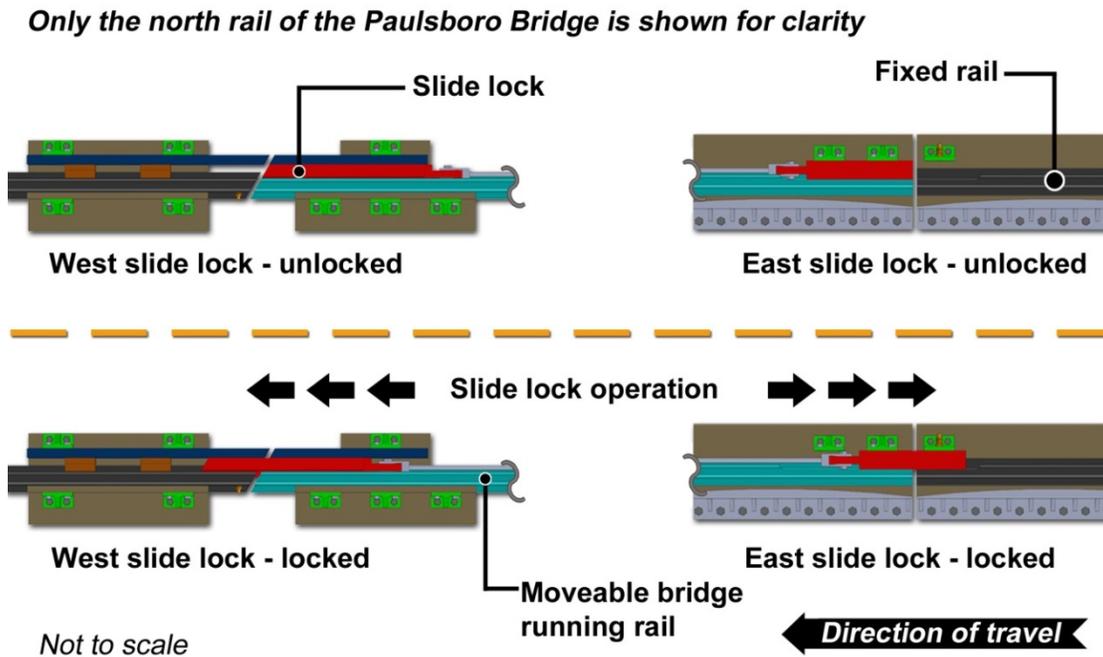
**Figure 5.** Slide lock operation.

The A-frame lift mechanism lowered the swing span onto piles, which aligned the rails in the vertical direction. Slide locks then engaged at the four rail connection points to prevent the bridge from rotating while the train was crossing the bridge (see figures 5 and 6). The slide locks traveled across the gap between the rails of both ends of the bridge. The east end slide locks would have had to travel about 8 inches to fully engage and the west end slide locks would have had to travel 6 inches to fully engage. Slide locks needed to be within 1/2 inch of proximity sensors to be fully engaged.
