Derailment and Hazardous Materials Release of
Union Pacific Railroad Unit Ethanol Train
Graettinger, Iowa
March 10, 2017

Accident Report

NTSB/RAR-18/02
PB2019-100084

National
Transportation
Safety Board

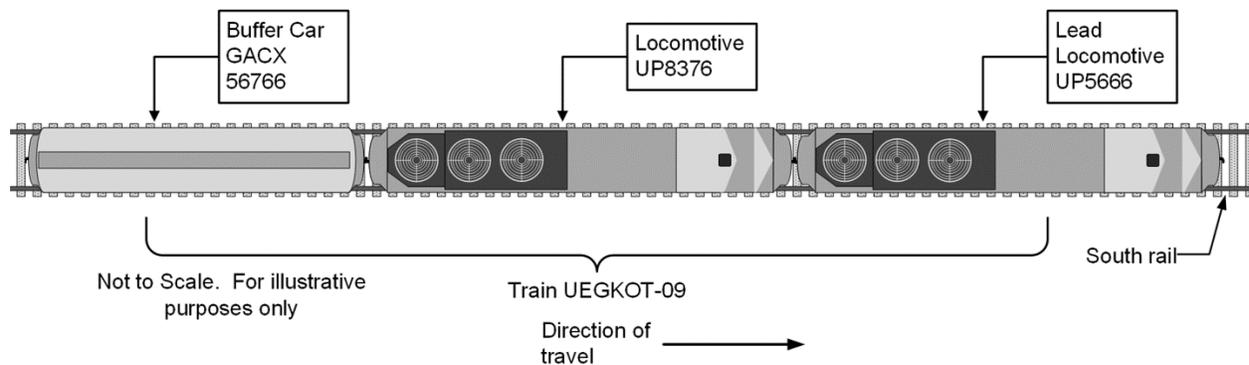
Figure 4. Illustration of train movement over rails.

NTSB investigators inspected the nonderailed cars (1st through the 20th) that traveled over the Jack Creek Bridge. NTSB investigators observed that the wheels on the right side of several cars that rolled over the right-side rail (or south rail) exhibited fresh horizontal impact damage (impressions perpendicular to the wheel tread).¹⁰ (See figure 4.) No such damage was observed on the wheels on the left side of the train. (See figure 5.)
