RAILROAD ACCIDENT REPORT

PENN CENTRAL COMPANY

COLLISION OF TRAINS

**N-48 AND N-49 AT
DARIEN, CONNECTICUT**

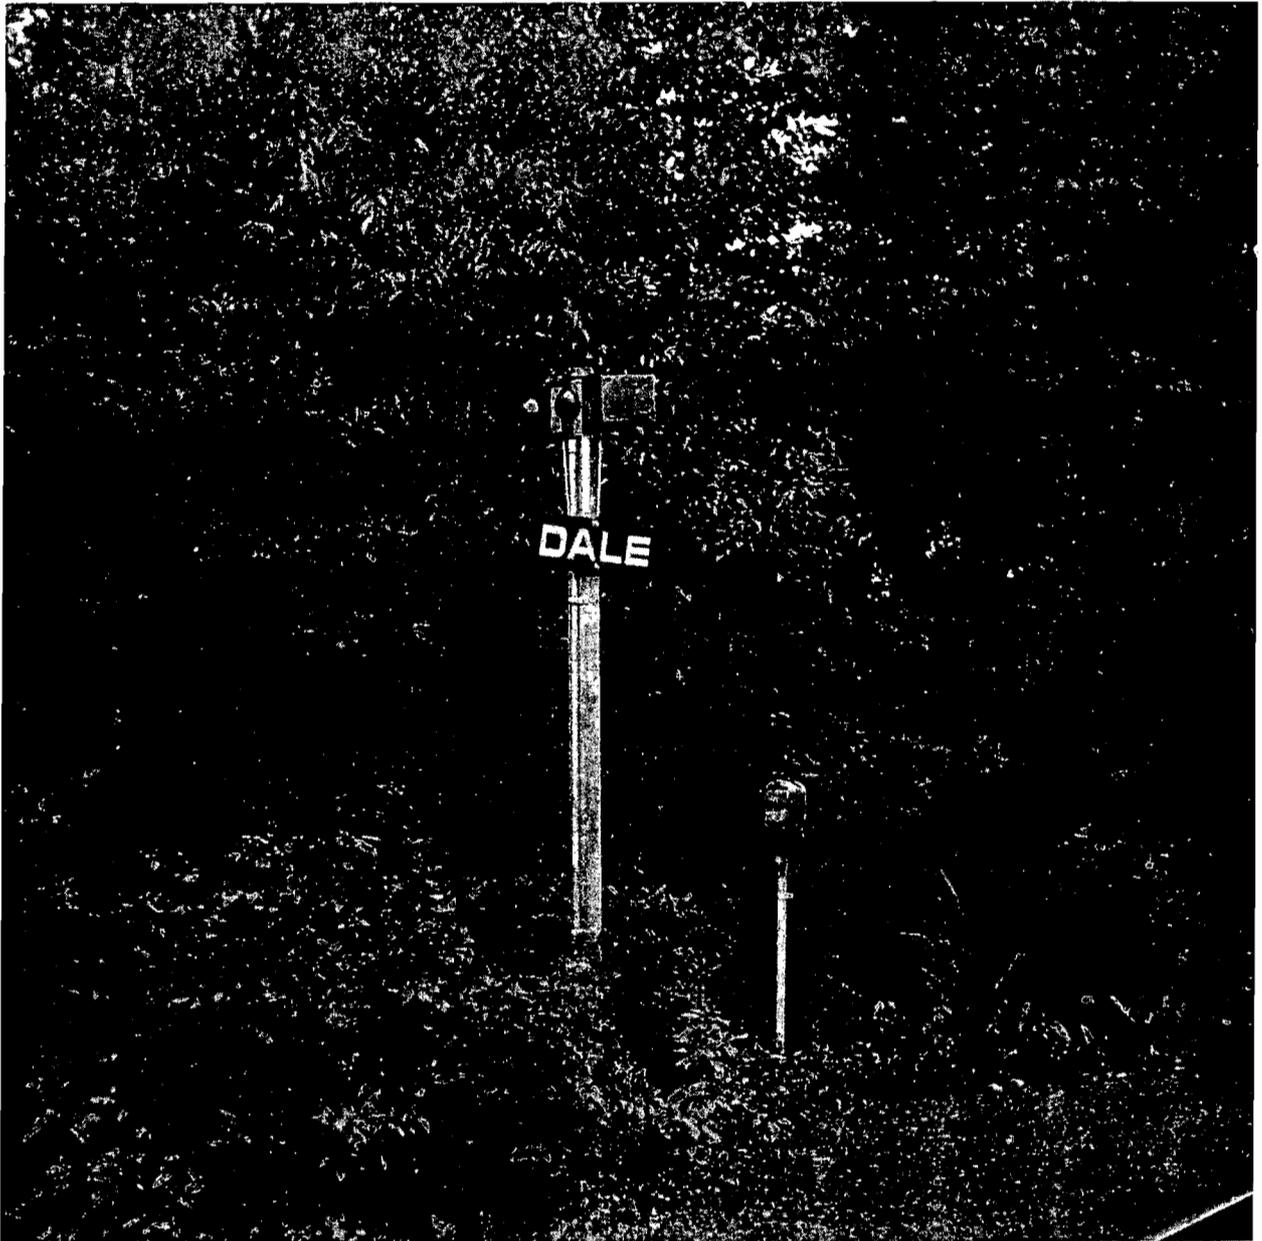
Figure No. 1

At Dale siding, there is a similar block-limit signal with "Dale" mounted below the lights. (See Figure 1, page 5.) This signal is located along the north side of the track, 299 feet east of the west switch of the siding. Dale block-limit station was opened by timetable instructions from 6:55 a.m. to 8:25 a.m. and from 6:10 p.m. to 7:25 p.m., daily except Saturday, Sunday, and holidays for regular meets between opposing trains. Dale block-limit station was opened as needed at other times by train order. Since the accident, rules regarding the time of the open block-limit station have been changed. When Dale block-limit station was opened, the New Canaan Branch was divided into two manual blocks, and a train was not permitted to pass the block-limit station without obtaining permission from the operator to occupy the block.

Dale block - limit station
