RAILROAD ACCIDENT REPORT

Deraiment of
TOLEDO, PEORIA and WESTERN RAILROAD COMPANY'S
Train No. 20 With Resultant Fire
and Tank Car Ruptures
Crescent City, Illinois

June 21, 1970

NATIONAL TRANSPORTATION SAFETY BOARD
Washington, D. C. 20591
REPORT NUMBER: NTSB-RAR-72-2

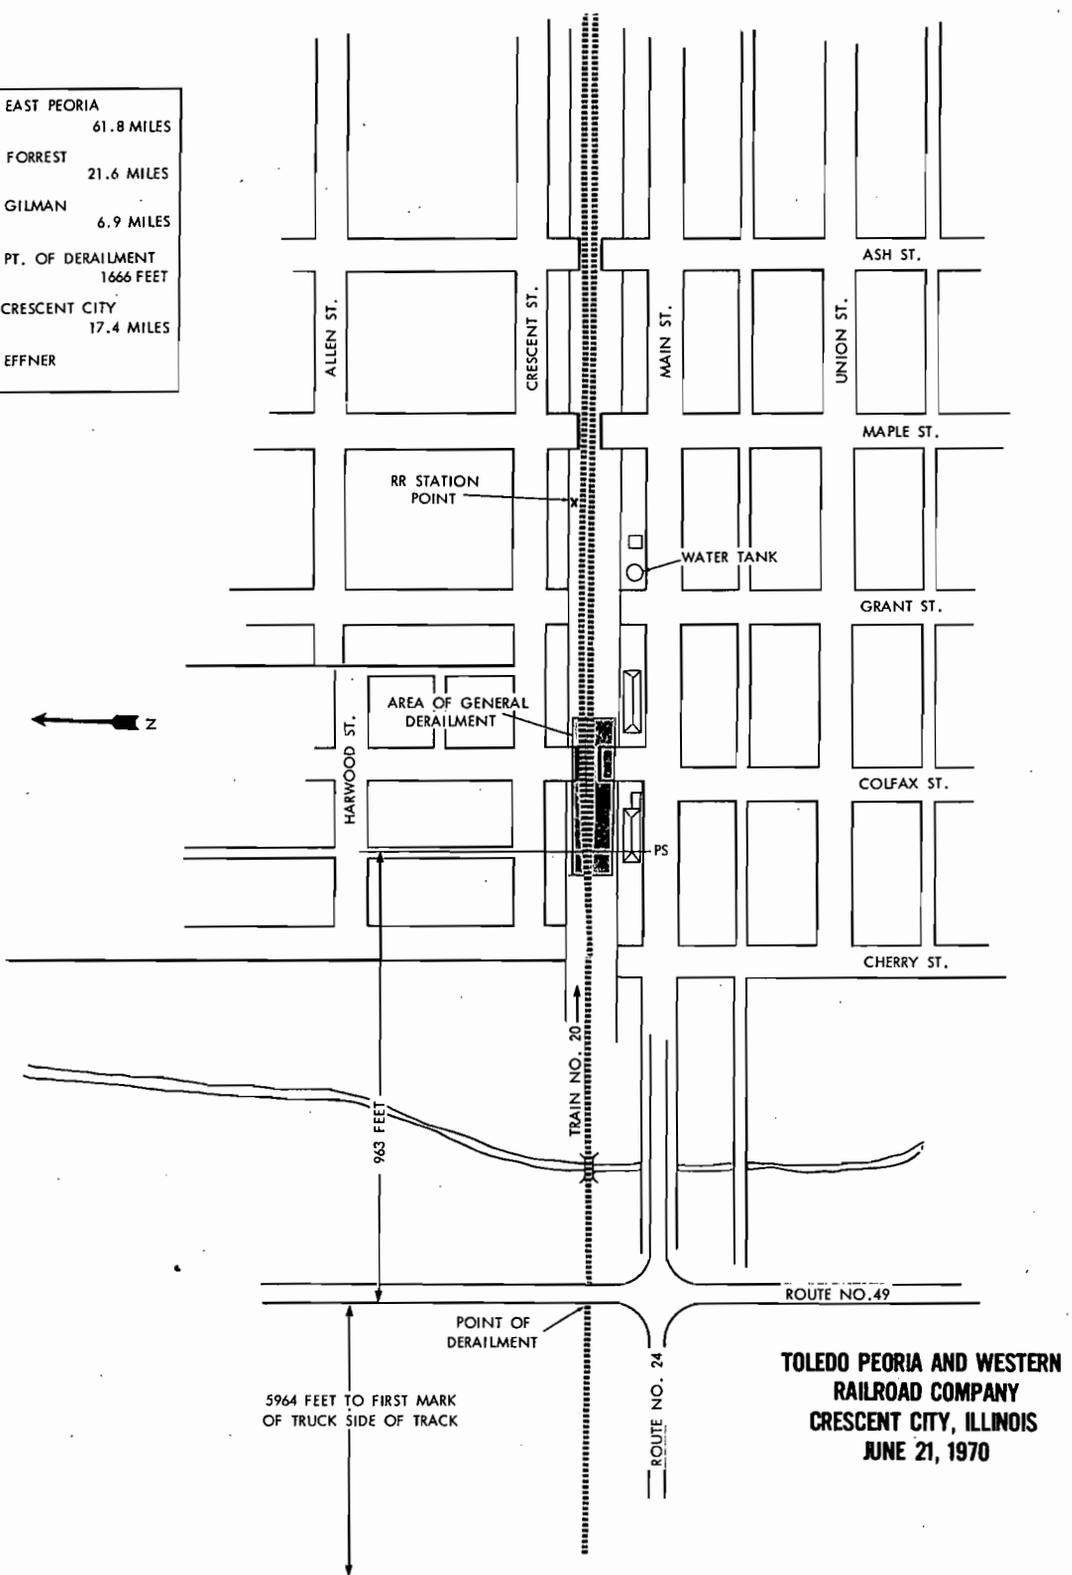
Figure No. 1

A siding, 2,560 feet in length, parallels the main track on the north side through the town. The west switch of the siding is located 703 feet west of the station point. This siding is designated as the elevator track. (See Figure No. 1.)

The town of Crescent City is built along each side of the railroad. The main street, which is also State Highway 24, extends east and west through the town about 100 feet south of the main track. Several industries are located between the railroad right-of-way and Main Street. Included in this area are the city building and a 50,000-gallon water storage tank, located immediately adjacent to the railroad about 559 feet east of the west switch of the siding. The buildings of several small businesses and apartments are located along the south side of the main street. Directly south of this area and also along the north side of the tracks are the residential areas of the town. The railroad bridges a stream at a point 1,576 feet west of the west switch of the siding. (See Figure 1.)

Illinois State Highway No. 49, extending north and south, crosses the railroad at grade at a point about 962 feet west of the west switch of the siding. This is a two-lane, undivided concrete highway. The crossing is 20 feet in width. The rails of the crossing are protected on each side by timbers, and the area between the timber is surfaced with bituminous material. (See Figure 1.)

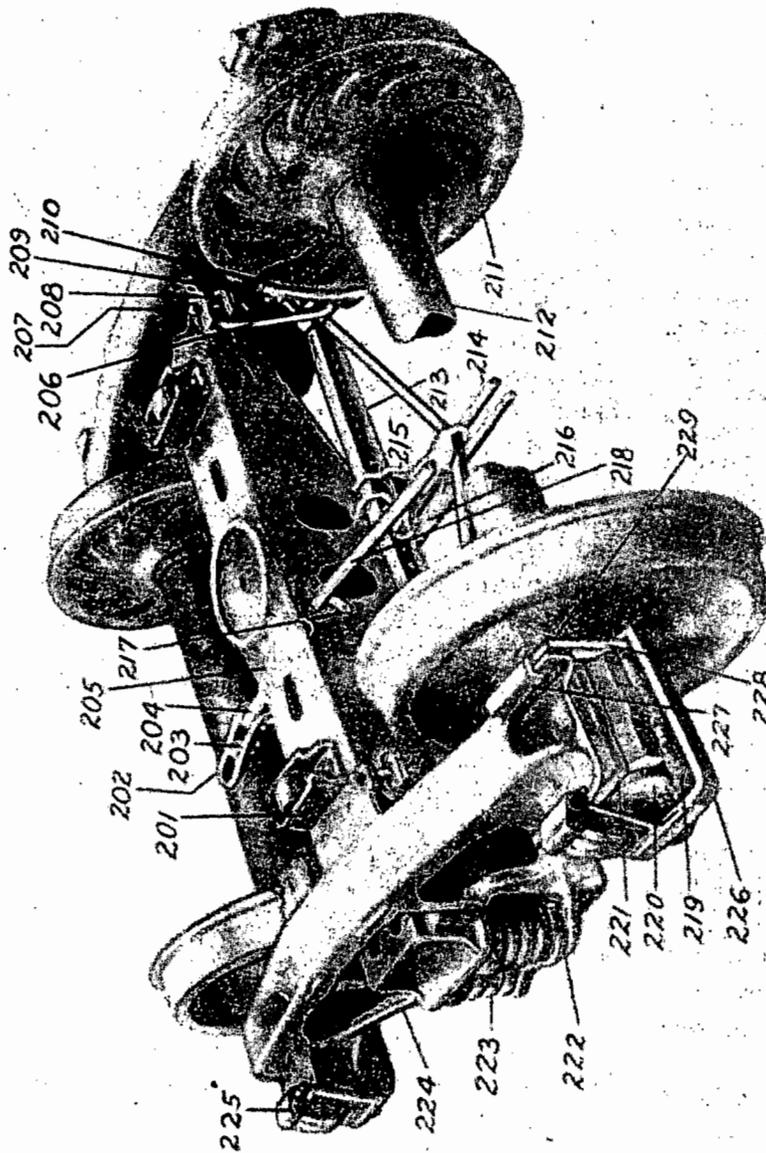
The collar thickness was seven-eighths of an inch. A longitudinal crack began at the fractured face and extended into the body of the journal a distance of 2 inches. Markings on the end of the broken journal indicated that the serial number was 735236, that it was manufactured in April 1952 from steel with a heat number of US4735. The journal on the opposite end of the axle, which would have been at location R-4, measured 5-15/16 inches in diameter by 11-1/8 inches in length.

A.A.R. self-aligning spring plankless double-truss truck.
