RAILROAD ACCIDENT REPORT

SOUTHERN PACIFIC TRANSPORTATION CO.

FREIGHT TRAIN 2ND BSM 22 MUNITIONS EXPLOSION

BENSON, ARIZONA

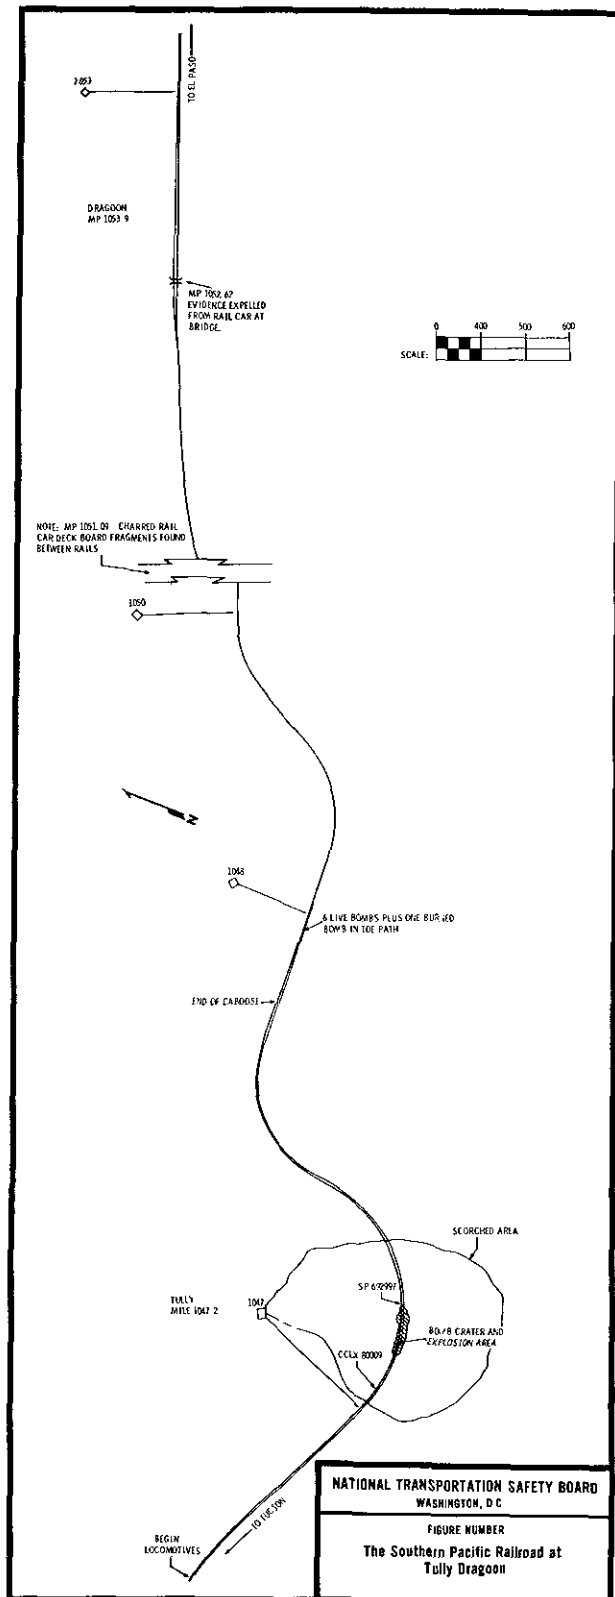
Figure 1. Main Crater Area.

The cars which followed the last car of bombs, containing zinc ash, clays, fiberboard, water heaters, auto tires, and asbestos, were severely damaged, and most of their cargoes spilled onto the right-of-way. The locomotives stopped at MP 1046.7; the caboose stopped at MP 1047.8. (See Figures 1 and 2.)

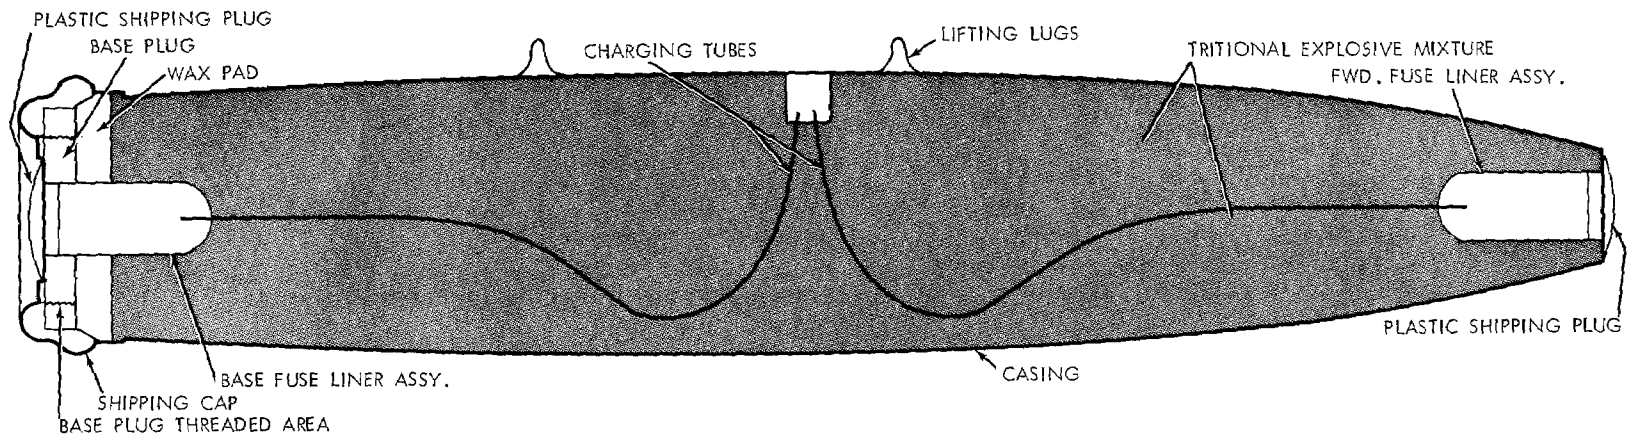
Figure 5. Diagram of MK 82 Bomb.

The MK 82 bombs -- The MK 82 bombs consisted of coated steel casings filled with tritonal (80 percent TNT and 20 percent aluminum powder), fuse wells and charging tubes for arming the bombs, and plastic plugs in each opening. (See Figure 5.) The tritonal was cast in place hot and allowed to partially solidify by ambient air cooling. After the tritonal solidified, its shrinkage required the addition of more tritonal to the base area. This procedure resulted in internal voids in the cast tritonal. Hot wax was poured on top of the tritonal to seal the casting.

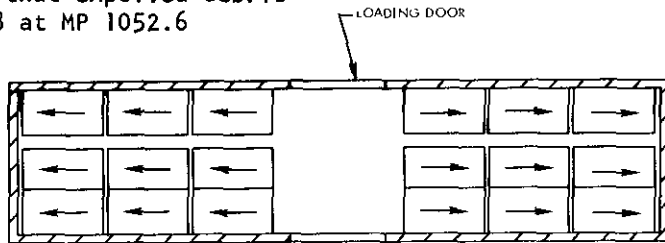
Location of pallet containing first bomb that expelled debris from car 38 at MP 1052.6
