RAILROAD ACCIDENT REPORT

LOUISVILLE & NASHVILLE
RAILROAD COMPANY FREIGHT TRAIN
DERAILMENT AND PUNCTURE OF
ANHYDROUS AMMONIA TANK CARS AT
PENSACOLA, FLORIDA
NOVEMBER 9, 1977

REPORT NUMBER: NTSB-RAR-78-4

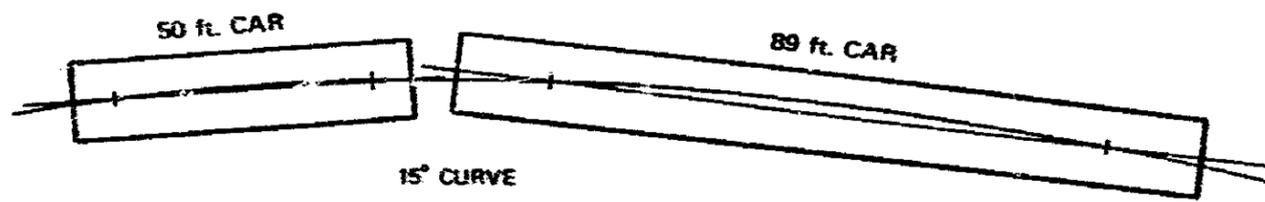
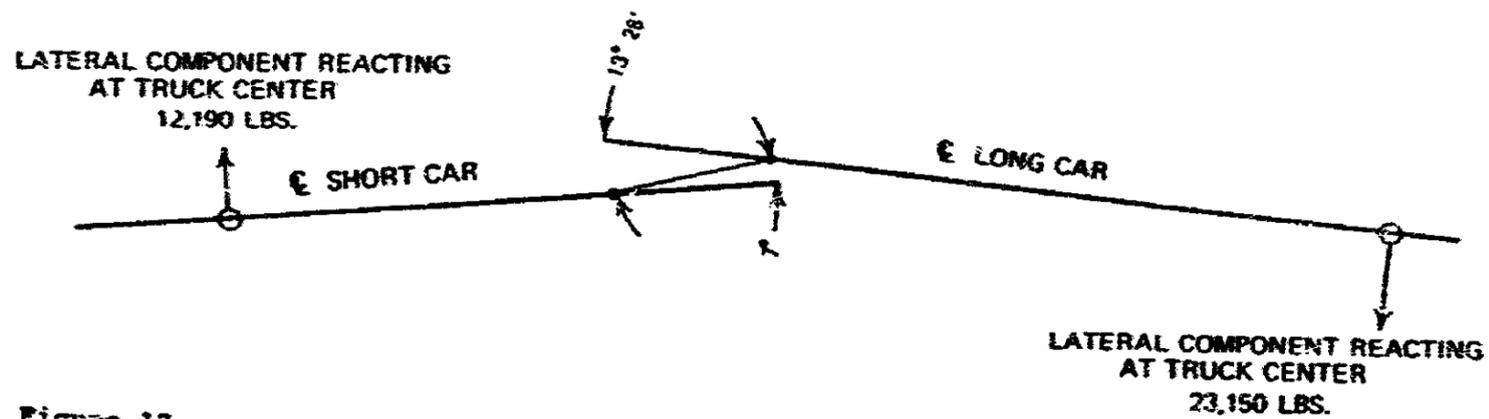
Figure 12.

Figure 12 illustrates the geometry of a long car - short car combination. Note the coupler angularity of the long car. It also illustrates the lateral forces produced by a 100,000 lb. drawbar force. When the coupler angle of the short car is 7 degrees the lateral force is 12,190 lbs. When the coupler angle is 13°28' the lateral force is 23,150 lbs.

Available research data has indicated that the lateral force produced by a drawbar reaction (draft) at a long car (89 ft. in length, having a 43 inch coupler) approaches a maximum when coupled to a short car (50 ft. or less in length, having a 33 inch coupler).

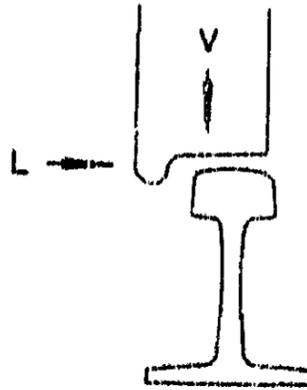
Figure 1. Forces on Rail

The forces expended by trains in starting, stopping, running, and negotiating curves and turnouts are transmitted from the wheel to the rail and can be divided into lateral and vertical components as illustrated in Figure 1.

The consideration of L/V ratios is important in any study of the interaction of wheel and rail in dynamic situations and must be recognized as a "time dependent occurrence" (an occurrence whose importance varies with the elapsed time.) L/V ratios are especially important in predicting track shift, wheel climb, wheel lift, and rail turnover. (See Section 3.2.4 Train Make-Up)

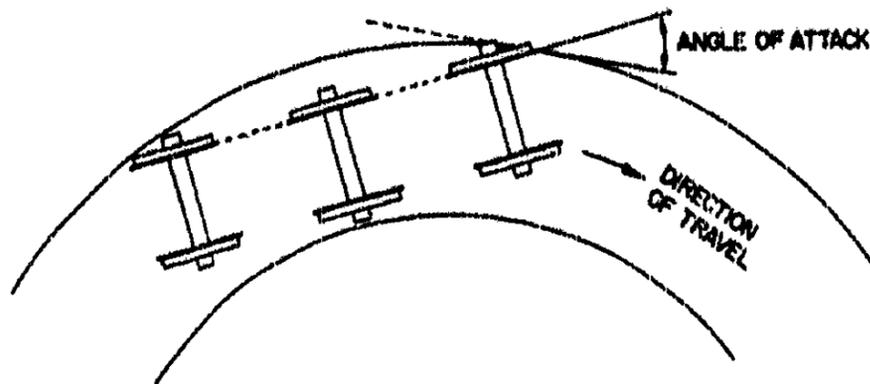
Figure 2. 3-Axle Rigid Frame Locomotive Truck

In the curve negotiation the lead wheel bears against the outside rail of the curve and the trailing wheels are restrained by the inside rail. The angle between the leading outer wheel and the outside rail is referred to as the "angle of attack." Figure 2 illustrates the relative position of a 3-axle rigid frame locomotive truck while traversing a curve.

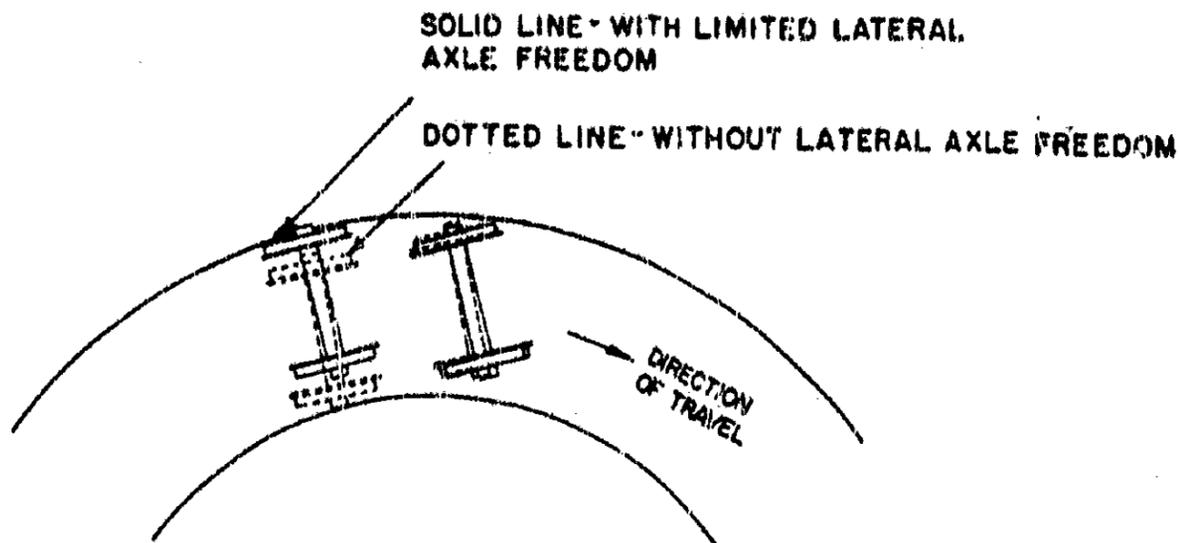
Figure 3. Standard 3-Piece Freight Car Truck.

Figure 3 illustrates the relative position of the wheels and axles of a standard 3-piece freight car truck while traversing a curve with and without the effect of lateral freedom.

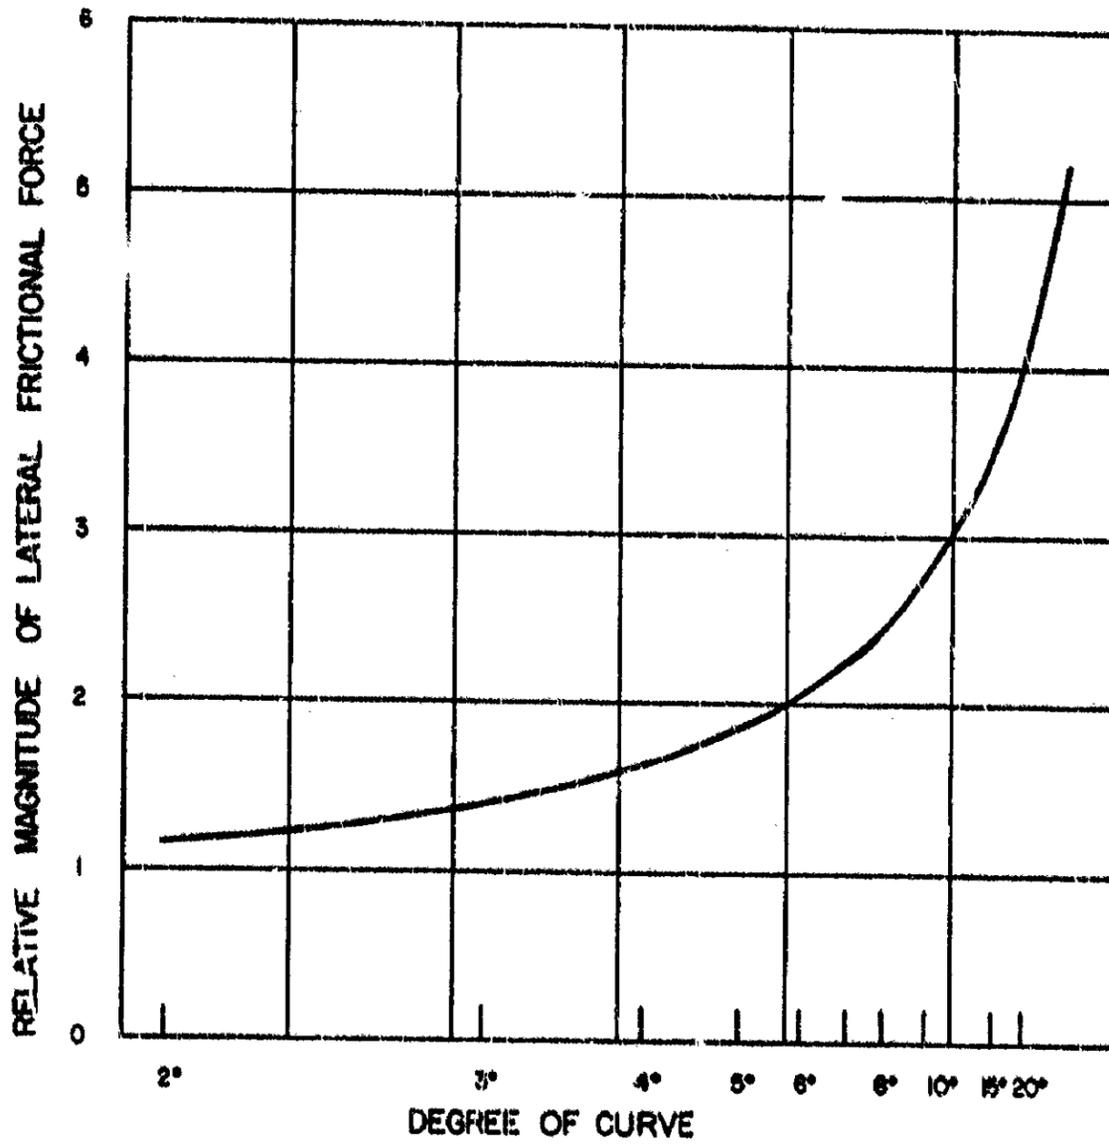
Figure 4. Relationship of Lateral Frictional Forces to Curvature

Wheel to rail frictional forces developed in curve negotiation are in addition to the normal forces generated in train operation and increase sharply as the degree of curvature increases. The relative magnitude of the lateral forces developed is shown in Figure 4.

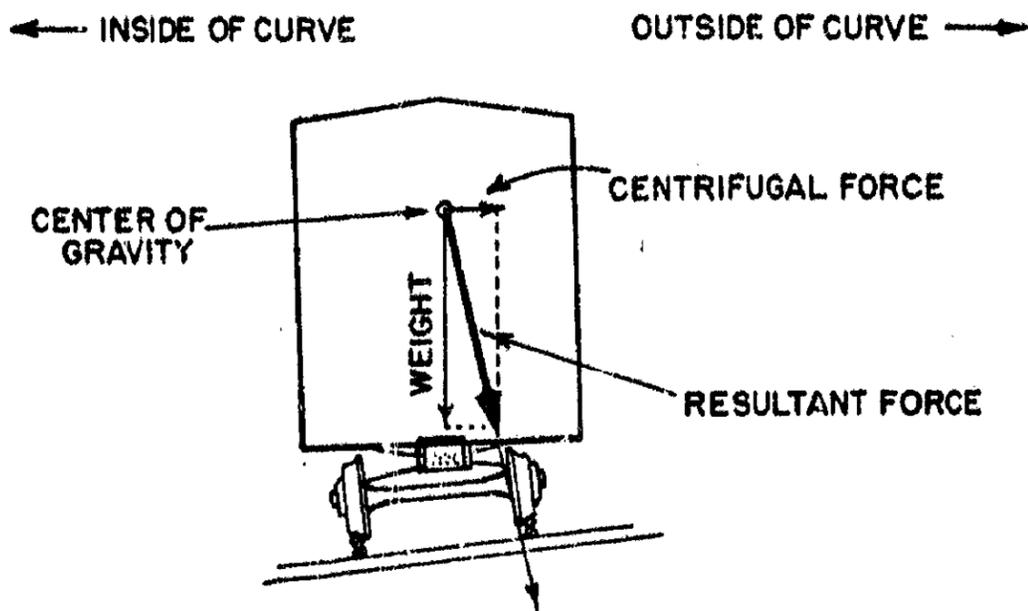
Figure 5. Effects of Centrifugal Force

Trains traveling around curves are also affected by centrifugal force which acts away from the center of the curve and tends to overturn the cars as illustrated in Figure 5. This tendency directs the weight of the train toward the outside rail.

Centrifugal force increases as the square of the speed and increases in direct proportion to the degree of curvature.

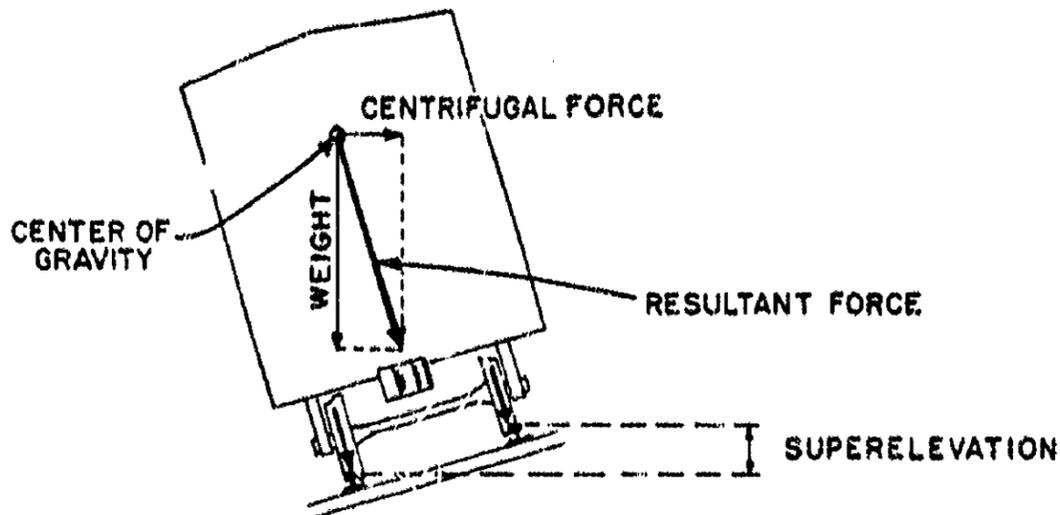
Figure 6. Superelevated Car In Equilibrium

Superelevation is the raising of the outer rail on a curve to permit using the weight (gravitational force) to counteract the effect of centrifugal force. Raising the outer rail moves the effect of the weight force toward the inside rail. Combining the effects of the centrifugal force and weight produces a resultant force as illustrated in Figure 6.

When the direction of the resultant force coincides with the centerline of the equipment and track the curve is described as being balanced and equilibrium speed has been reached. In this condition the vertical forces on each rail are equal and minimal frictional forces are occurring between the wheels and the rail. This permits maximum utilization of tractive effort and minimum wear on wheels and rail. However, trains may operate at all speeds from the maximum allowable to a complete stop on a curve. Also, the consist may have many different types of cars with varying centers of gravity. Therefore, the design of superelevation of a curve and the speeds allowed must be carefully chosen. Insufficient superelevation may allow a car to climb the rail or overturn. However, railway equipment will generally "climb" over the rail due to lateral flange pressure and friction before the car

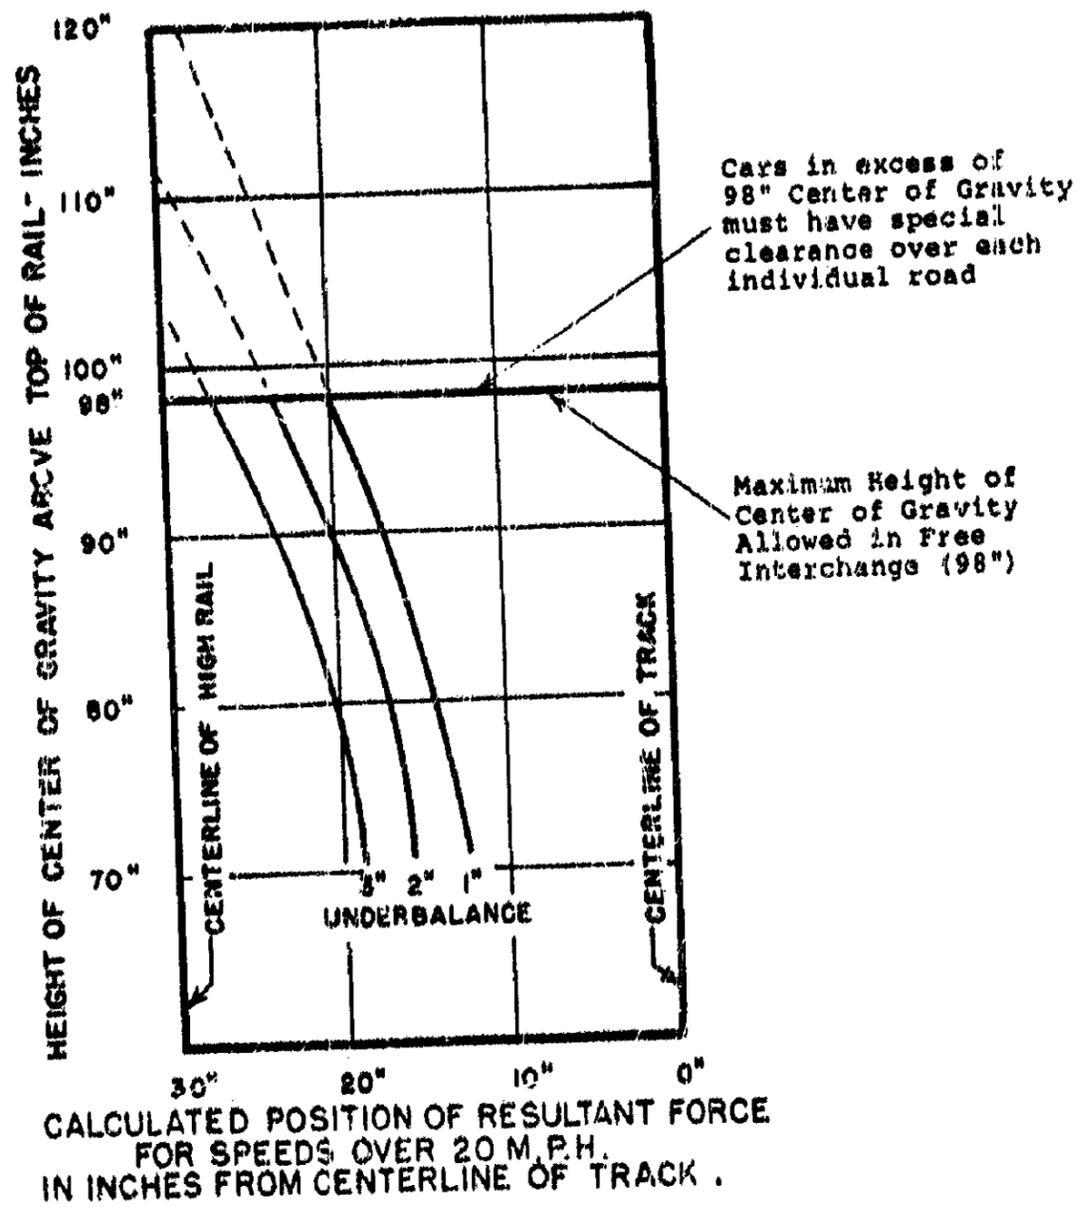
Figure 7. Effect of Unbalanced Superelevations (Underbalanced) on Vehicle Stability

This is illustrated in Figure 7 which shows the approximate position of the dynamic resultant force of freight cars on curved track when traveling at speeds above 20 mph. As the center of gravity increases, less underbalance can be permitted.

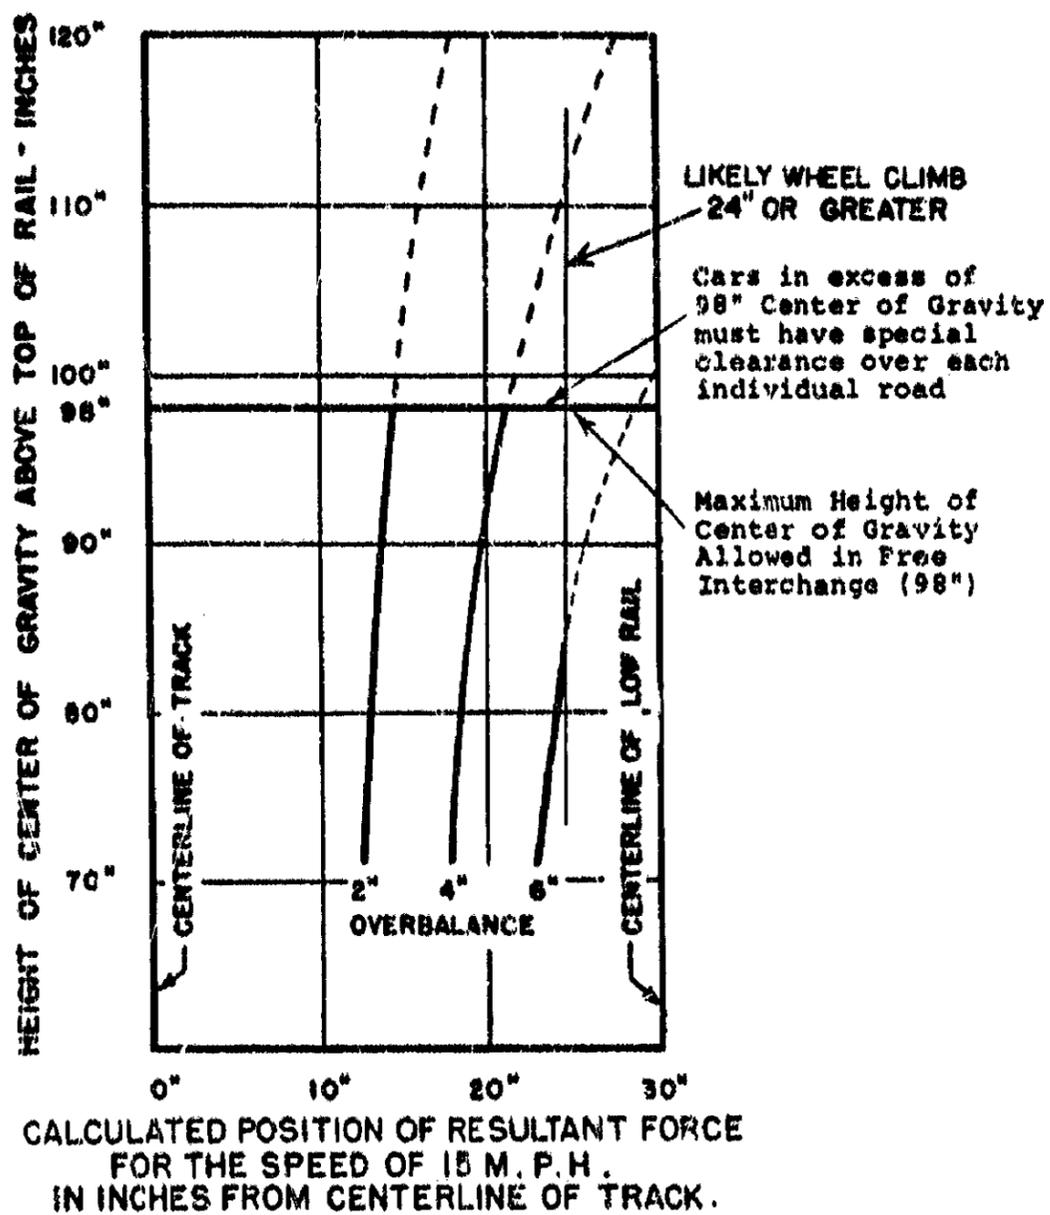
Figure 8. Effect of Unbalanced Superelevations (Overbalanced) on Vehicle Stability

When a train travels at less than the equilibrium speed around a superelevated curve there is an unbalance with the resultant force directed toward the inside or low rail. As more of the weight is carried by the low rail, there is an unloading of the outer or high rail. The extreme condition is for the low rail to carry the entire vertical force and the high rail to be completely unloaded. This is an unstable operating condition which can result in wheels lifting off the rail. Figure 8 illustrates the approximate position of the dynamic resultant force with overbalance to the low rail for a speed of 15 mph.

Figure 8 is based on lateral roll amplitudes running over track with normal irregularities. Equipment with 98 inch high center of gravity will not unload the high rail of well maintained track until the overbalance is slightly in excess of 6 inches. However, the "string line" effect of starting or pulling a drag train combined with overbalance effect may cause unloading of the high rail with less than 6 inches superelevation in the track.
