# NATIONAL TRANSPORTATION SAFETY BOARD

## RAILROAD ACCIDENT REPORT

REAR END COLLISION OF  
CONSOLIDATED RAIL CORPORATION  
FREIGHT TRAINS ALPG-2 AND APJ-2  
NEAR ROYERSFORD, PENNSYLVANIA  
OCTOBER 1, 1979

NTSB-RAR-80-2

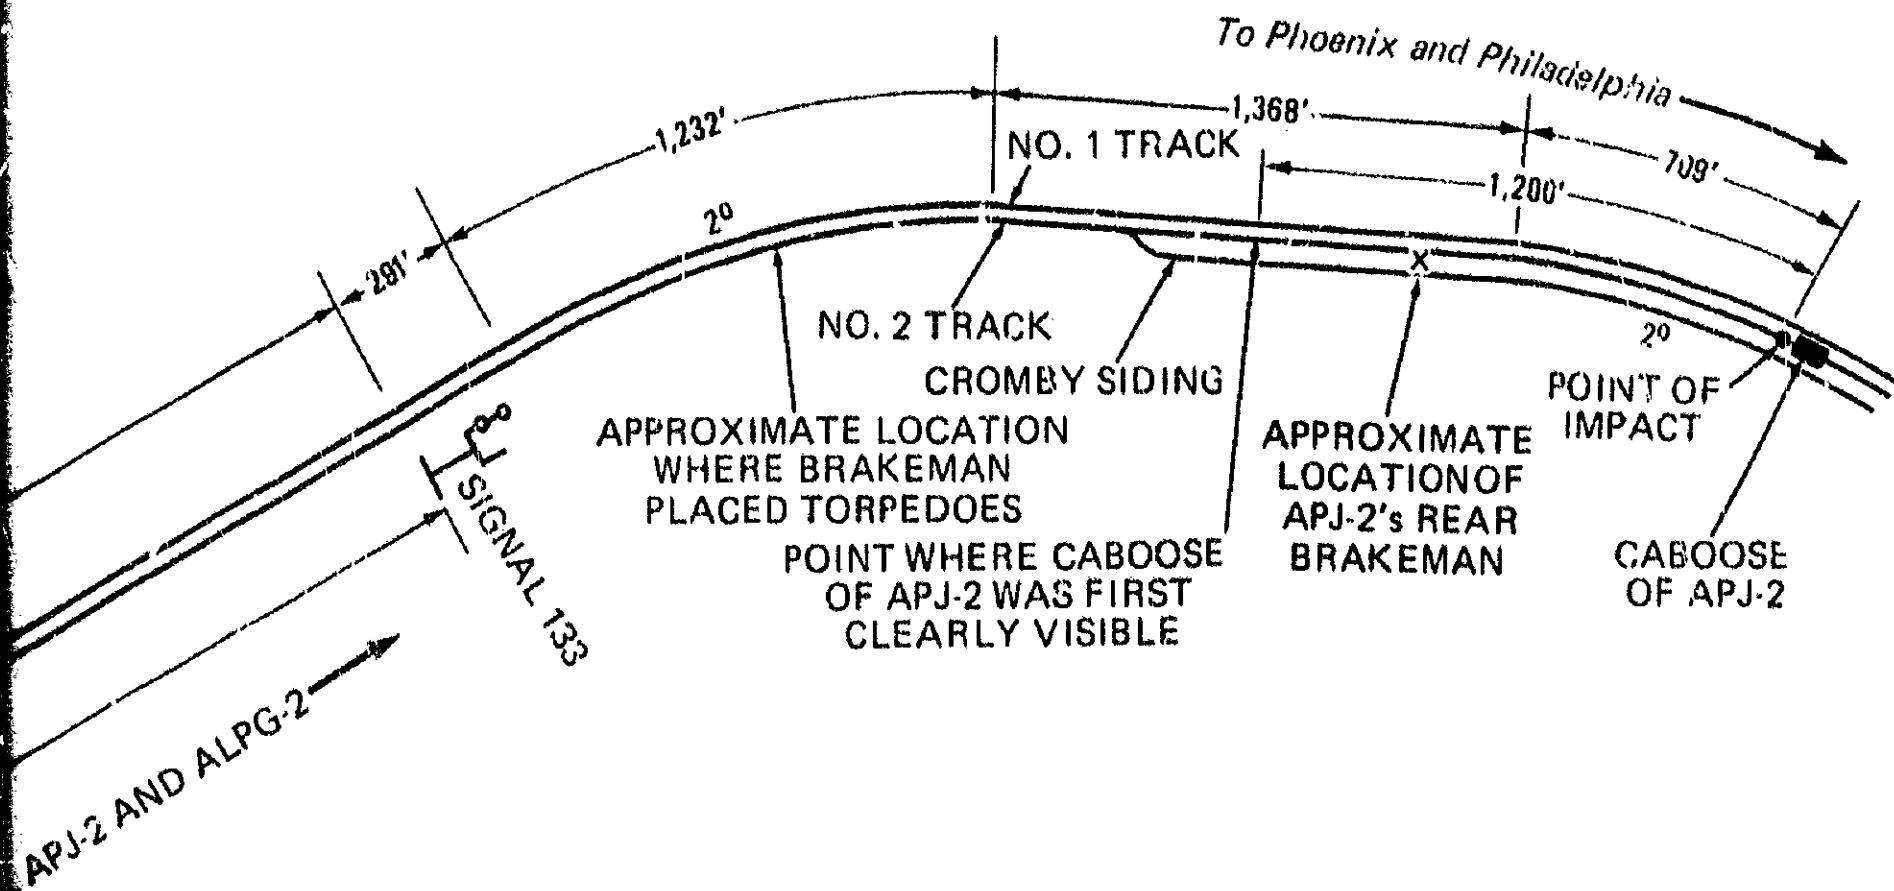
**of accident location and approach from signal 131-B**

At about 5:14 a.m., ALPG-2 passed signal 131-B at Royersford station, 8.6 miles east of Colebrookdale Junction and about 1.9 miles west of the standing caboose of train APJ-2. A signal maintainer observed signal 131-B continuously display an "approach"

aspect 4/ as ALPG-2 approached it. He stated that the train was running under power, without evidence of braking, at a speed he considered too high for the train to stop short of signal 133, 1.2 miles eastward. He also observed that ALPG-2 failed to whistle, as required, for the Main Street and Arch Street crossings east of Royersford station. Although the signal maintainer had a radio, he did not try to communicate with ALPG-2.

back from signal 131-B

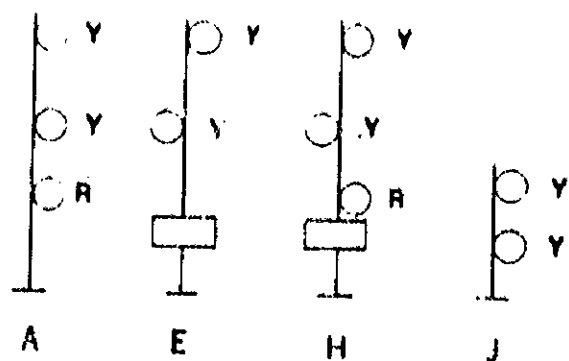
RULE 282A

Name Advance approach.

Indication. Proceed prepared to stop at second signal.

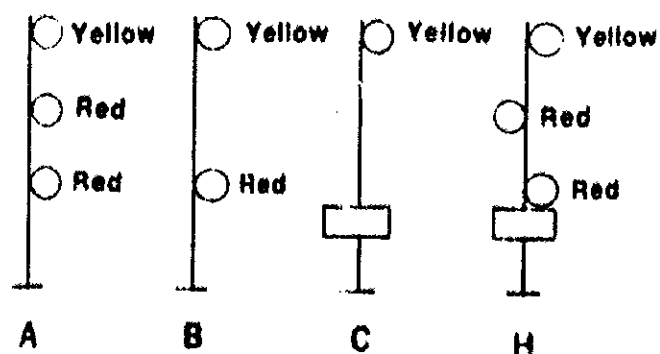
RULE 285

Name Approach.

Indication: Proceed prepared to stop at next signal. Train exceeding medium speed must at once reduce to that speed. If the next signal in advance is seen to indicate "Clear", normal speed may be resumed unless otherwise restricted.

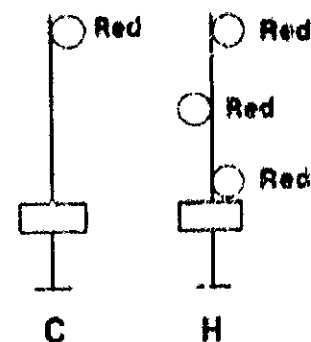
RULE 291

Name: Stop and Proceed.

Indication Stop; then proceed at restricted speed
