NATIONAL TRANSPORTATION SAFETY BOARD

RAILROAD ACCIDENT REPORT

DERAILMENT OF AMTRAK TRAIN NO. 4
THE SOUTHWEST LIMITED
ON THE ATCHISON, TOPEKA
AND SANTA FE RAILWAY COMPANY
LAWRENCE, KANSAS
OCTOBER 2, 1979

NYSB-RAR-80-4

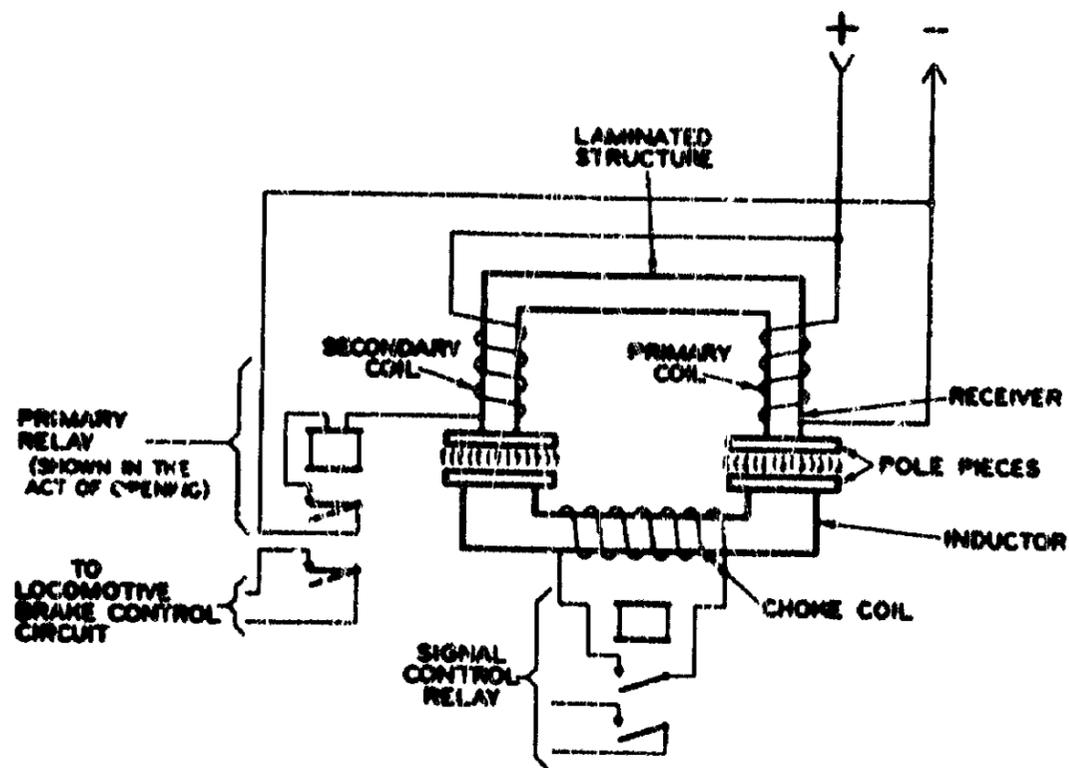
Figure 5. Principle of inductive control, wayside to train.

The method of transmitting control from the wayside to the moving locomotive is shown in simplified form in Figure 5. The circuits on the locomotive are controlled through a normally-energized primary relay; if the primary relay is deenergized for more than 4 seconds, a penalty brake application occurs unless the acknowledging button (not shown) is in its actuated position. The primary relay is energized through its own front contact and the secondary coil wound on the receiver core structure.

Since the system must distinguish between restrictive and nonrestrictive conditions, provision is made for controlling the effect of the inductor on the receiver in accordance with signal indications. This is done by the choke coil (sometimes called "control" coil) wound on the inductor core, as shown in Figure 5. When the signal is restrictive, the

signal control relay is down, leaving the choke coil open-circuited. Under this condition no current can flow in the coil, and the inductor produces a flux surge in the receiver to drop the primary relay. But if the signal is clear, the signal control relay is up, and the choke coil circuit is closed through a front contact on the signal control relay. Now, when the receiver passed over the inductor and the flux starts to build up in the receiver inductor magnetic circuit, the voltage induced in the choke coil causes a current to flow through the coil. According to the laws of induced currents, the magnetic flux produced by this current opposes the magnetic flux which causes the current. As a result, the net change in flux is much less than the change which occurs when the choke coil is open-circuited, and the bucking voltage, which appears in the secondary coil, is much smaller. Curve A-F-C-G-E, Figure 6, shows the current variation in the primary relay under these conditions. The current does not go below the dropaway value at any point, so that the primary relay remains energized while the receiver passes over the inductor.

Note that the transmission of control between inductor and receiver requires no energy in the inductor winding. Whether or not a locomotive receives a train control pulse depends only on the inductor choke coil circuit. If this circuit is open, the primary relay releases when the receiver passes; if the circuit is closed, the primary relay remains energized.

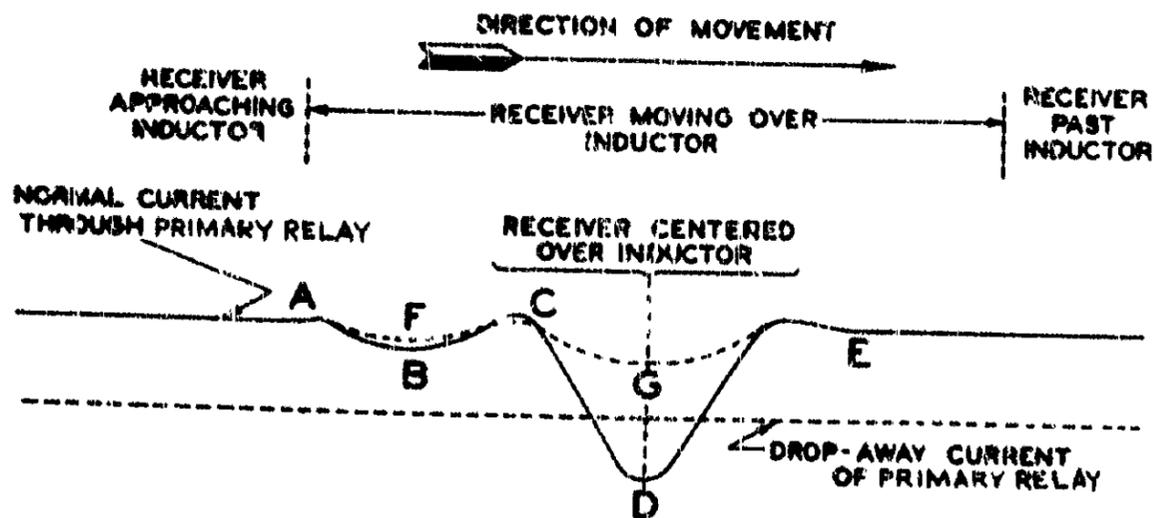
Figure 6. Current through primary relay.

Curve A-B-C-D-E, Figure 6, shows the effect this induced voltage would have on the current passing through the primary relay if it were not a stick relay. Starting with the normal current at point A, the bucking voltage causes the relay current to drop to a minimum at D. Then, as the receiver moves away from the inductor, the current rises again to its normal value. (The small fluctuations on the current curve before and after the main current dip are caused by minor flux variations as the receiver approaches and leaves the inductor, and have no effect on the over-all operation of the system.)

In actual practice, of course, this complete curve would not occur, because the primary relay would drop as soon as the current became less than the drop-away current shown in Figure 6, and would then remain down because of the opening of the stick circuit.
