RAILROAD ACCIDENT REPORT

**REAR-END COLLISION OF
CONRAIL COMMUTER TRAINS
PHILADELPHIA, PENNSYLVANIA**

OCTOBER 16, 1979

NTSB-RAR-80-5

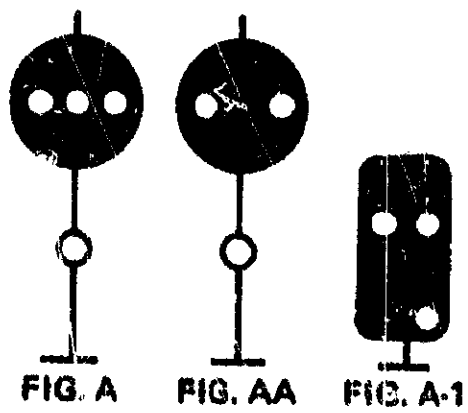
Aspect Displayed by Signal B-42

INDICATION--Stop; then proceed at Restricted speed.

NAME: Stop and proceed.

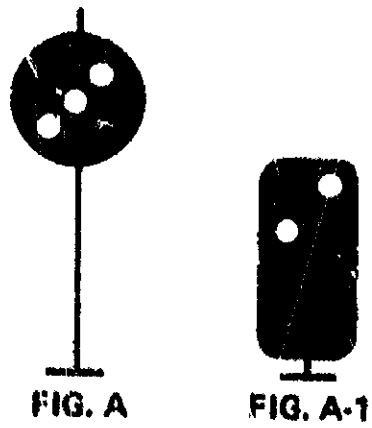
Aspect Displayed by Signal B-56

INDICATION-- Proceed prepared to stop at next signal. Train exceeding Medium speed must at once reduce to that speed.
