# NATIONAL TRANSPORTATION SAFETY BOARD

## RAILROAD ACCIDENT REPORT

ILLINOIS CENTRAL GULF  
RAILROAD COMPANY  
FREIGHT TRAIN DERAILMENT  
HAZARDOUS MATERIAL RELEASE  
AND EVACUATION  
MULDRAUGH, KENTUCKY  
JULY 26, 1980

NTSB-RAR-81-1

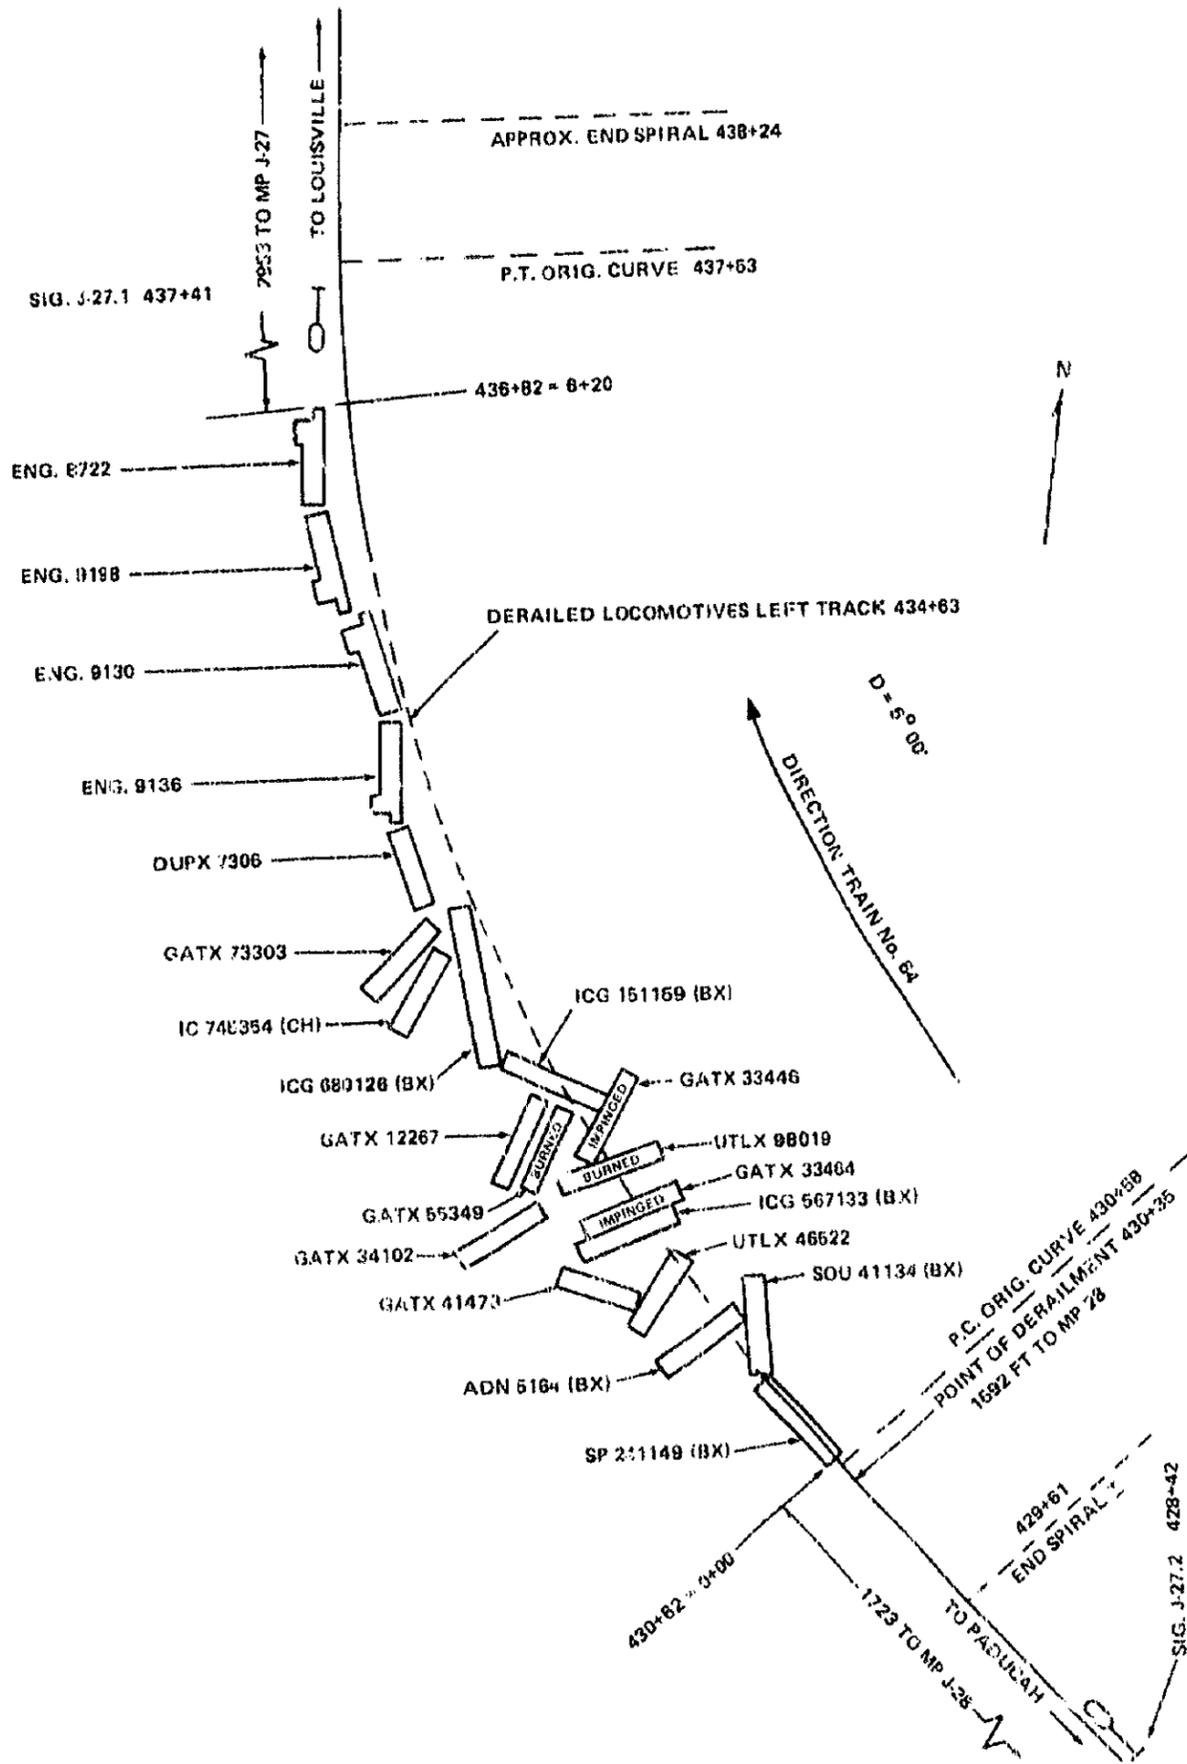
Figure 1.—Plan View of Accident

The following 17 cars were derailed. (See figure 1.) Seven were tank cars containing hazardous materials. Six of the tank cars carried vinyl chloride and one contained chlorine. Both vinyl chloride and chlorine produce toxic fumes when released to the atmosphere. Two of the tank cars of vinyl chloride were breached. The pressurized compressed gas escaped and formed a gas cloud around the derailed equipment.
