## **RAILROAD ACCIDENT REPORT**

**REAR END COLLISION OF  
LOUISVILLE & NASHVILLE RAILROAD COMPANY  
TRAINS NO. 586 AND EXTRA 8072 NORTH  
NEW JOHNSONVILLE, TENNESSEE  
DECEMBER 28, 1981**

**NTSB-RAR-82-4**

**Adopted: August 23, 1982**

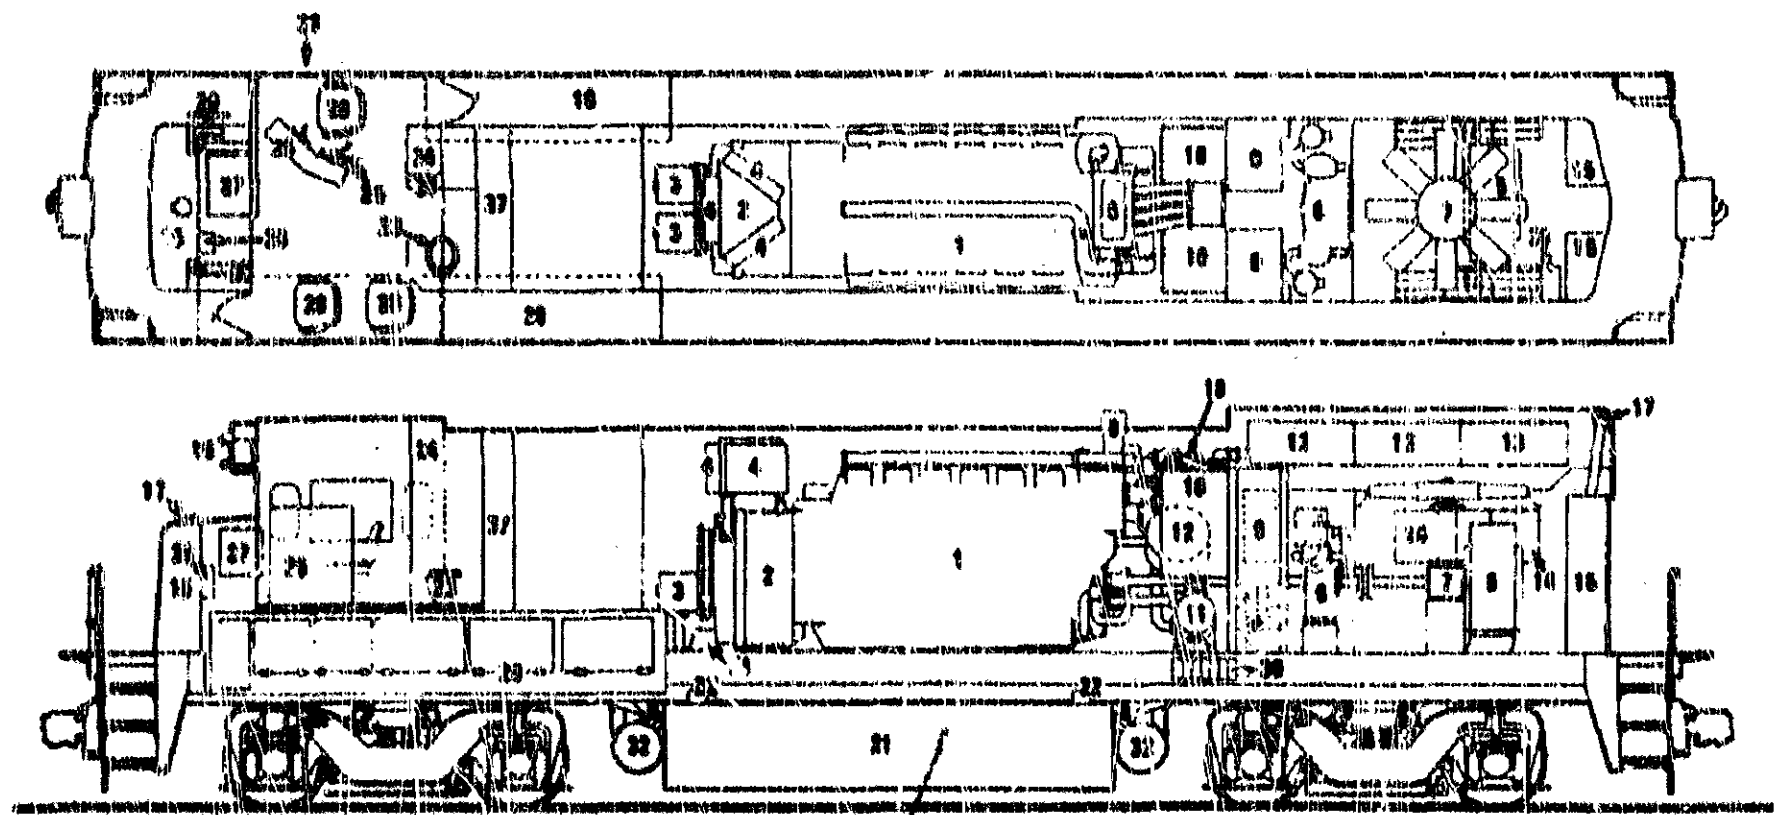
Figure 4.--Floor plan and characteristics of B23-7 locomotive unit.

Safety Board investigators inspected a locomotive operating compartment similar in design to that of the lead unit of No. 586. The engineer's seat is a floor-mounted swivel chair with no arm rests, which is adjustable fore and aft. The seat that the Safety Board investigators inspected was hard to turn, and they were told that the resistance to turning was typical of most seats at the control stand. The chair is close to the control stand with little side clearance between the chair and the control stand. The door behind the control stand is narrow and low. The walkway along the long hood of the locomotive unit is narrow and passage is severely restricted in the vicinity of the engine air intake because the hood is wide at that point to accommodate the air intake shutters and filters. The forward windows of the locomotive operating compartment are low, relative to the ceiling, and a man 5 feet tall or taller standing upright would have his line of sight restricted beyond about 100 feet ahead of the locomotive. (See figure 4.)
