NATIONAL TRANSPORTATION SAFETY BOARD

RAILROAD ACCIDENT REPORT

**DERAILMENT OF
WASHINGTON METROPOLITAN AREA
TRANSIT AUTHORITY
TRAIN NO. 410
AT SMITHSONIAN INTERLOCKING
JANUARY 13, 1982**

NTSB-RAR-82-6

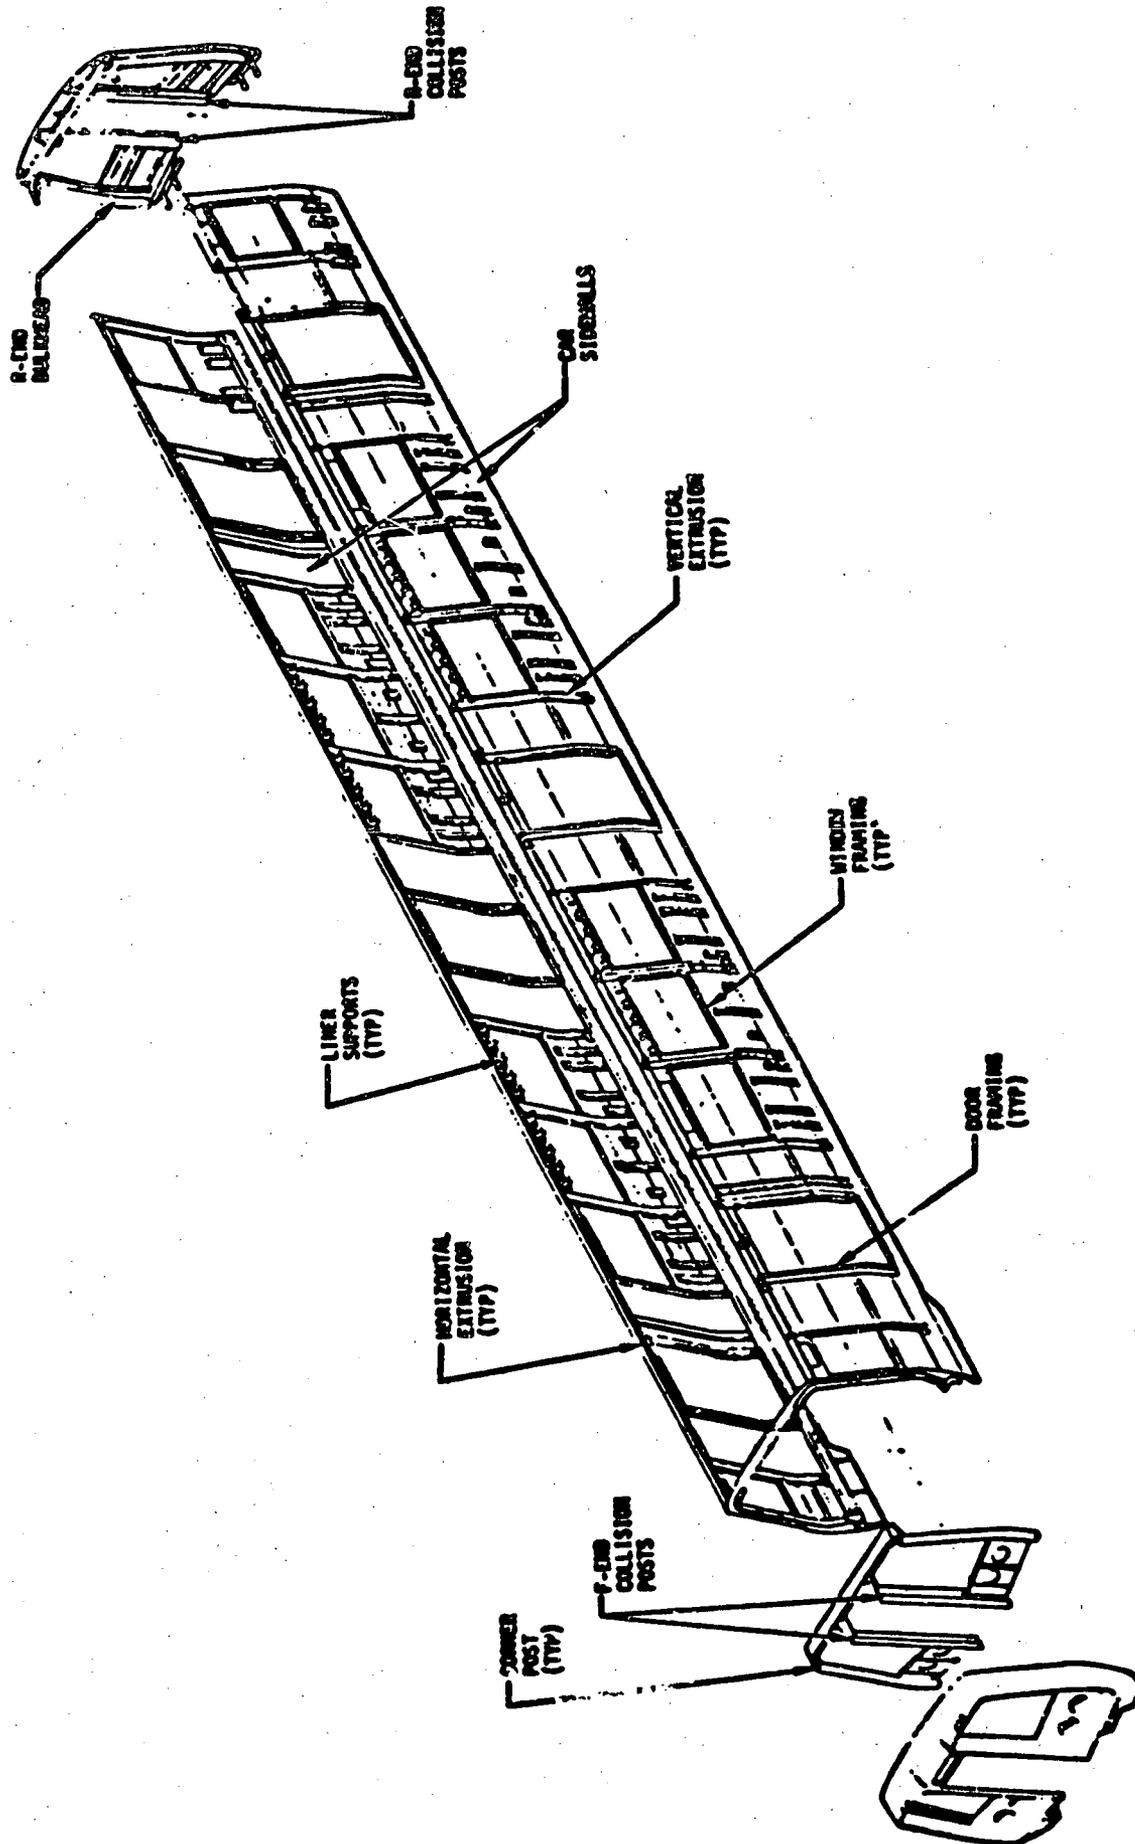
Figure 10.—Carbody structure of typical WMATA rapid transit car.

The vertical carside struts are aluminum extrusions riveted to the roof and lower sidewall extrusions on each side of the side doors and the windows. There are two vertical collision posts on each end of the cars that also serve as the frames for the end doors. The posts are butt-welded to the end sills and have a maximum horizontal buff force resistance of 200,000 pounds. (See figure 10.)

WMATA accepted its cars on the basis of the manufacturer's May 1974 report of carbody compression and vertical load tests which was approved by the equipment consultant. No side impact crashworthiness tests were performed. According to WMATA, the state-of-the-art of rapid transit car design and testing at that time primarily addressed the forces that act on the end of a car.

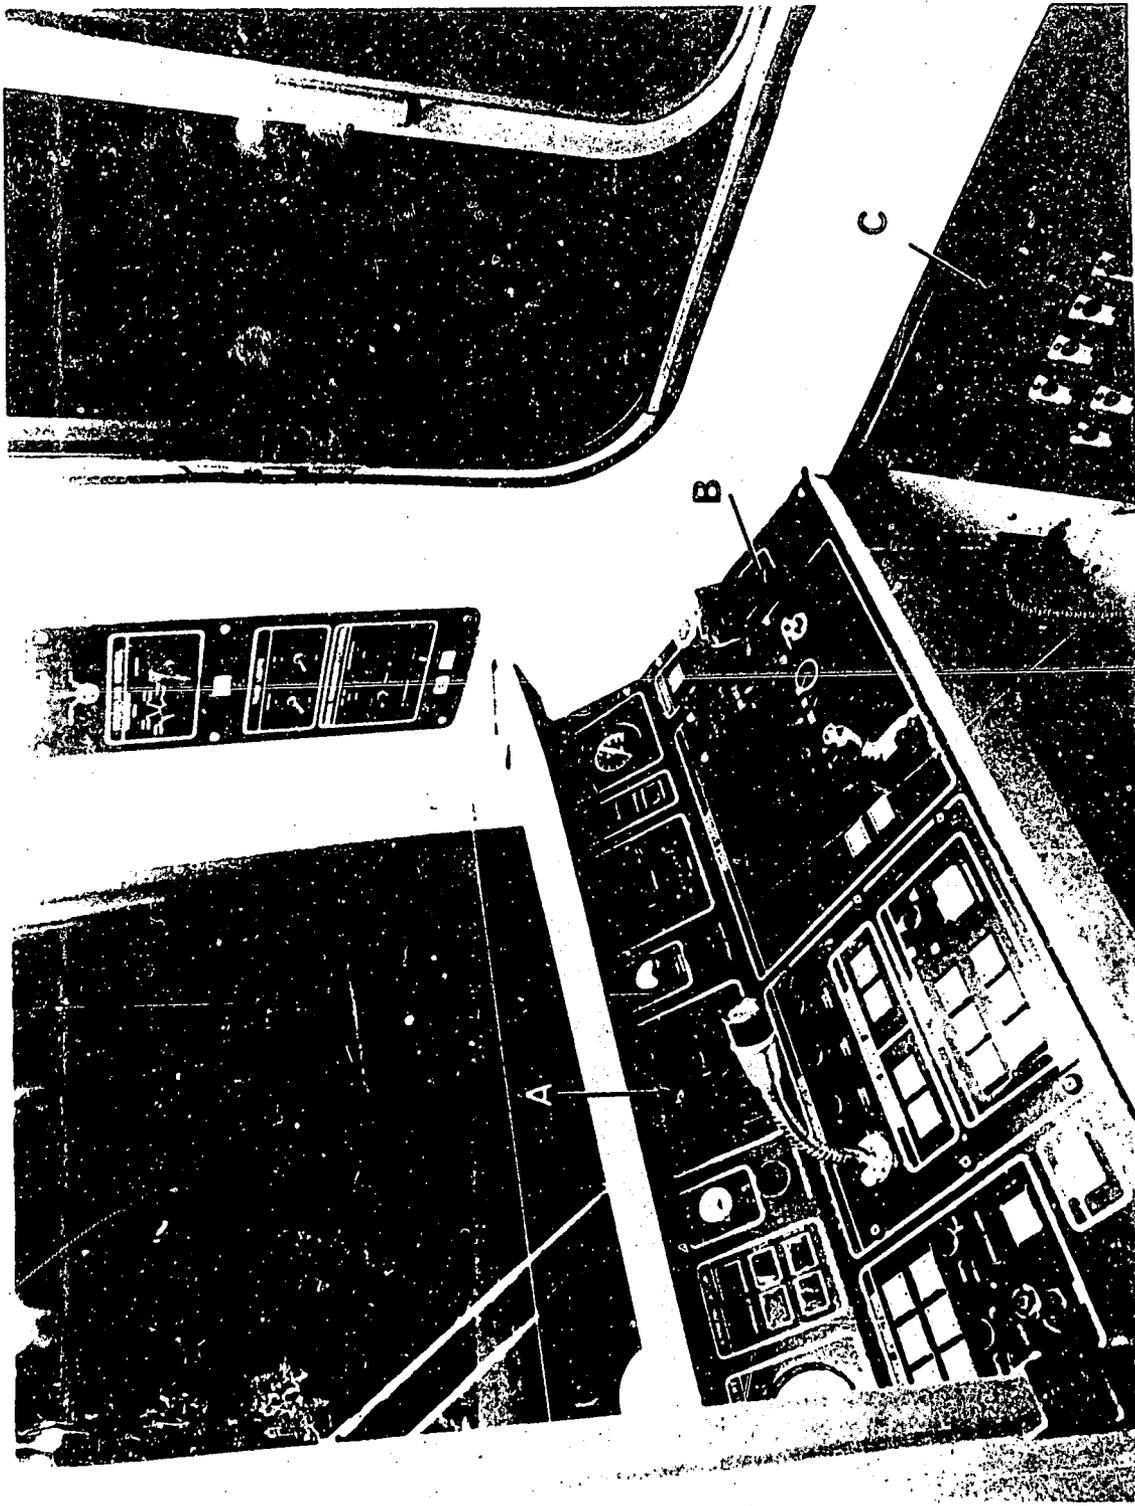
Figure 11.--Operator's compartment of WMATA car No. 1029. Control console and front window at left, circuit breaker panel at lower right, and auxiliary control panel at upper center. (A) is speed panel, (B) is master controller handle, (C) is ATP cut-out switch.

The operating console consists of two panels. (See figure 11.) In the center of the upper panel, three speed indications are displayed in lighted, digital form. These three speeds are the limiting speed, or speed command established by the ATP system, in red; the regulating speed, or desired speed established by the ATP or the ATS system, in yellow; and the actual train speed, in white. There are also train control information lights that indicate what operating mode is in use. A red "ATP cutout" light is illuminated when the ATP system is cut out and there is no overspeed protection. There is also a red light that illuminates when the ATS regulated speed indication is "invalid" or "missing," as well as an audible overspeed alarm which sounds when actual speed exceeds the regulated ATP speed in manual operation.

The lower portion of the control console contains the energizing key switch, the ATC stop and start buttons, the red "mushroom" emergency braking button, a communications control panel with adjustable microphone, the mode selector switch, and the master controller for control of propulsion and braking. A "deadman" switch is incorporated into the main handle which, if it is released, causes the brakes to apply in emergency.

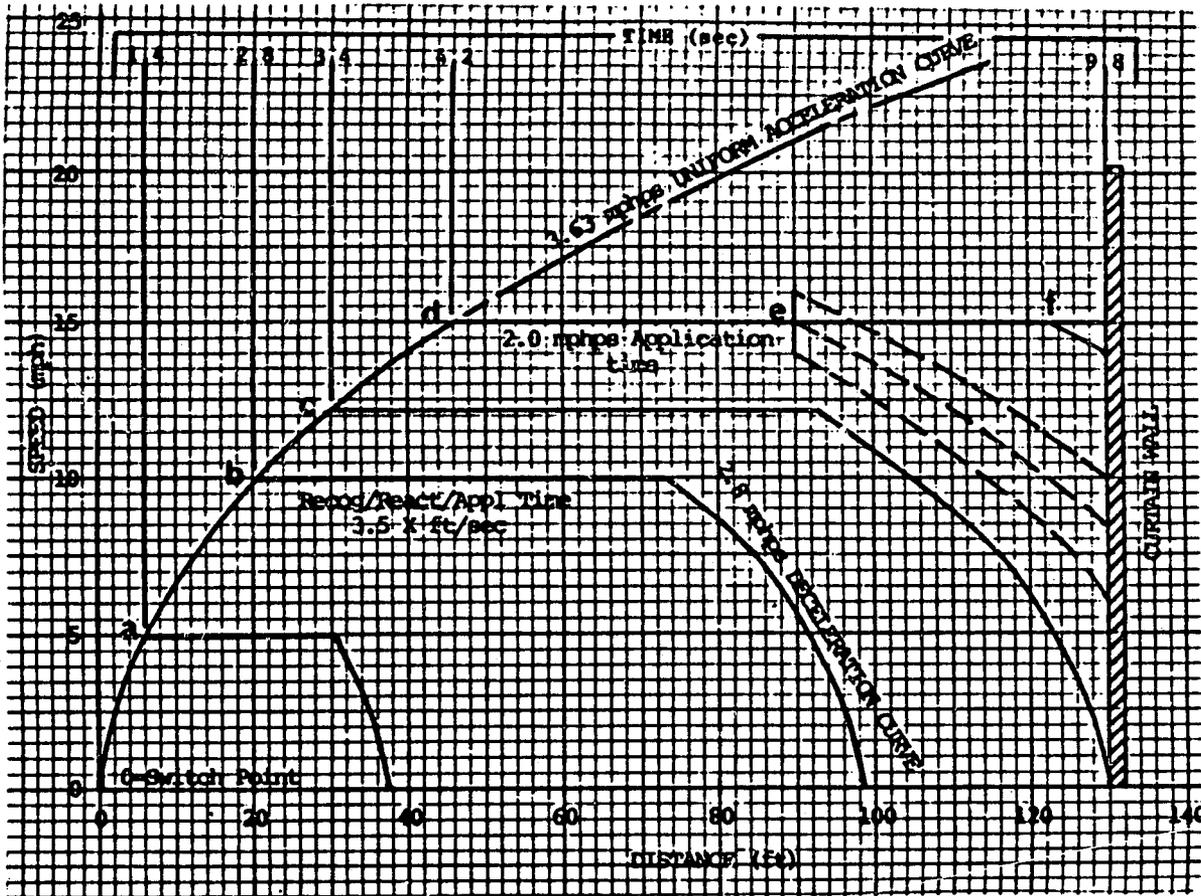
The operator was located behind the derailed truck and should have noticed the jolt caused by the lead wheel rims dropping off the rails. There should have been a second, even more noticeable, jolt when the rear wheels came off the rails. It is questionable as to whether or not the operator would have recognized these events as constituting an emergency. However, when the lead wheels began riding on the rail fasteners, there should have been no doubt that the car was derailed. At the time, the speed of the train would have not exceeded 12 mph. Had the operator immediately reacted and pushed the emergency "mushroom" button, the train would have stopped before car No. 1029 struck the barrier wall. (See figure 15.) However, the only thing the operator had been taught that related to the situation was that he should never use the "mushroom" except in what he perceived to be a real emergency.

Corrected for 1.9 percent negative curve.

- (a) Stopping distance from 5 miles per hour.
- (b) Stopping distance from 10 miles per hour.
- (c) Approximate location where first discernible effect of derailment occurred and last point where an emergency brake application would have stopped train short of the wall.
- (d) Approximate location where overspeed device would have cut off propulsion power.
- (e) Braking curves for 14, 15, and 16 miles per hour.
- (f) Operator-initiated stop from 15 miles per hour.
