RAILROAD ACCIDENT REPORT

ILLINOIS CENTRAL GULF RAILROAD COMPANY
FREIGHT TRAIN DERAILMENT
FORT KNOX, KENTUCKY
MARCH 22, 1983

NTSB/RAR-83/07

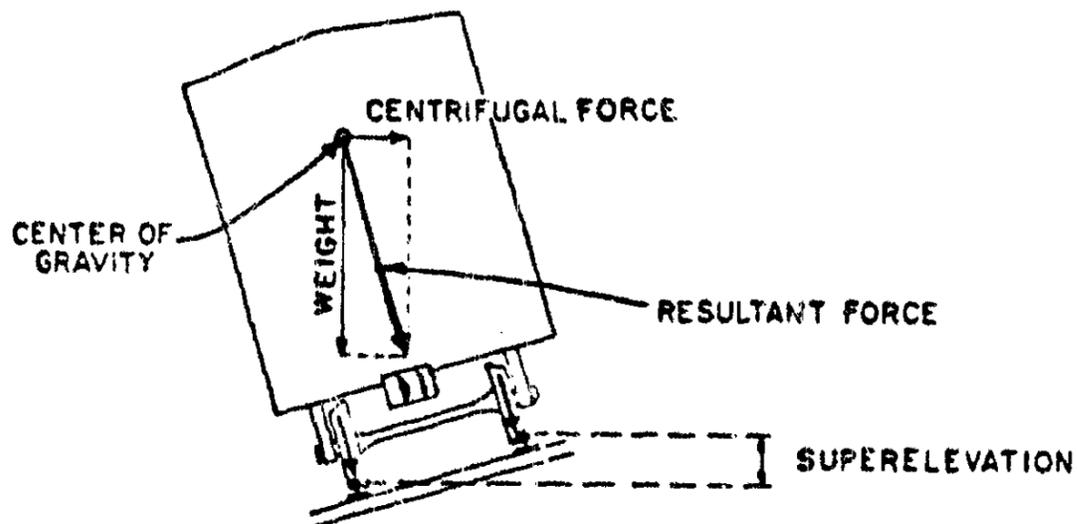
Figure 6. Superelevated Car In Equilibrium

Superelevation is the raising of the outer rail on a curve to permit using the weight (gravitational force) to counteract the effect of centrifugal force. Raising the outer rail moves the effect of the weight force toward the inside rail. Combining the effects of the centrifugal force and weight produces a resultant force as illustrated in Figure 6.

When the direction of the resultant force coincides with the centerline of the equipment and track the curve is described as being balanced and equilibrium speed has been reached. In this condition the vertical forces on each rail are equal and minimal frictional forces are occurring between the wheels and the rail. This permits maximum utilization of tractive effort and minimum wear on wheels and rail. However, trains may operate at all speeds from the maximum allowable to a complete stop on a curve. Also, the consist may have many different types of cars with varying centers of gravity. Therefore, the design of superelevation of a curve and the speeds allowed must be carefully chosen. Insufficient superelevation may allow a car to climb the rail or overturn. However, railway equipment will generally "climb" over the rail due to lateral flange pressure and friction before the car

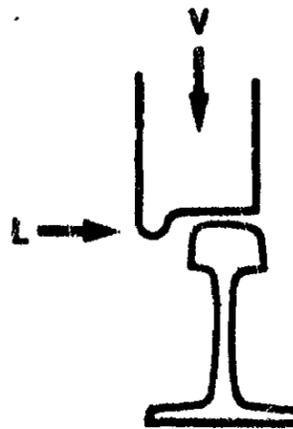
Figure 4-15
Forces on Rail

Although it is necessary that the lateral and vertical forces, acting separately, be absorbed and restrained by the track structure, the effect of these two types of forces acting simultaneously, as illustrated in Figure 4-15, must be recognized.

Failure of some form may occur if the L/V ratio exceeds certain critical values. The ratio will increase if the lateral force increases and the vertical force remains constant, or if the vertical force decreases and the lateral force remains constant. High lateral forces are usually accompanied by high vertical loads which keep L/V ratios below critical levels. The highest L/V ratios most often occur because of a sudden reduction in vertical load.
