RAILROAD ACCIDENT REPORT

REAR END COLLISION
OF SEABOARD SYSTEM RAILROAD
FREIGHT TRAINS EXTRA 8051 NORTH
AND EXTRA 1751 NORTH
SULLIVAN, INDIANA
SEPTEMBER 14, 1983

NTSD/RAR-84/02

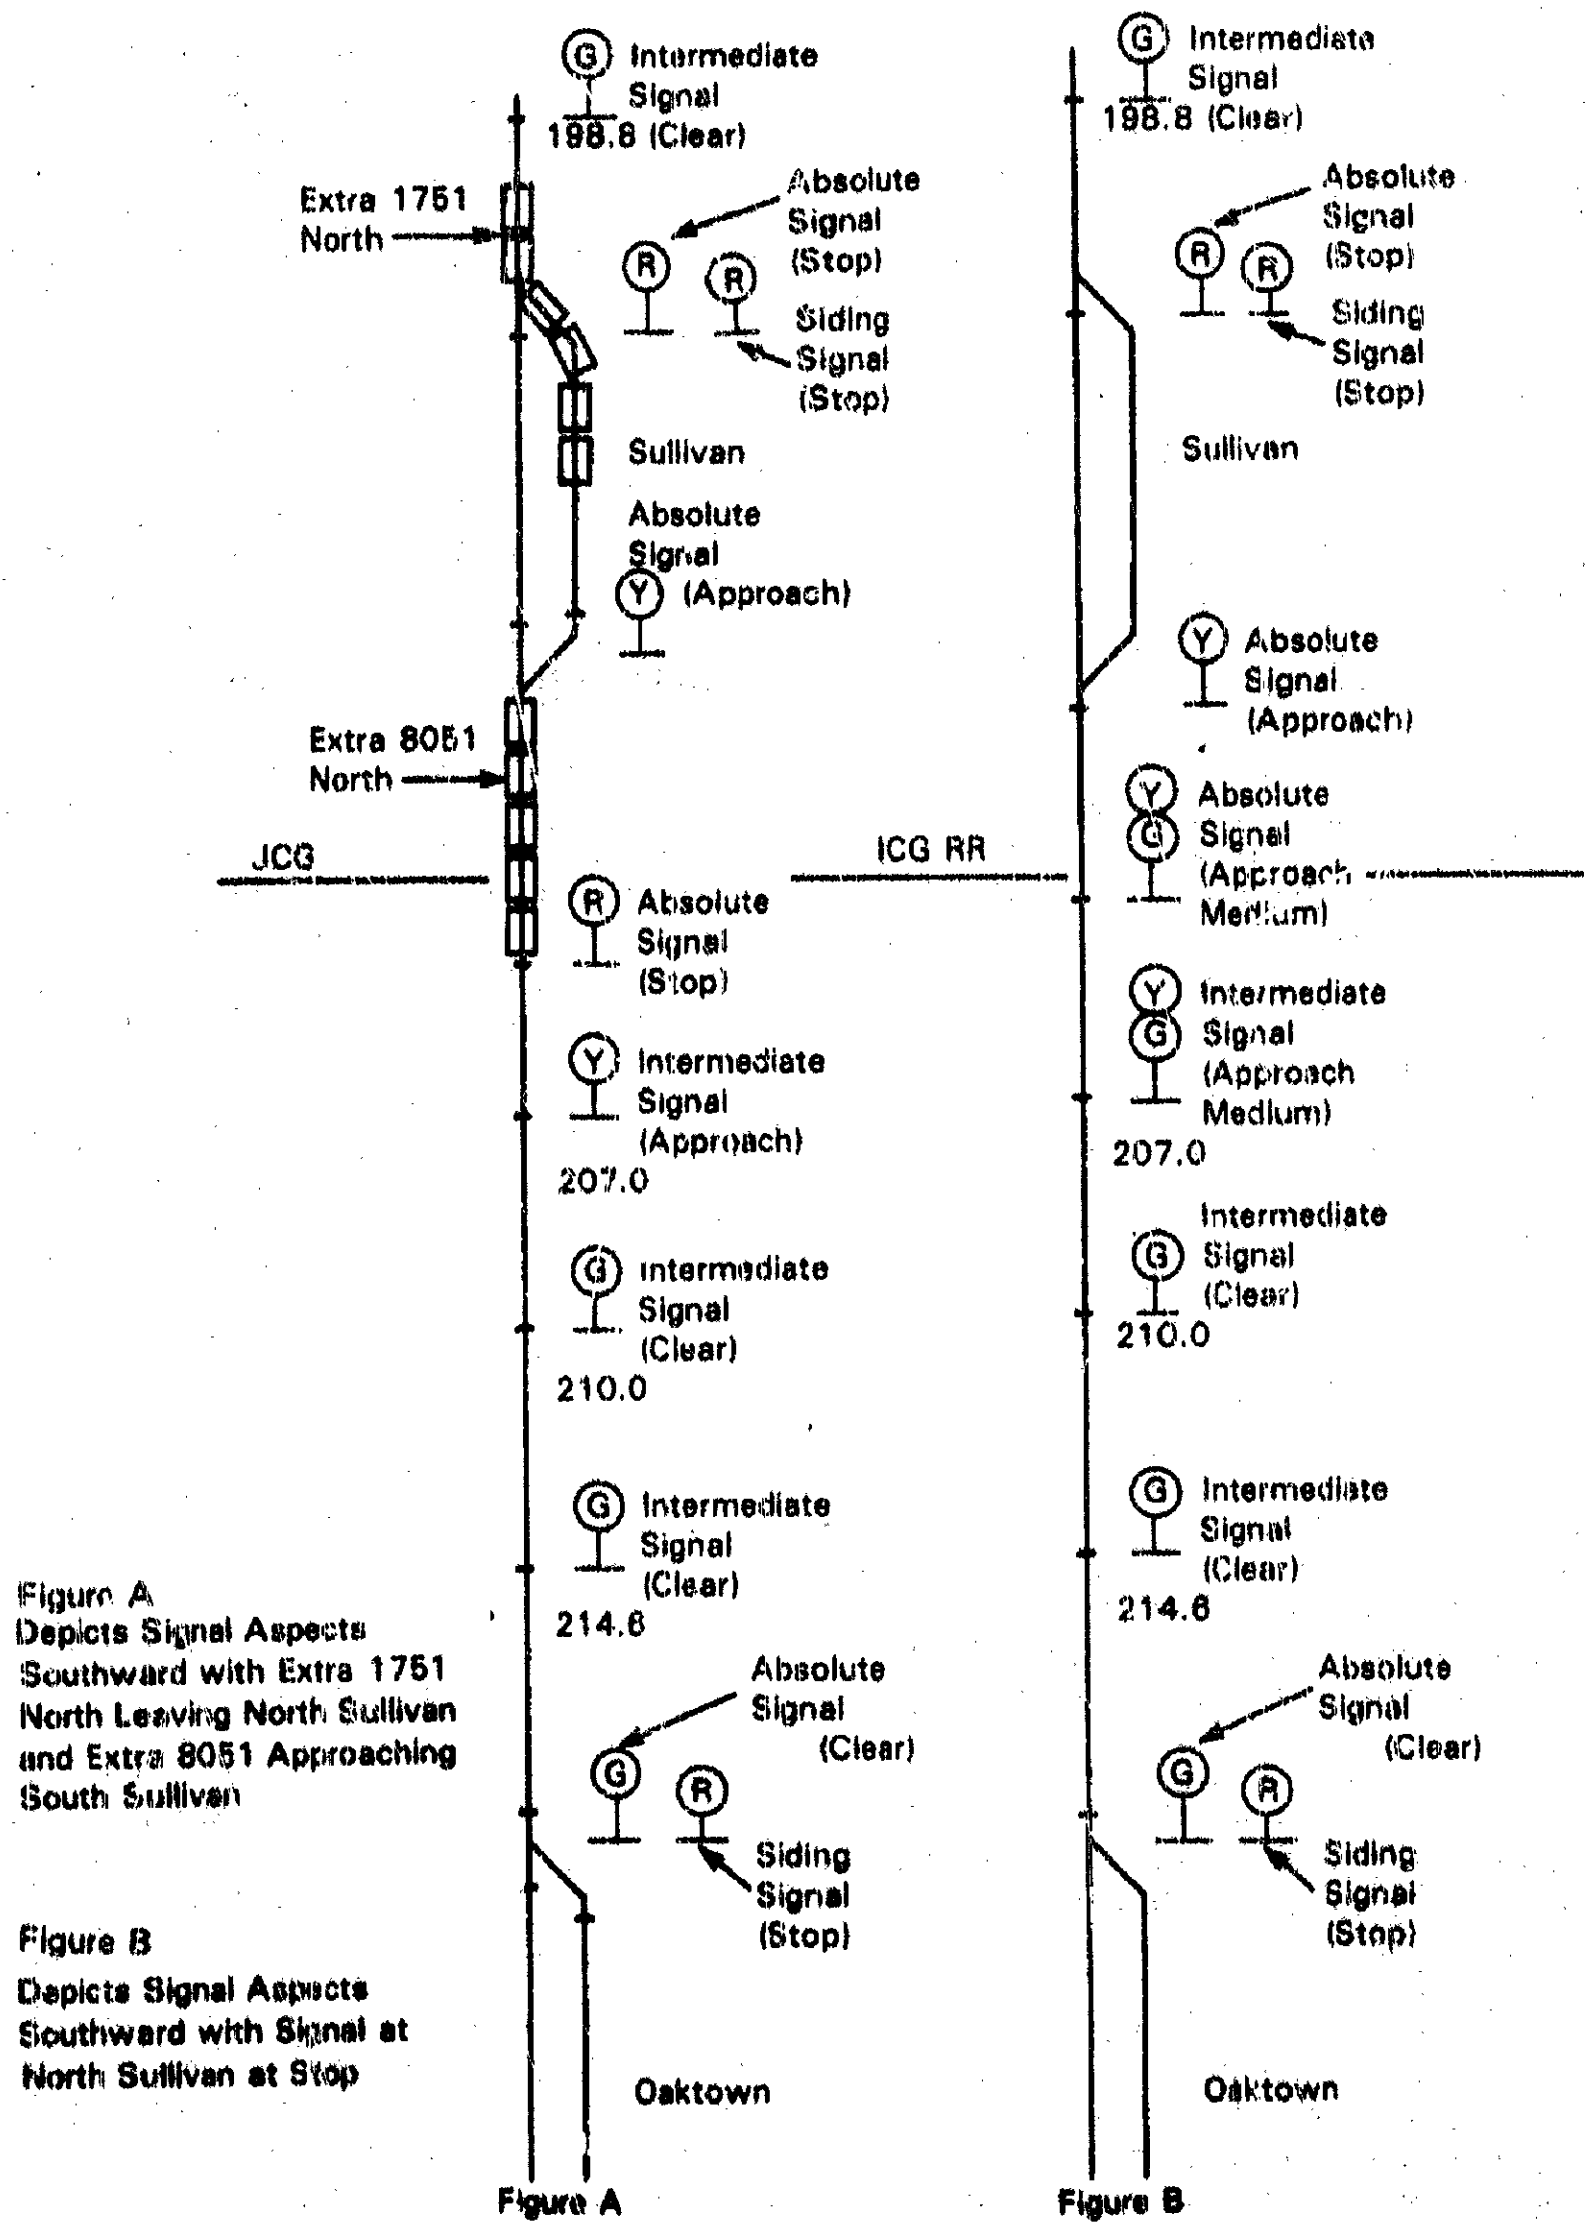
Figure 8.--Signal arrangement between Oaktown and Sullivan.

Absolute signals are located at North Sullivan and South Sullivan. Southward from South Sullivan, signals are located at the ICG grade crossing at MP 204.49, and intermediate signals are located at MP 206.90 (signal 207.0), MP 209.85 (signal 210.0), and MP 214.69 (signal 214.6). An absolute signal is located at North Oaktown. When the absolute signal at North Sullivan displays a red (stop) aspect, the signals in approach to North Sullivan display aspects as follows: the absolute signal at South Sullivan displays an approach (yellow) aspect, requiring a train to be operated at a speed of not more than 30 mph and prepared to stop at the next signal; the signal at the ICG crossing and signal 207.0 both display an approach medium (yellow over green) aspect requiring a train to approach the signal at South Sullivan displaying an approach aspect at a speed of not more than 30 mph; signal 210.0 displays a clear (green) aspect which allows maximum authorized speed. (See figure 8 and appendix C.) On the morning of September 14, the signal block occupied by Extra 8051 North would have caused the signal aspects to the rear to reflect the occupancy of Extra 8051 North. The engineers on trains No. 722 and Extra 1751 North did not report any discrepancies with the signal system between North Oaktown and North Sullivan on September 14.
