NATIONAL TRANSPORTATION SAFETY BOARD

RAILROAD ACCIDENT REPORT

**REAR END COLLISION
BETWEEN CONRAIL TRAINS
OIP1-6 AND ENPI-6X
NEAR SALTSBURG, PENNSYLVANIA
FEBRUARY 26, 1984**

NTSB/RAR-85/02

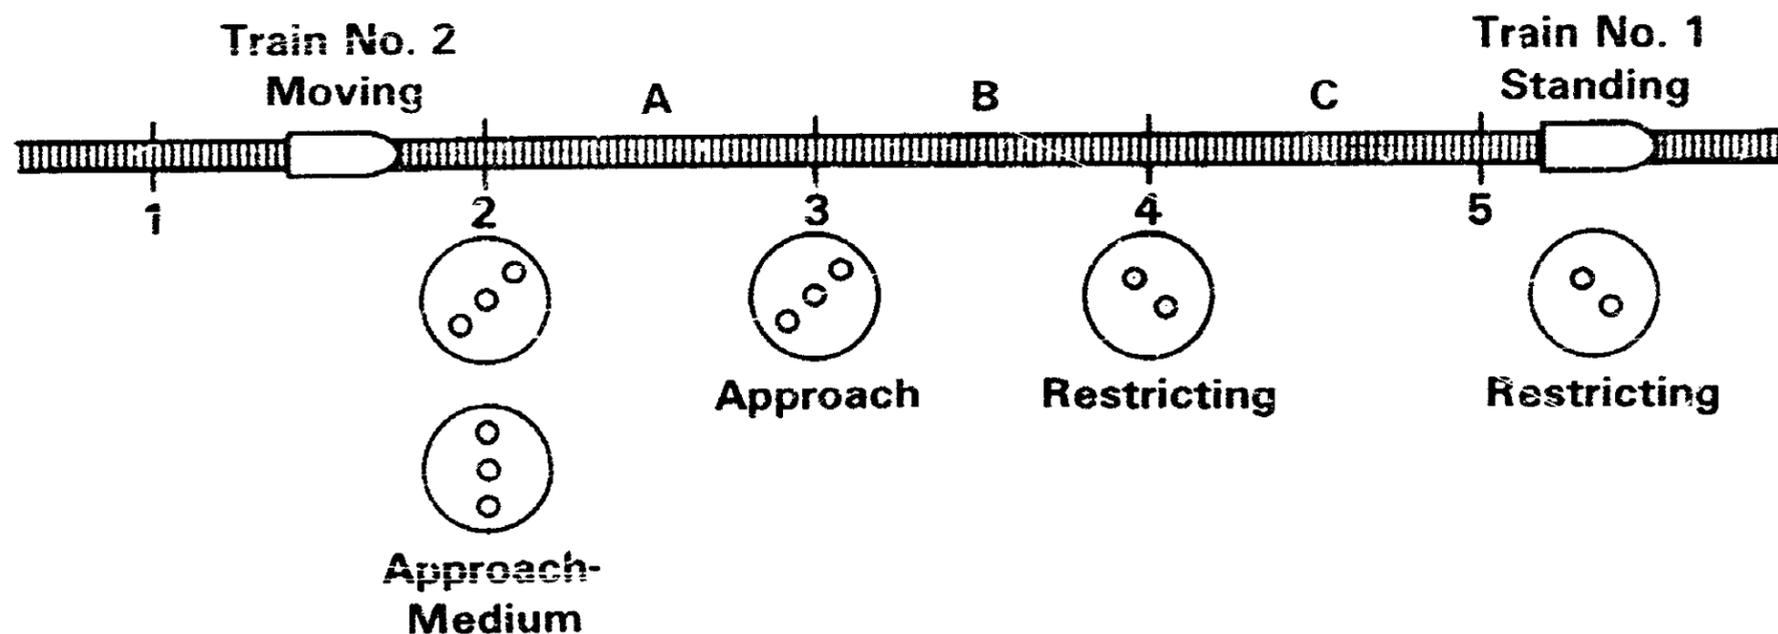
The cab signal system for the Conemaugh Line is designed on the four-aspect, three block plan. When a clear cab signal aspect is displayed to the engineer of a train, it indicates to him that at least three signal blocks ahead are clear. If a train were standing in the fourth signal block ahead, the cab signal aspects of a train approaching from the rear would indicate progressively clear, approach-medium, approach, restricting, and a second restricting. (See figure 6.)

Using figure 6, signal CS Point No. 1 would have been clear as the second train approached it and the locomotive cab signal would have indicated a clear block to signal CS Point No. 2. It would have meant to the crew of the second train that blocks A, B, and C were not obstructed. The cab signal is not arranged to display a stop aspect. The most restrictive aspect that can be displayed is a restricting aspect. The cab signal aspect displayed in the locomotive will not allow an engineer to determine whether his train is in the first red (restricting) signal block or the second. However, when a code change point is passed and the signal aspect is for a lower speed than the train is traveling, an audible whistle sounds to alert the engineer of the cab signal change. This audible whistle also sounds when the second restrictive signal point is passed.

Figure 6.—Four aspect three block cab signalling system -
 aspects displayed in locomotive operating compartment for condition shown.
 (Not related to the track/signal conditions between CP Blair and CP Salts.)
