NATIONAL TRANSPORTATION SAFETY BOARD

RAILROAD ACCIDENT REPORT

**HEAD-ON COLLISION OF
BURLINGTON NORTHERN RAILROAD
FREIGHT TRAINS EXTRA 6760 WEST AND
EXTRA 7907 EAST
NEAR MOTLEY, MINNESOTA
JUNE 14, 1984**

NTSB/RAR-85/06

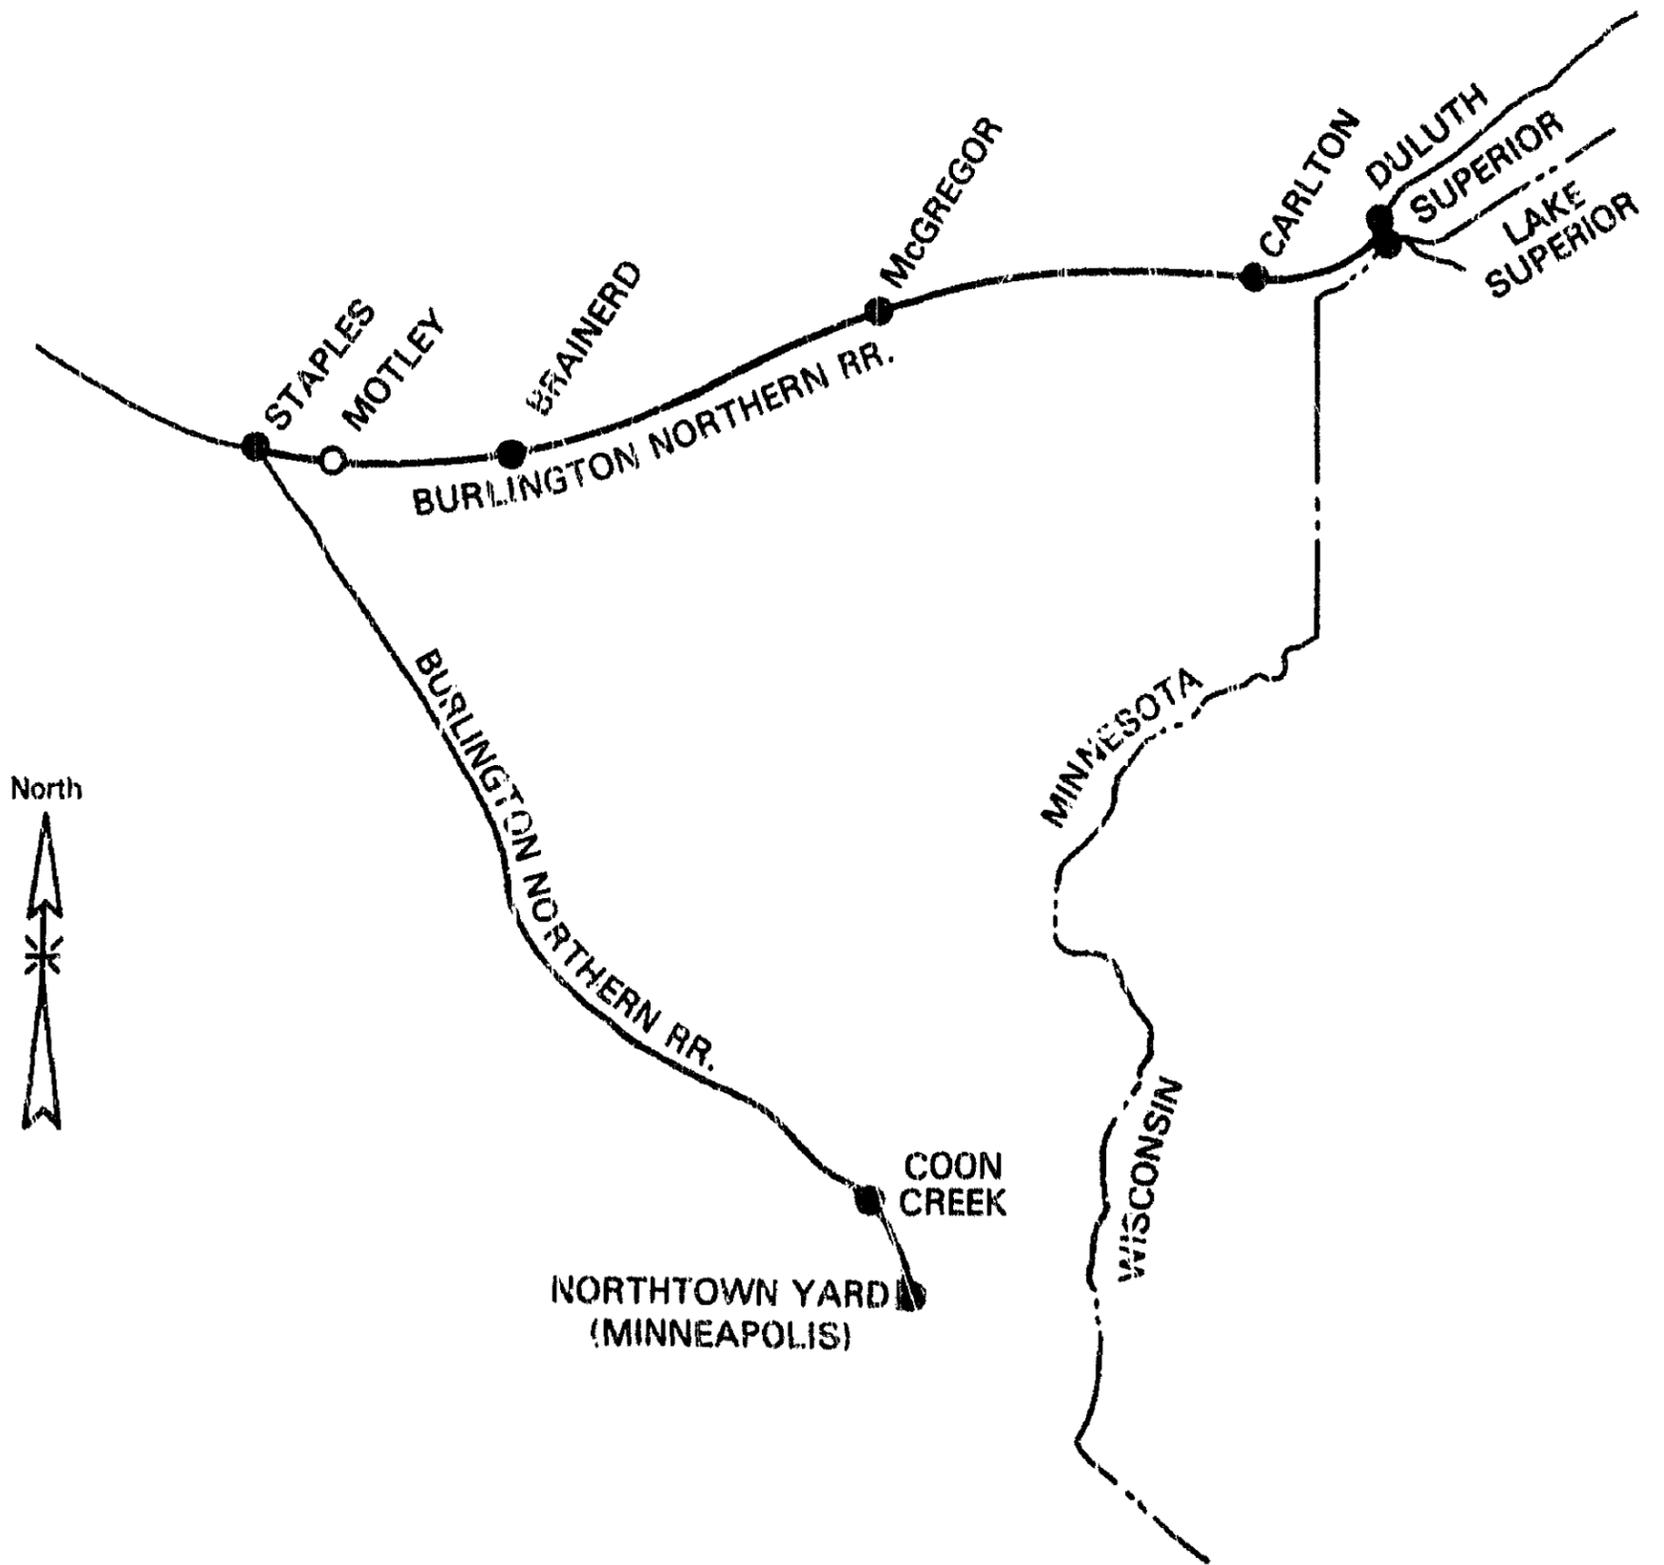
Figure 1.—Location diagram.

About 11:41 p.m. the dispatcher, located at Northtown Yard in Minneapolis, issued Train Order No. 85 (see appendix C), establishing authority for train Extra 7907 East from Staples to Carlton. (See figures 1 and 2.) (The route from Carlton to Superior is on a different subdivision and under the jurisdiction of another dispatcher.) Train Order No. 85 authorized train Extra 7907 East to proceed after train Extra 6730 West had arrived at Staples; however, train Extra 6730 West had already arrived at Staples at 11:35 p.m. The Train Order Crew Board (TOCB) clerk at Staples advised the dispatcher of the train's arrival, but the dispatcher did not cancel Train Order 85 and issue a new order. Rather, he issued Train Order No. 86 as an advisory that train Extra 6730 West had arrived. The dispatcher issued the clearance allowing train Extra 7907 East to proceed about 11:50 p.m. Shortly after the train order and clearance were received at Staples, the engineer and brakemen returned from the restaurant, met with the conductor, read the train orders and clearance, and were transported by a van to train Extra 7907 East.
