NATIONAL TRANSPORTATION SAFETY BOARD

RAILROAD ACCIDENT REPORT

DERAILMENT OF
AMTRAK PASSENGER TRAIN NO. 60,
THE MONTREALER, ON THE
CENTRAL VERMONT RAILWAY
NEAR ESSEX JUNCTION, VERMONT
JULY 7, 1984

NTSB/RAR-85/14

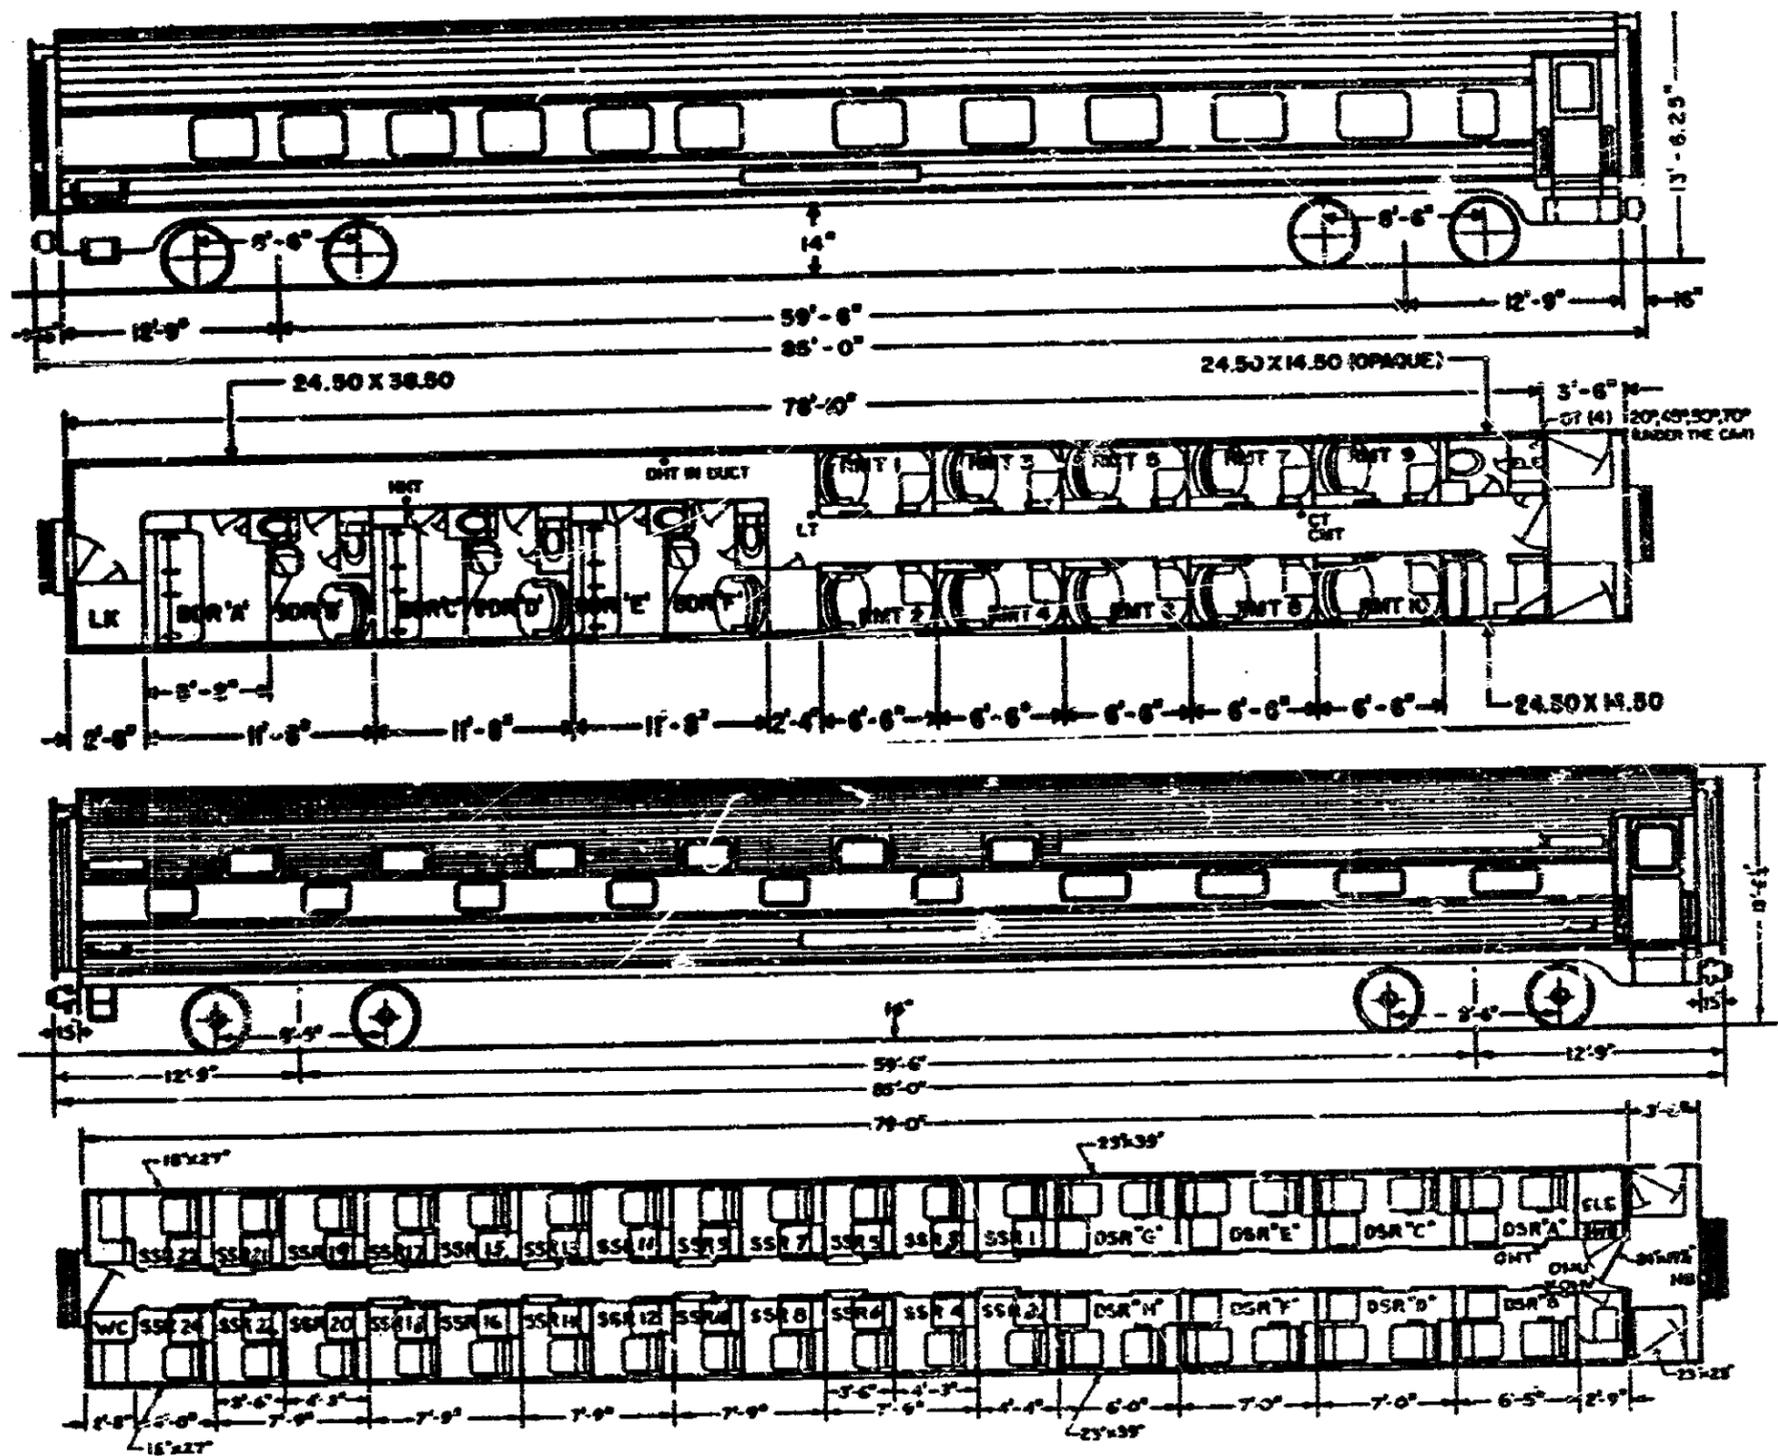
Slumbercoach No. 2083 had 24 small, staggered-level, single-occupancy roomettes forward, and 8 double-occupancy roomettes to the rear. Half of each group of roomettes was located on each side of a center corridor. (See figure 3). Fifteen passengers and 5 Amtrak crewmembers were assigned to 20 of the single roomettes, and 11 passengers were assigned to 7 of the 8 double roomettes. Several Amtrak crewmembers who were assigned space in the sleeping cars were on duty in other cars of the train when the accident occurred.

Figure 3.-- Plan view for Amtrak Bedroom/Roomette car No. 2915 (above) and Slumbercoach No. 2083 (below).

Evacuation of bedroom/roomette car No. 2915 proved difficult. The car came to rest on its left side on the south side of the embankment west of the opening. The rear end was at the base of the embankment; the forward end was at the top. The doors of the occupied compartments were closed, and many were jammed making it impossible for the occupants to open them unassisted. The windows of the five roomette compartments on the bottom side were against the embankment, so the occupants of these compartments were trapped and had to be extricated from above. Since the emergency lighting apparatus did not function, these occupants were in total darkness. Most occupants of the topside roomettes were able to evacuate through their window openings after rescuers had removed the windows. Injured occupants of one bedroom had to be rescued through the compartment window; persons in the other bedrooms had to crawl down the narrow corridor to the rear vestibule. Head room was greatly reduced because the car was on its side. (See figure 3.) The baggagemaster and passengers in the bottom side roomettes were evacuated through topside window openings after rescuers forced open their compartment doors and helped them climb out. The baggagemaster stated that upwards of an hour passed before he was evacuated.

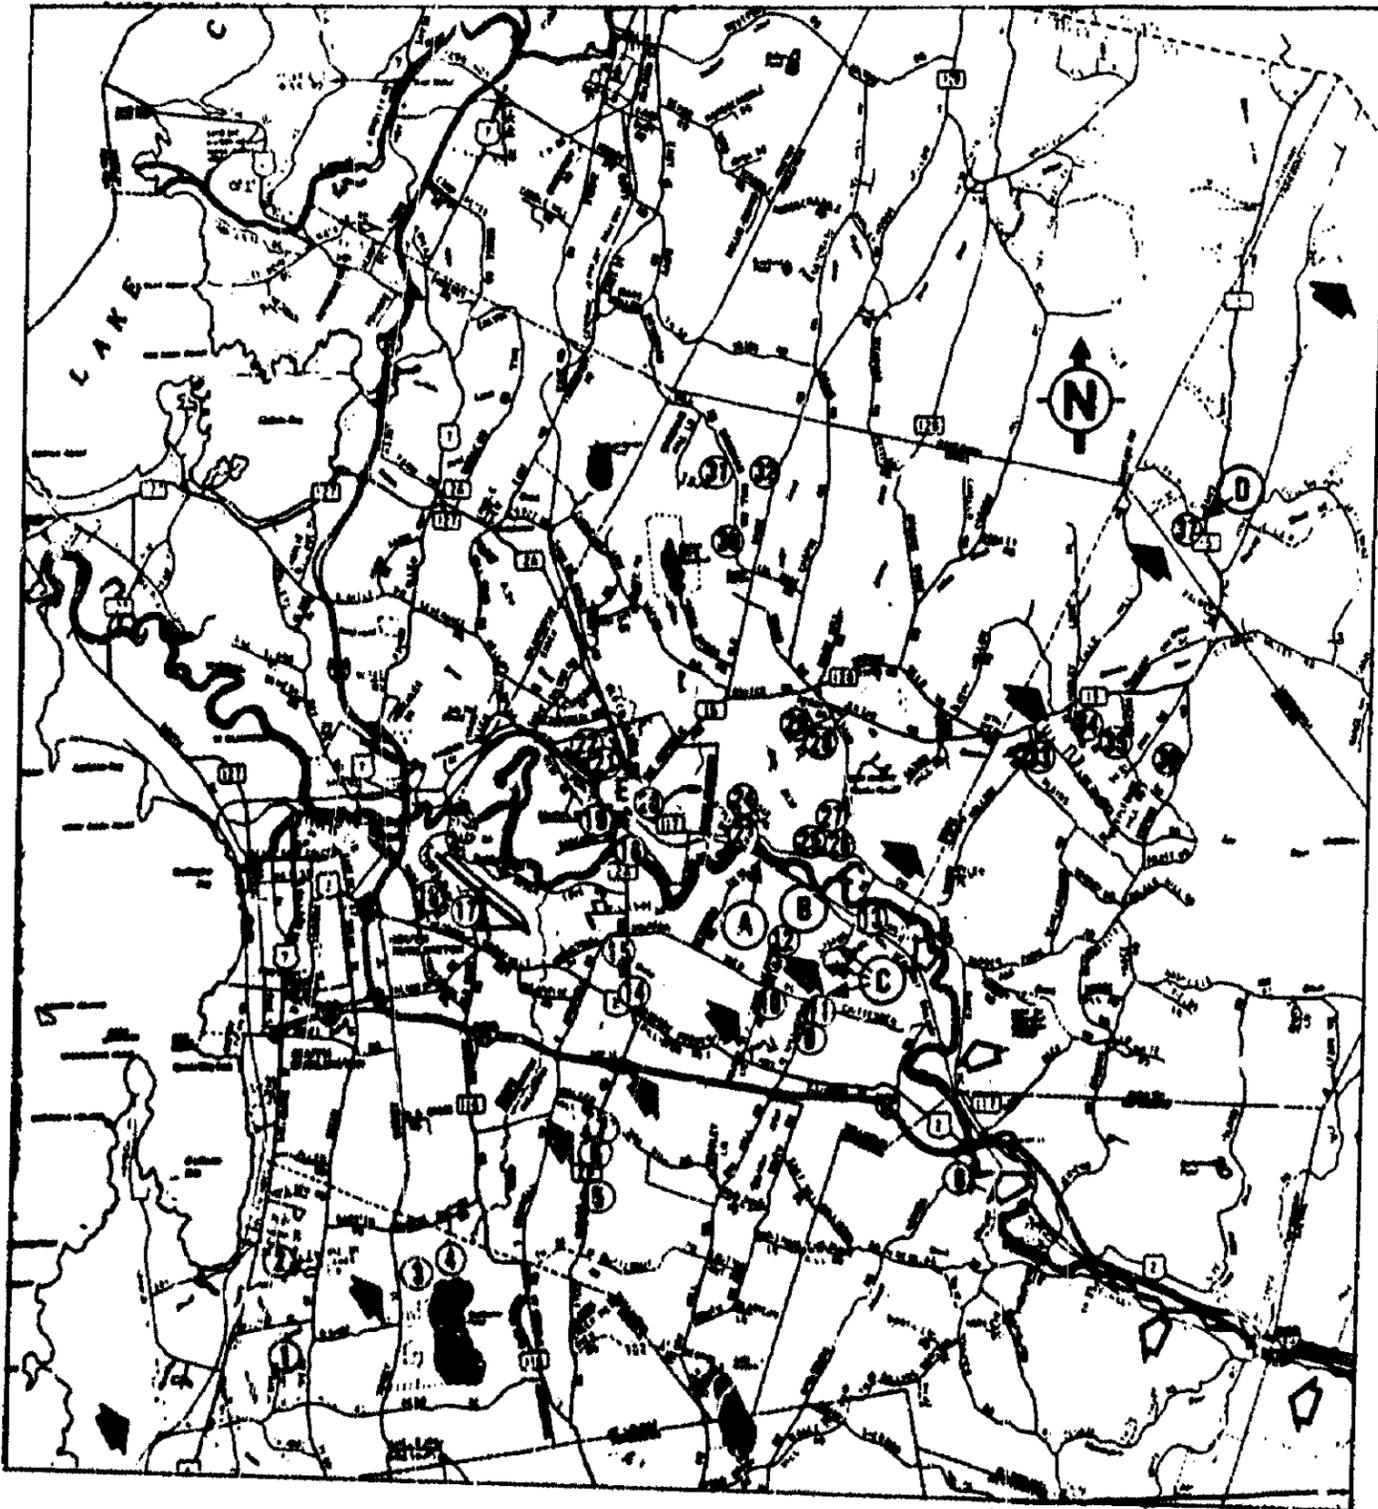
REPORTED RAINFALL READINGS
BURLINGTON-ESSEX JUNCTION AREA
July 6-7, 1984
